NOTICE OF NON-PERFORMANCE

INSPECTION REPORT

Electrical Corporation:	PacifiCorp
Report Number:	CAD_PC_IAG_20250522_1252
Inspector:	Ivan Garcia
WMP Year Inspected:	2024
Quarterly Data Report (QDR) Referenced:	Quarter 4 (Q4)
Inspection Selection:	Energy Safety viewed the contents of the Q4 QDR and performed an analysis that resulted in the selection of the WMP initiatives and locations referenced in this report.
Relevant WMP Initiative(s):	8.1.2.12 - Expulsion Fuse Replacements
Date of inspection:	May 22, 2025
City and/or County of Inspection:	Yreka, Siskiyou County
Inspection Purpose:	Assess the accuracy of PacifiCorp's QDR data, completeness of its work, compliance with WMP requirements, and compliance with its protocols.

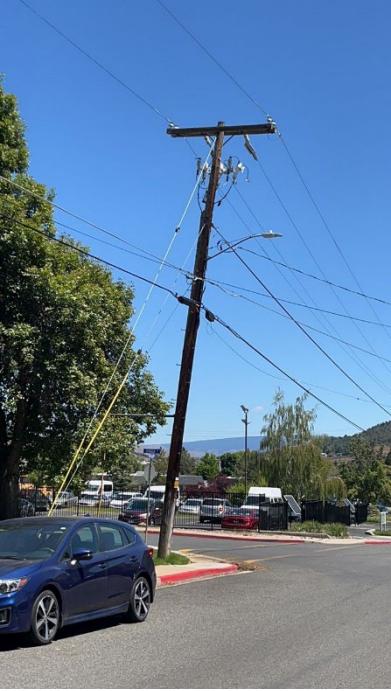
Item1GImg1: Overall pole	Item1GImg2: Pole ID

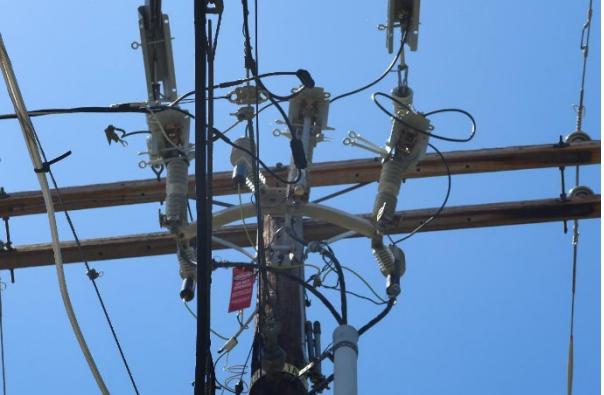
On Pole ID 624507.272701, Grid Hardening ID 7074439 at 935 Shasta Ave, Yreka, CA, 96097, USA, 41.7241174853914, -122.645554862033, the inspector observed that California Department of Forestry and Fire Protection (CAL FIRE)-approved non expulsion fuses were not installed in the cutouts. The inspector's observation is documented in Deficiency 1 photographs, which are attachments to this report. Photo numbers Item1GImg1, Item1IA1Img1, and Item1IA1Img2 depict incomplete installation of CAL FIRE-approved non expulsion fuses. In the 2024 Q4 Quarterly Data Report submission, PC reported that work on WMP initiative 8.1.2.12 – Expulsion Fuse Replacements were completed at this location on Pole ID 624507.272701, Grid Hardening ID 7074439.

1. Two of three CAL FIRE-approved non expulsion fuses were not installed in the cutouts.
2. Two fuses were observed hanging from the pole.

Item1IA1Img1: Two of three fuses not installed in the cutouts.	Item1IA1Img2: Two fuses hanging from the pole.

Deficiency 1. Energy Safety observed that in implementing 2024 WMP initiative 8.1.2.12 - Expulsion Fuse Replacements, PC failed to complete the installation of CAL FIRE-approved non expulsion fuses on Pole ID 624507.272701, Grid Hardening ID 7074439 at coordinates 41.7241174853914, -122.645554862033. Energy Safety considers this non-performance to be in the Minor risk category. PC must complete a corrective action for this deficiency by 12 months from date of this notice.¹
