NOTICE OF NON-PERFORMANCE

INSPECTION REPORT

Electrical Corporation:	Pacific Gas and Electric Company
Report Number:	CAD_PGE_CYA_20250827_1038
Inspector:	Cecilia Yaniz
WMP Year Inspected:	2024
Quarterly Data Report (QDR) Referenced:	Quarter Q4 (Q4)
Inspection Selection:	Energy Safety viewed the contents of the Q4 QDR and performed an analysis that resulted in the selection of the WMP initiatives and locations referenced in this report.
Relevant WMP Initiative(s):	8.1.2.5.1 - Traditional Overhead Hardening - Transmission Conductor
Date of inspection:	August 27, 2025
City and/or County of Inspection:	Sonoma, Sonoma County
Inspection Purpose:	Assess the accuracy of Pacific Gas and Electric Company's QDR data, completeness of its work, compliance with WMP requirements, and compliance with its protocols.

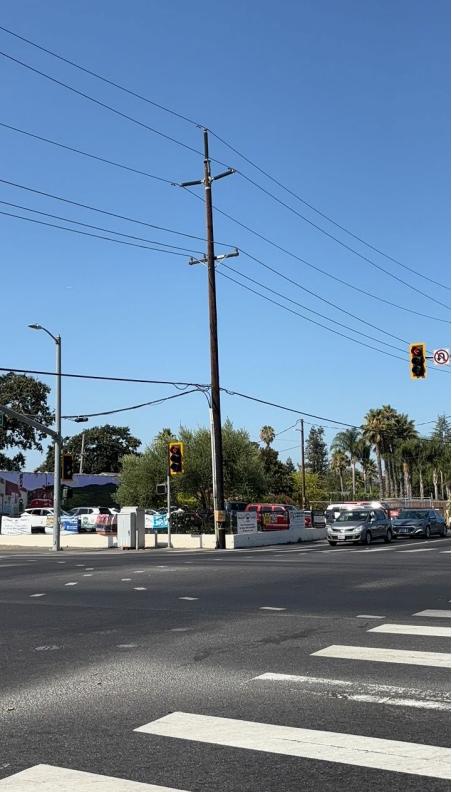
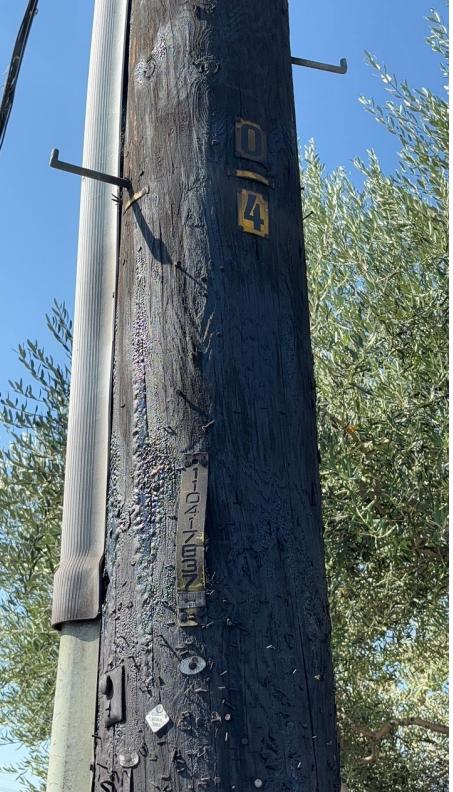
Item1GImg1: Overall Structure	Item1GImg2: Structure ID

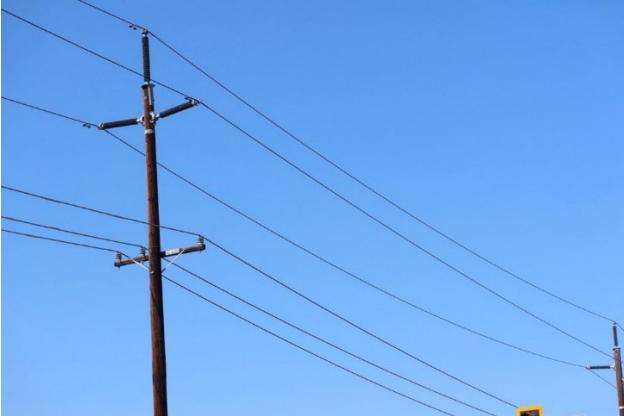
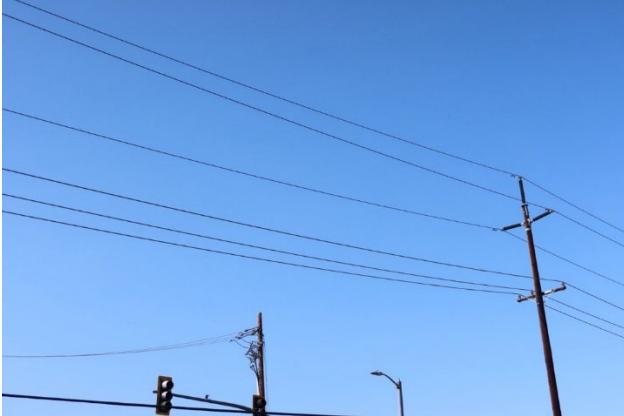
On Pole ID 000/004, Grid Hardening ID 74057097-1 at Mile 38.7 State Rte 12 E, Sonoma, CA, 95476, USA, 38.275761, -122.460516, the inspector observed no shunt splice on spans connecting to Pole 000/004. A splice was present on the eastern span of Pole 000/004 and was not shunted. The inspector's observation is documented in Deficiency 1 photographs, which are attachments to this report. Photo numbers Item1IA1Img1, Item1IA1Img2, and Item1IA1Img3 depict incomplete installation of shunt splices on transmission spans attached to Pole 000/004. In the 2024 Q4 Quarterly Data Report submission, PG&E reported that work on WMP initiative 8.1.2.5.1 - Traditional Overhead Hardening - Transmission Conductor were completed at this location, with the Description of Work field reading “Shunt Splice Installation.”

1. One existing splice was present on the spans connected to Pole 000/004. The splice is present on the eastern side between Pole 000/004 and 000/005.
2. No shunt splice was observed on top of the existing splice.
3. No shunt splice was observed on spans connected to either side of Pole 000/004.

Item1IA1Img1: Span between Pole 000/004 and 000/003.	Item1IA1Img2: Portion of span between Pole 000/004 and 000/005.

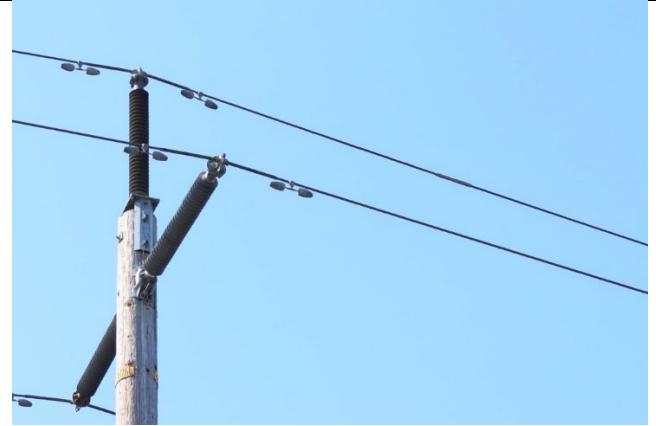
Deficiency #	Structure ID	Grid Hardening ID	Lat/Long	HFTD	Initiative Number	Severity	Deficiency Description
Deficiency 1	000/004	74057097-1	38.275761, -122.460516	Non-HFTD	8.1.2.5.1 - Traditional Overhead Hardening - Transmission Conductor	Minor	Failed to complete work on transmission shunt splice install.

Item1IA1Img3: A splice with no shunt on span between 000/004 and 000/005.

Deficiency 1. Energy Safety observed that in implementing 2024 WMP initiative 8.1.2.5.1 - Traditional Overhead Hardening - Transmission Conductor, PG&E failed to install splice shunts on Pole ID 000/004, Grid Hardening ID 74057097-1 at coordinates 38.275761, -122.460516. Energy Safety considers this non-performance to be in the Minor risk category. PG&E must complete a corrective action for this deficiency by 12 months from date of this notice.¹
