NOTICE OF NON-PERFORMANCE

INSPECTION REPORT

Electrical Corporation:	Pacific Gas and Electric Company
Report Number:	CAD_PGE_IAG_20250730_1537
Inspector:	Ivan Garcia
WMP Year Inspected:	2024
Quarterly Data Report (QDR) Referenced:	Quarter 4 (Q4)
Inspection Selection:	Energy Safety viewed the contents of the Q4 QDR and performed an analysis that resulted in the selection of the WMP initiatives and locations referenced in this report.
Relevant WMP Initiative(s):	8.1.2.10.1 – Down Conductor Detection Devices
Date of inspection:	July 30, 2025
City and/or County of Inspection:	Arroyo Grande, San Luis Obispo County
Inspection Purpose:	Assess the accuracy of PG&E's QDR data, completeness of its work, compliance with WMP requirements, and compliance with its protocols.

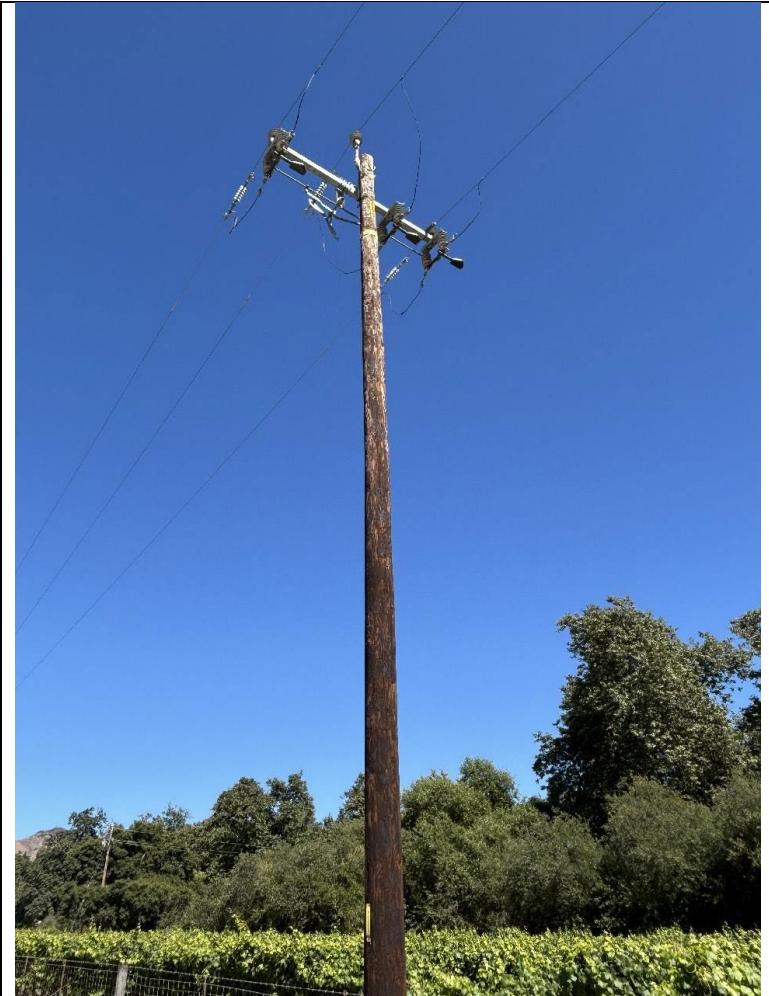
On Pole ID 121426400, Grid Hardening ID {02896B1A-0763-4C6D-956E-B1F4B47D7741} at Lopez Dr, Arroyo Grande, CA, 93420, USA, 35.175662, -120.525458, the inspector observed that no DCD device was installed at the subject pole. The inspector's observation is documented in Deficiency 1 photographs, which are attached to this report. Photo numbers Item1GImg1 and Item1IA1Img1 depict incomplete installation of a DCD device. In the 2024 Q4 Quarterly Data Report submission, PG&E reported that work on WMP initiative 8.1.2.10.1 – Down Conductor Detection Devices was completed at this location.

1. No DCD device was observed at the subject pole.

Item1IA1Img1: No DCD installed at this pole

Deficiency 1. Energy Safety observed that in implementing 2024 WMP initiative 8.1.2.10.1 - Downed Conductor Detection (DCD) Devices, PG&E failed to complete installation of a Downed Conductor Detection device on Pole ID 121426400, Grid Hardening ID {02896B1A-0763-4C6D-956E-B1F4B47D7741} at coordinates 35.175662, -120.525458. Energy Safety considers this non-performance to be in the Minor risk category. PG&E must complete a corrective action for this deficiency by 12 months from date of this notice.¹
