NOTICE OF NON-PERFORMANCE

On November 19, 2025, Energy Safety conducted an inspection of Southern California Edison Company's WMP initiatives in the vicinity of the city of Beaumont, California. The inspection report is enclosed herewith. Energy Safety found the following deficiencies:

INSPECTION REPORT

Electrical Corporation:	Southern California Edison Company
Report Number:	PAD_SCE_YLO_20251119_1355
Inspector:	Yana Loginova
WMP Year Inspected:	2025
Quarterly Data Report (QDR) Referenced:	Quarter 2 (Q2)
Inspection Selection:	Energy Safety viewed the contents of the Q2 QDR and performed an analysis that resulted in the selection of the WMP initiatives and locations referenced in this report.
Relevant WMP Initiative(s):	8.1.3.1 - Distribution Detailed Inspections and Remediations (IN-1.1)
Date of inspection:	November 19, 2025
City and/or County of Inspection:	Beaumont, Riverside County
Inspection Purpose:	Assess the accuracy of Southern California Edison Company's QDR data, completeness of its work, and performance of WMP requirements.

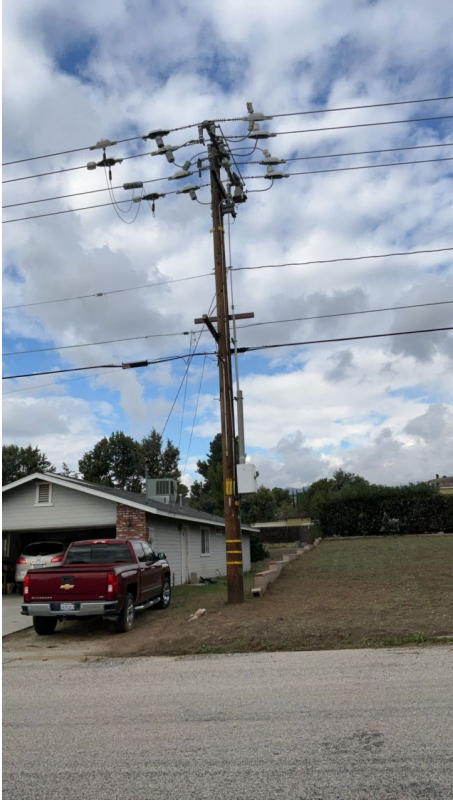
A close-up photograph of a white, vertically oriented tag attached to a wooden pole. The tag has the number '4804671E' printed on it.
<p>G1mg1: Overall Structure</p>	<p>G1mg2: Structure ID</p>

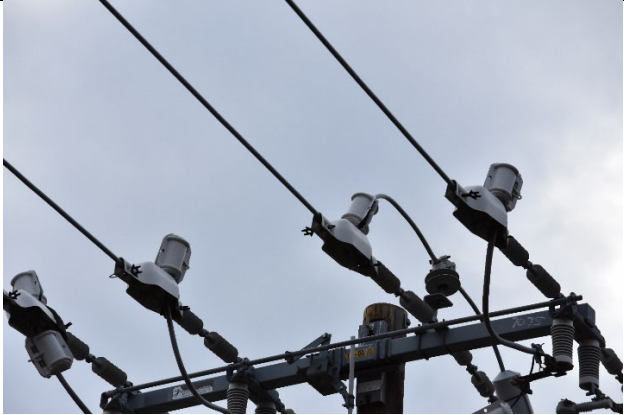
On Pole ID 4804671E, Grid Hardening ID 414065037-4804671E at 40501-40799 High St, Beaumont, CA, 92223, USA, 33.9706958300596, -116.954069974971, the inspector observed that the connector cover was opened. The inspector's observation is documented in Deficiency 1 photographs, which are attachments to this report. Photo numbers IA1Img1, IA1Img2, IA1Img3 and IA1Img4 depict an opened connector cover.

1. Southern California Edison Company's 2025 WMP initiative number 8.1.3.1 Distribution Detailed Inspections and Remediations work identified that remediation of connectors missing covers was completed at this location.
2. A connector cover was opened.

A close-up photograph of a utility pole showing a connector cover that has been opened, revealing internal wiring and components.
<p>IA1Img1: View showing opened connector cover</p>	<p>IA1Img2: View showing opened connector cover</p>

Deficiency 1. Energy Safety observed that in implementing 2025 WMP initiative 8.1.3.1 - Distribution High Fire Risk-Informed (HFRI) Inspections and Remediations (IN-1.1), SCE failed to complete the remediation of missing connector covers on Pole ID 4804671E, Grid Hardening ID 414065037-4804671E at coordinates 33.9706958300596, -116.954069974971. Energy Safety considers this non-performance to be in the Minor risk category. SCE must complete corrective action for this deficiency by 12 months from date of this notice.¹

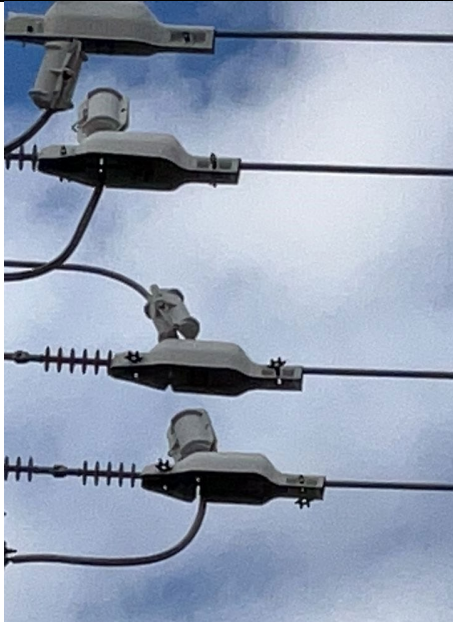
IA1Img3: View showing opened connector cover

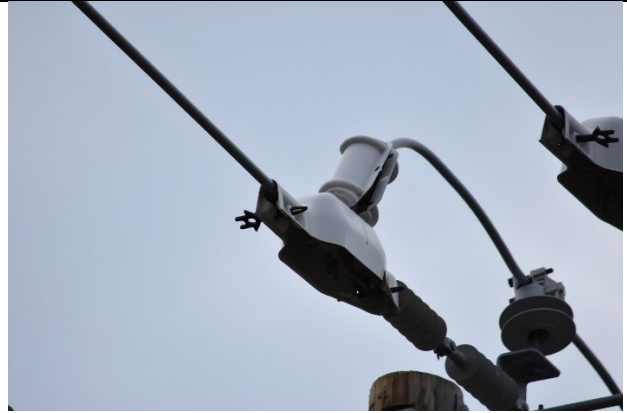
IA1Img4: View showing opened connector cover
