NOTICE OF NON-PERFORMANCE

INSPECTION REPORT

Electrical Corporation:	PacifiCorp
Report Number:	PAD_PC_IAG_20251007_0944
Inspector:	Ivan Garcia
WMP Year Inspected:	2025
Quarterly Data Report (QDR) Referenced:	Quarter 2 (Q2)
Inspection Selection:	Energy Safety viewed the contents of the Q2 QDR and performed an analysis that resulted in the selection of the WMP initiatives and locations referenced in this report.
Relevant WMP Initiative(s):	8.1.2.12 - Expulsion Fuse Replacements
Date of inspection:	October 7, 2025
City and/or County of Inspection:	Montague, Siskiyou County
Inspection Purpose:	Assess the accuracy of PacifiCorp's QDR data, completeness of its work, and performance of WMP requirements.

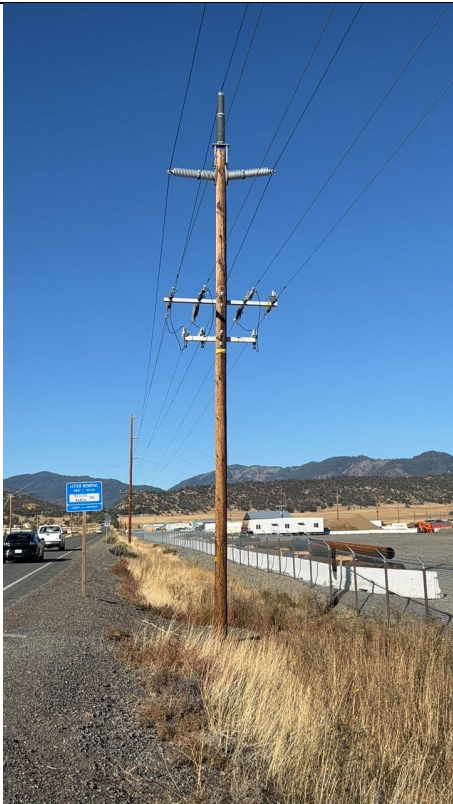
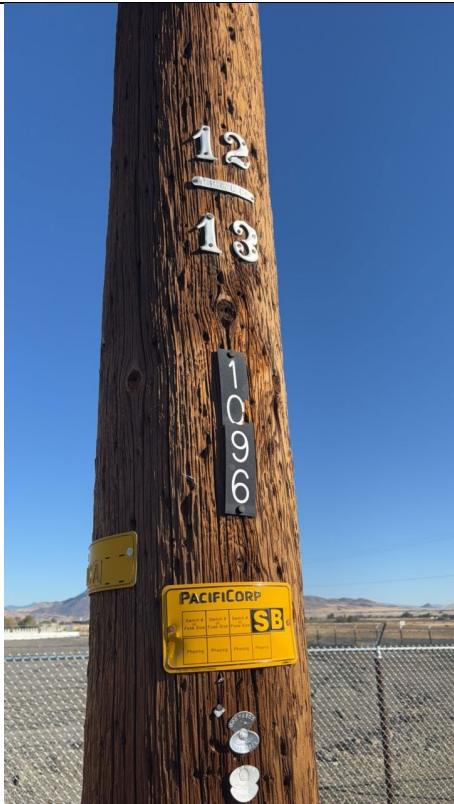
Deficiency 1

<p>G1mg1: Overall Structure</p>	<p>G1mg2: No Structure ID</p>

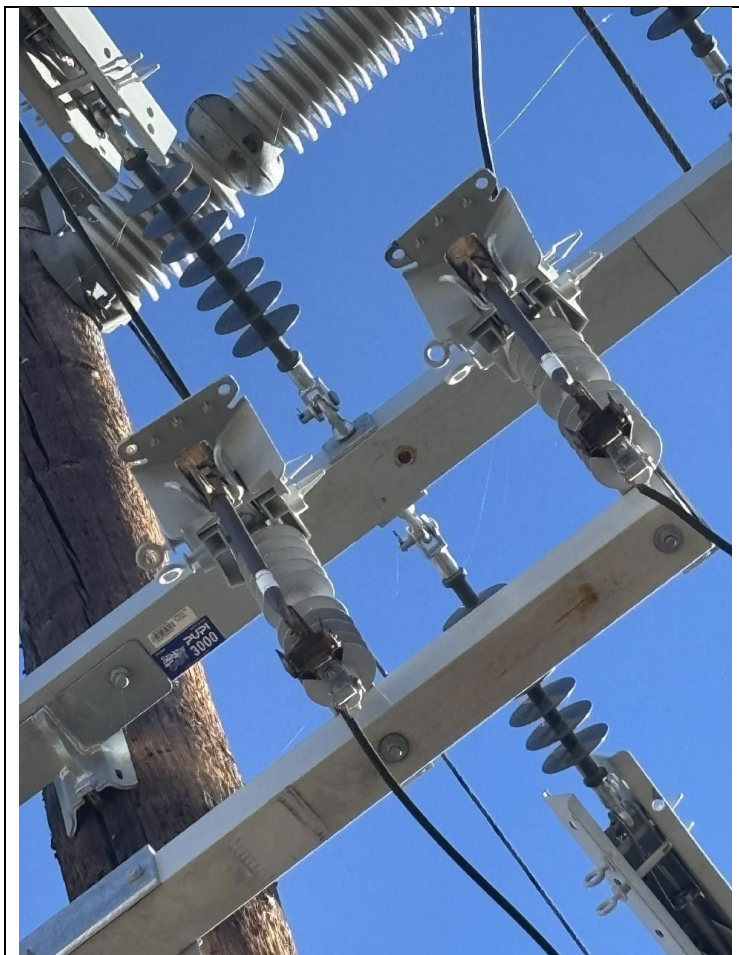
On pole with work associated with Grid Hardening ID 7112939 at 2534-2698 E Oberlin Rd, Montague, 96064, USA, 41.71146536840899, -122.59407909092792, the inspector observed California Department of Forestry and Fire Protection (CAL FIRE)-approved non expulsion fuses were not installed. The inspector's observation is documented in Deficiency 1 photographs, which are attachments to this report. Photo number IA1Img1 depicts incomplete installation of CAL FIRE-approved non expulsion fuses. In the 2025 Q2 Quarterly Data Report submission, PC reported that work on WMP initiative 8.1.2.12 – Expulsion Fuse Replacements were completed at this location.

1. CAL FIRE-approved non expulsion fuses were not installed at the subject pole.
2. The inspector observed solid blade disconnects on the subject pole.
3. No reclosers, sectionalizers, or voltage regulators were observed at the subject pole.

IA1Img1: Solid blade disconnects installed
