NOTICE OF NON-PERFORMANCE

INSPECTION REPORT

Electrical Corporation:	PacifiCorp
Report Number:	PAD_PC_IAG_20251007_1041
Inspector:	Ivan Garcia
WMP Year Inspected:	2025
Quarterly Data Report (QDR) Referenced:	Quarter 2 (Q2)
Inspection Selection:	Energy Safety viewed the contents of the Q2 QDR and performed an analysis that resulted in the selection of the WMP initiatives and locations referenced in this report.
Relevant WMP Initiative(s):	8.1.2.12 - Expulsion Fuse Replacements
Date of inspection:	October 07, 2025
City and/or County of Inspection:	Montague, Siskiyou County
Inspection Purpose:	Assess the accuracy of PacifiCorp's QDR data, completeness of its work, and performance of WMP requirements.

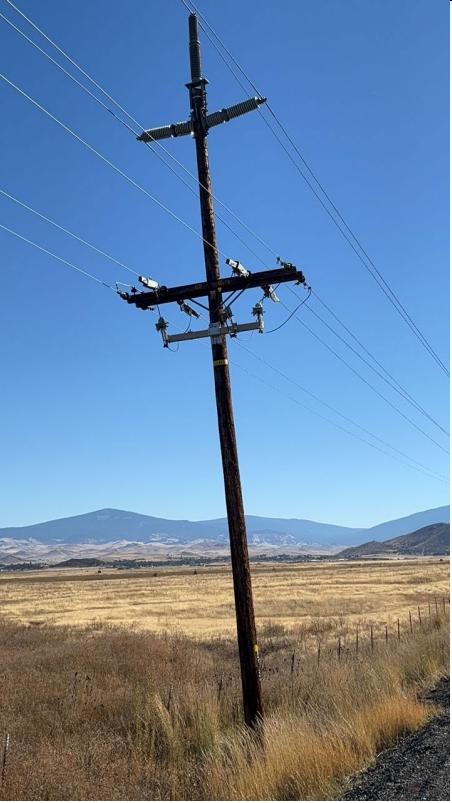
GImg1: Overall Structure	GImg2: No Structure ID

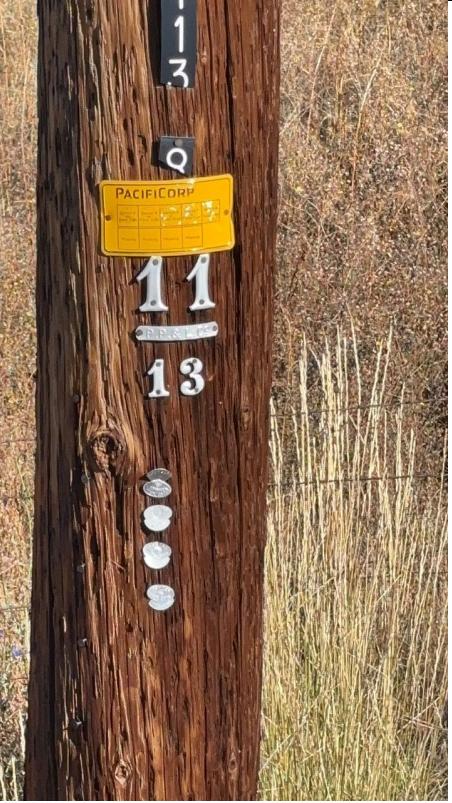
Structure ID: No Structure ID

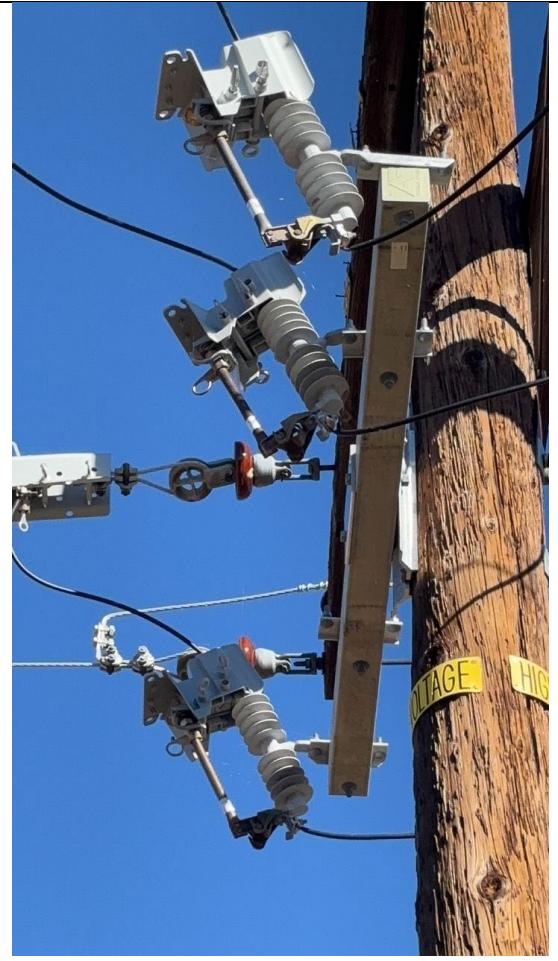
On pole with work associated with Grid Hardening ID 7112939 at 2701-3399 Oberlin Rd, Montague, 96064, USA, 41.71135922538462, -122.59285126282776, the inspector observed California Department of Forestry and Fire Protection (CAL FIRE)-approved non expulsion fuses were not installed. The inspector's observation is documented in Deficiency 1 photographs, which are attachments to this report. Photo number IA1Img1 depicts incomplete installation of CAL FIRE-approved non expulsion fuses. In the 2025 Q2 Quarterly Data Report submission, PC reported that work on WMP initiative 8.1.2.12 – Expulsion Fuse Replacements was complete at this location.

1. CAL FIRE-approved non expulsion fuses were not installed at the subject pole.
2. The inspector observed solid blade disconnects on the subject pole.
3. No reclosers, sectionalizers, or voltage regulators were observed at the subject pole.

IA1Img1: Solid blade disconnects installed

Deficiency 1. Energy Safety observed that in implementing 2025 WMP initiative 8.1.2.12 - Expulsion Fuse Replacements, PC failed to complete the installation of CAL FIRE-approved non expulsion fuses on a pole with work associated with Grid Hardening ID 7112939 at coordinates 41.71135922538462, -122.59285126282776. Energy Safety considers this non-performance to be in the Minor risk category. PC must complete a corrective action for this deficiency by 12 months from date of this notice.¹
