NOTICE OF NON-PERFORMANCE

INSPECTION REPORT

Electrical Corporation:	PacifiCorp
Report Number:	PAD_PC_IAG_20251007_1142
Inspector:	Ivan Garcia
WMP Year Inspected:	2025
Quarterly Data Report (QDR) Referenced:	Quarter 2 (Q2)
Inspection Selection:	Energy Safety viewed the contents of the Q2 QDR and performed an analysis that resulted in the selection of the WMP initiatives and locations referenced in this report.
Relevant WMP Initiative(s):	8.1.2.12- Expulsion Fuse Replacements
Date of inspection:	October 7, 2025
City and/or County of Inspection:	Montague, Siskiyou County
Inspection Purpose:	Assess the accuracy of PacifiCorp's QDR data, completeness of its work, and performance of WMP requirements.

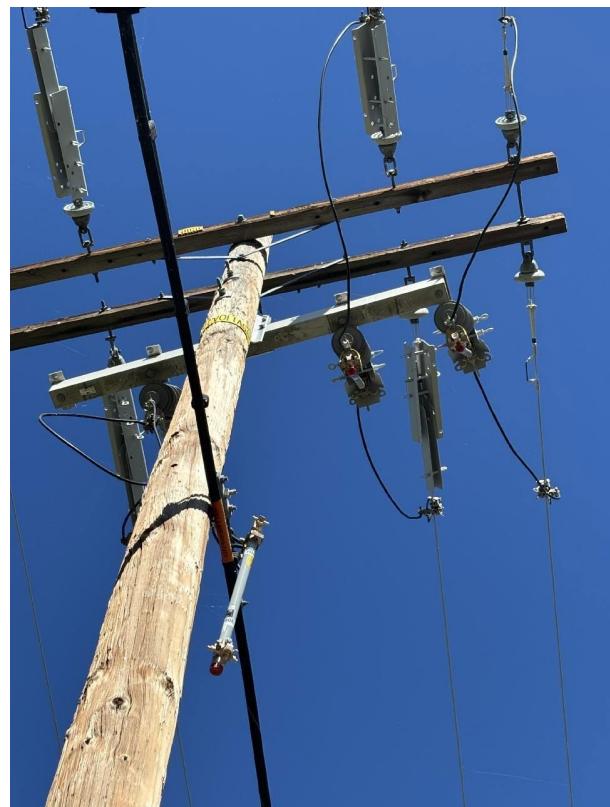
On Pole ID 624506.332400, Grid Hardening ID 7112939 at 1301-1399 Scala Ln, Montague, 96064, USA, 41.70484664234158, -122.54966794542612, the inspector observed that one of the three California Department of Forestry and Fire Protection (CAL FIRE)-approved non expulsion fuses was not installed. The inspector's observation is documented in Deficiency 1 photographs, which are attachments to this report. Photo numbers Item1GImg1, Item1IA1Img1, and Item1IA1Img2 depict incomplete installation of a CAL FIRE-exempt fuse. In the 2025 Q2 Quarterly Data Report submission, PC reported that work on WMP initiative 8.1.2.12 – Expulsion Fuse Replacements was complete at this location.

1. A CAL FIRE-approved non expulsion fuse was not installed in the cutout at the subject pole.
2. A CAL FIRE-approved non expulsion fuse was observed hanging from the subject pole.

Item1IA1Img1: One CAL FIRE-approved non expulsion fuse not installed in the cutout.

Deficiency 1. Energy Safety observed that in implementing 2025 WMP initiative 8.1.2.12- Expulsion Fuse Replacements, PC failed to complete the installation of CAL FIRE-approved non expulsion fuses on Pole ID 624506.332400, associated with Grid Hardening ID 7112939 at coordinates 41.70484664234158, -122.54966794542612. Energy Safety considers this non-performance to be in the Minor risk category. PC must complete a corrective action for this deficiency by 12 months from the date of this notice.¹

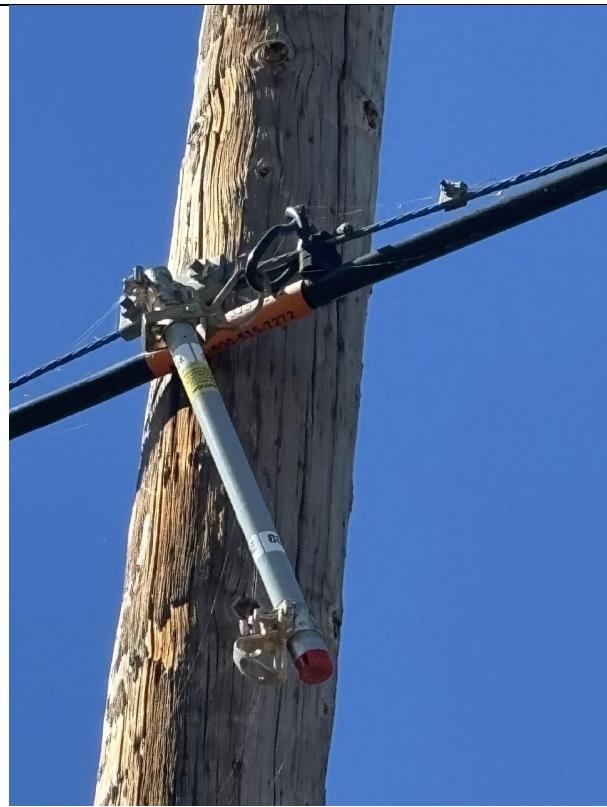
Item1IA1Img2: One CAL FIRE-approved non expulsion fuse hanging from the pole.
