NOTICE OF NON-PERFORMANCE

INSPECTION REPORT

Electrical Corporation:	PacifiCorp
Report Number:	PAD_PC_RMA_20251007_1050
Inspector:	Romeo Marroquin Ajcac
WMP Year Inspected:	2025
Quarterly Data Report (QDR) Referenced:	Quarter 2 (Q2)
Inspection Selection:	Energy Safety viewed the contents of the Q2 QDR and performed an analysis that resulted in the selection of the WMP initiatives and locations referenced in this report.
Relevant WMP Initiative(s):	8.1.2.12 - Expulsion Fuse Replacements
Date of inspection:	October 7, 2025
City and/or County of Inspection:	Montague, Siskiyou County
Inspection Purpose:	Assess the accuracy of PacifiCorp's QDR data, completeness of its work, and performance of WMP requirements.

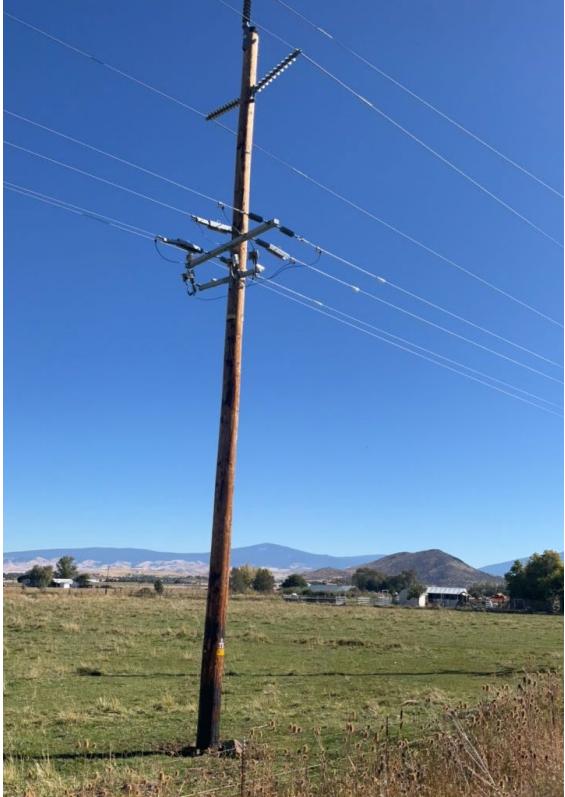
GImg1: Overall Structure	GImg2: Structure ID

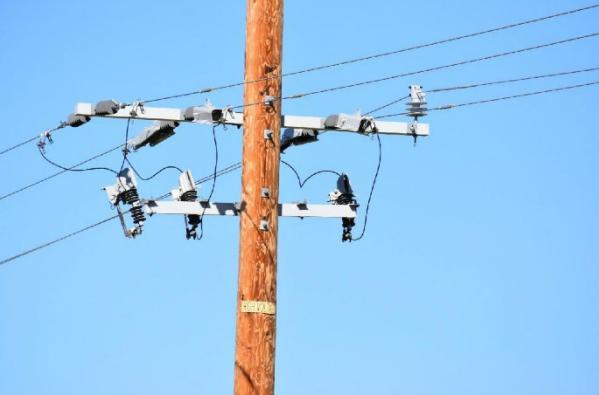
On a pole associated with Grid Hardening ID 7112939 at 41.7058549755094, -122.564514, the inspector observed that CAL FIRE-approved non-expulsion fuses were not installed. The inspector's observation is documented in Deficiency 1 photographs, which are attached to this report. Photo numbers IA1Img1 and IA1Img2 depict incomplete installation of CAL FIRE-approved non-expulsion fuses. In the 2025 Q2 Quarterly Data Report submission, PC reported that work on WMP initiative 8.1.2.12 – Expulsion Fuse Replacements was complete at this location.

1. The inspector observed that three fuses were installed that were not CAL FIRE-approved non-expulsion fuses.
2. Three solid blade disconnects were observed at the inspected location.
3. No reclosers, sectionalizers, or voltage regulators were observed at the subject pole.

IA1Img1: Three solid blade disconnects were installed.	IA1Img2: Three solid blade disconnects were installed (detailed view).

Deficiency 1. Energy Safety observed that in implementing the 2025 WMP initiative - 8.1.2.12 - Expulsion Fuse Replacements, PC failed to complete the installation of CAL FIRE-approved non expulsion fuses on pole associated with Grid Hardening ID 7112939, at coordinates 41.7058549755094, -122.564514. Energy Safety considers this non-performance to be in the Minor risk category. PC must complete a corrective action for this deficiency by 12 months from date of this notice.¹
