NOTICE OF NON-PERFORMANCE

INSPECTION REPORT

Electrical Corporation:	PacifiCorp
Report Number:	PAD_PC_RMA_20251007_1132
Inspector:	Romeo Marroquin Ajcac
WMP Year Inspected:	2025
Quarterly Data Report (QDR) Referenced:	Quarter 2 (Q2)
Inspection Selection:	Energy Safety viewed the contents of the Q2 QDR and performed an analysis that resulted in the selection of the WMP initiatives and locations referenced in this report.
Relevant WMP Initiative(s):	8.1.2.12 - Expulsion Fuse Replacements
Date of inspection:	October 7, 2025
City and/or County of Inspection:	Yreka, Siskiyou County
Inspection Purpose:	Assess the accuracy of PacifiCorp's QDR data, completeness of its work, and performance of WMP requirements.

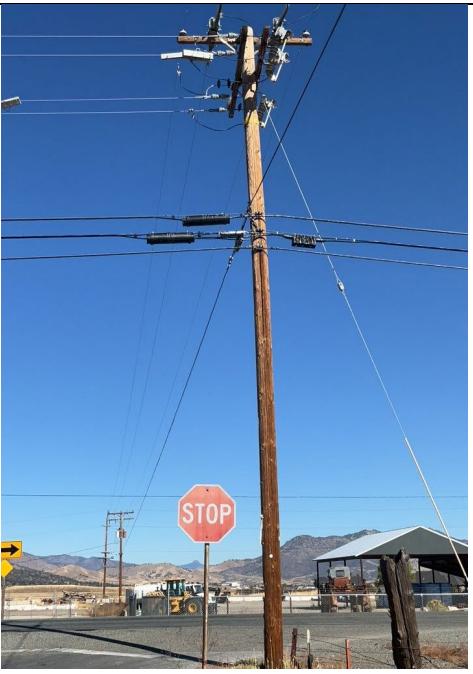
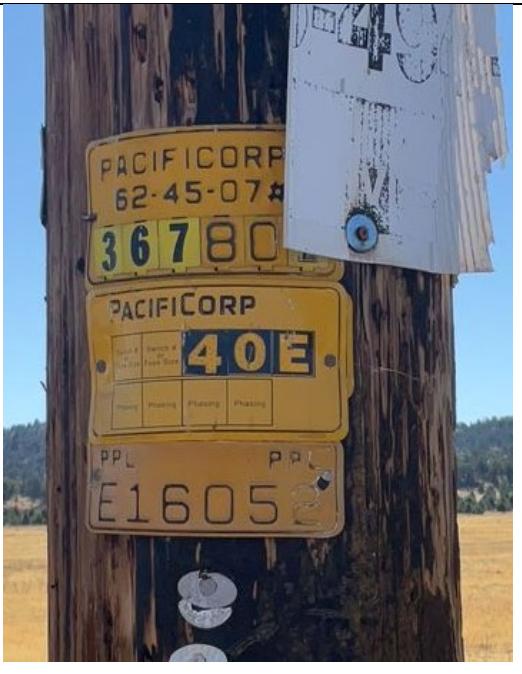
GImg1: Overall Structure	GImg2: Structure ID

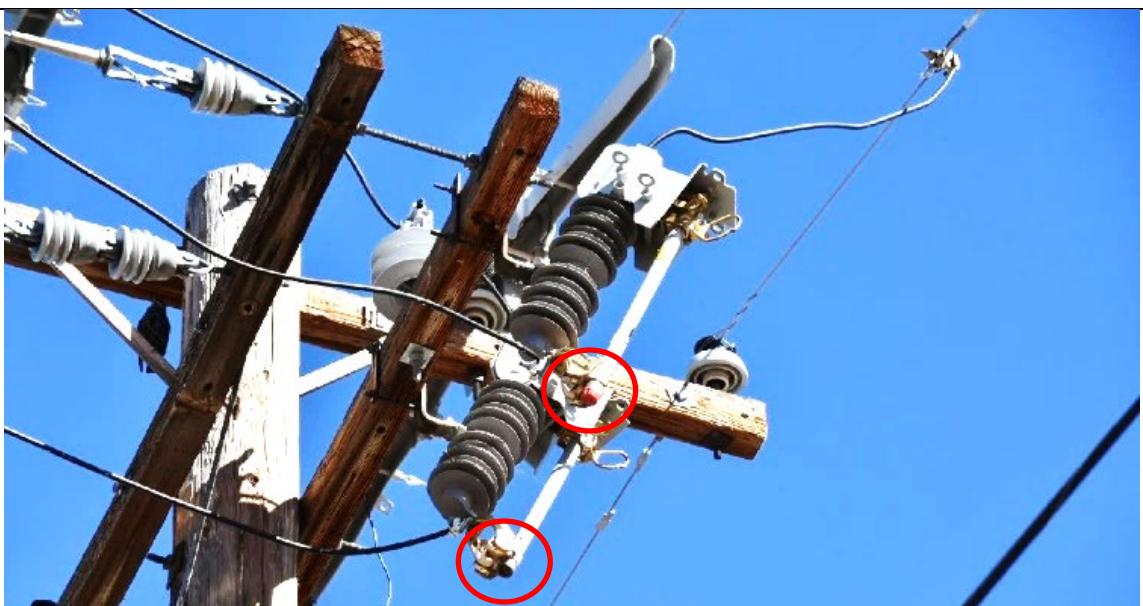
On Pole ID 624507.367802, Grid Hardening ID 7112939 at Sanitary Landfill Rd, Yreka, CA, 96097, USA, 41.71141544174789, -122.598414, the inspector observed that one of the installed CAL FIRE-approved non-expulsion fuses was missing its red cap. The inspector's observation is documented in Deficiency 1 photographs, which are attached to this report. Photo number IA1Img1 depicts a CAL FIRE-approved non-expulsion fuse missing its red cap. Additionally, photo numbers Item1B1Img1 and Item1B1Img2 depict PC construction standards, which clarify that CAL FIRE-approved non-expulsion SMU-20 fuses, such as the one observed by the inspector at the inspection location, must have its red cap intact and in place when installed in an SMD-20 mounting. In the 2025 Q2 Quarterly Data Report submission, PC reported that work on WMP initiative 8.1.2.12 – Expulsion Fuse Replacements was complete at this location.

1. One of the CAL FIRE-approved non-expulsion SMU-20 fuses was missing its red cap.
2. PC's construction standards for CAL FIRE-approved non-expulsion SMU-20 fuses require the presence of a red cap when installed in SMD-20 mounting.

IA1Img1: CAL FIRE-approved non expulsion fuse with a missing red cap (bottom left) and second CAL FIRE-approved non expulsion fuse with red cap attached (upper right).

Deficiency 1. Energy Safety observed that in implementing the 2025 WMP initiative 8.1.2.12 – Expulsion Fuse Replacements, PC failed to complete the installation of CAL FIRE-approved non-expulsion fuses on Pole ID 624507.367802, Grid Hardening ID 7112939 at coordinates 41.71141544174789, -122.598414. Energy Safety considers this non-performance to be in the Minor risk category. PC must complete a corrective action for this deficiency by 12 months of this notice.¹

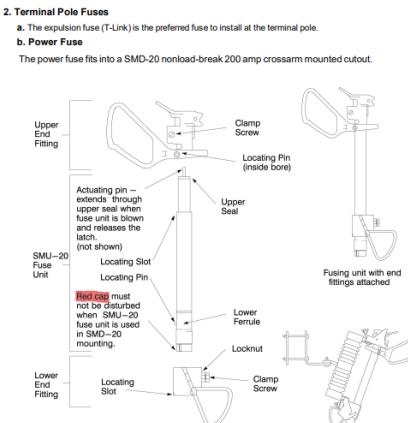
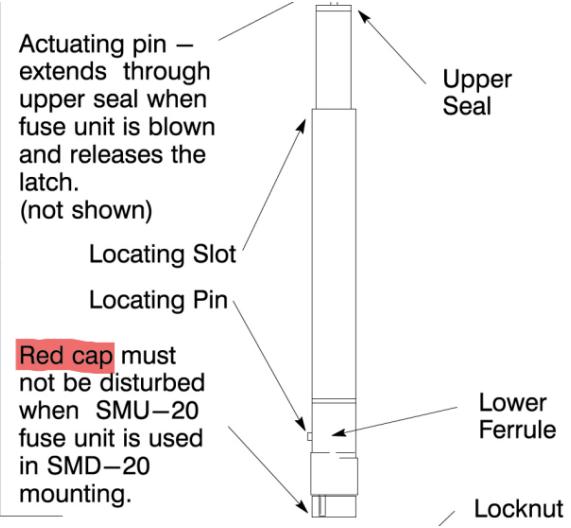
<p>Figure 4—SMU-20 Power Fuse with End Fitting for Use with SMD-20 Mounting in Pole-Mounted Applications</p> <p><small>Distribution Construction Standard Page 5 of 8 Published Date: 24 Feb 00 Last Reviewed: 11 Jul 24 Printed versions of this standard require prior approval. Contact the standard engineering manager for approval processes and forms. Printed versions of this standard may be out of date. Please consult the online standards for the most recent version. This standard shall be used and duplicated only in support of PacifiCorp projects. © 2024 PacifiCorp. All rights reserved. by PacifiCorp.</small></p> <p>ROCKY MOUNTAIN POWER PACIFIC POWER</p>	<p>SMU-20 Fuse Unit</p> <p>Actuating pin – extends through upper seal when fuse unit is blown and releases the latch. (not shown)</p> <p>Upper Seal</p> <p>Locating Slot</p> <p>Locating Pin</p> <p>Red cap must not be disturbed when SMU-20 fuse unit is used in SMD-20 mounting.</p> <p>Lower Ferrule</p> <p>Locknut</p>

<p>Item1IB1Img1: PC construction standards call for the red cap to not be disturbed when installed in SMD-20 mounting.</p> <p>Item1IB1Img2: Close-up view of PC construction standards.</p>
