## NOTICE OF NON-PERFORMANCE

# INSPECTION REPORT

| Report Number: | PAD_PC_RMA_20251007_1214 |
| Relevant WMP Initiative(s): | 8.1.2.12 - Expulsion Fuse Replacements |

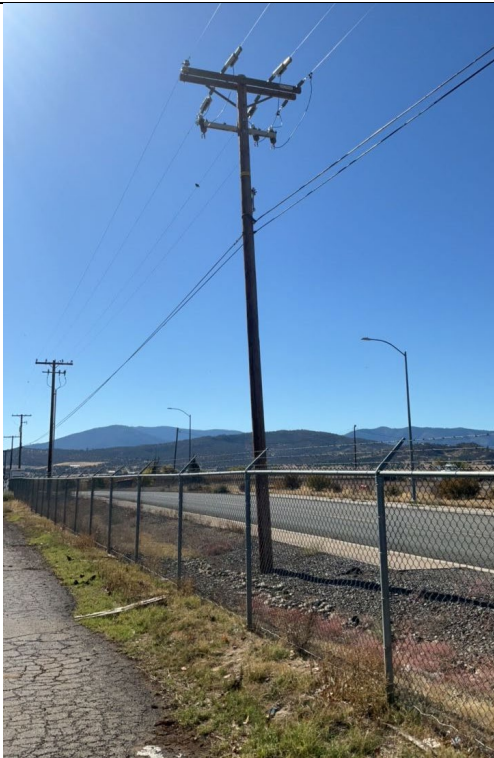
**GI1mg1:** Overall Structure.

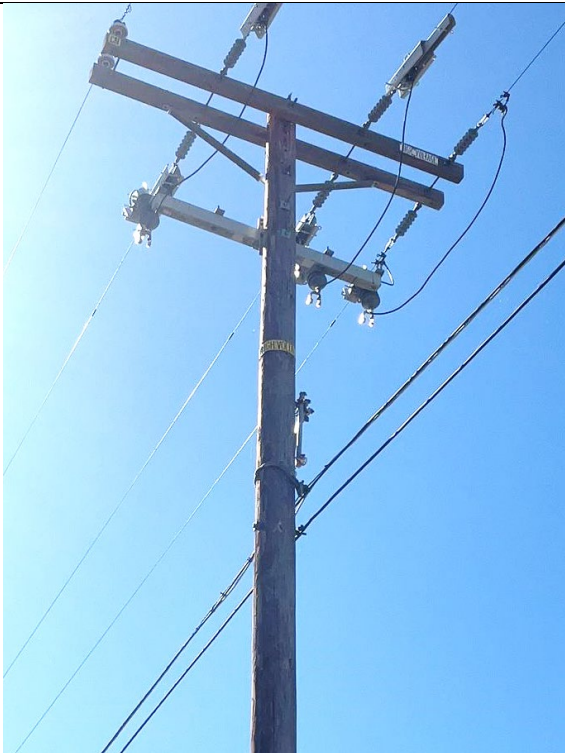
On Pole ID 6245006.0190102, Grid Hardening ID 7112939 at 41.72965220003691, -122.593214, the inspector observed three empty cutouts without CAL FIRE-approved non-expulsion fuses. The inspector's observation is documented in Deficiency 1 photographs, which are attached to this report. Photo numbers IA1Img1 and IA1Img2 depict incomplete installation of three fuses. In the 2025 Q2 Quarterly Data Report submission, PC reported that work on WMP initiative 8.1.2.12 - Expulsion Fuse Replacements was complete at this location.

1. Three empty cutouts without CAL FIRE-approved non-expulsion fuses were observed at the subject pole.
2. Inspector observed three fuses hanging from the subject pole.

**IA11mg1:** Three empty cutouts observed.

Deficiency 1. Energy Safety observed that in implementing the 2025 WMP initiative - 8.1.2.12 Expulsion Fuse Replacements, PC failed to complete the installation of CAL FIRE-approved non-expulsion fuses on Pole ID 6245006.0190102, Grid Hardening ID 7112939 at coordinates 41.72965220003691, -122.593214. Energy Safety considers this non-performance to be in the Minor risk category. PC must complete a corrective action for this deficiency by 12 months from date of this notice.<sup>1</sup>

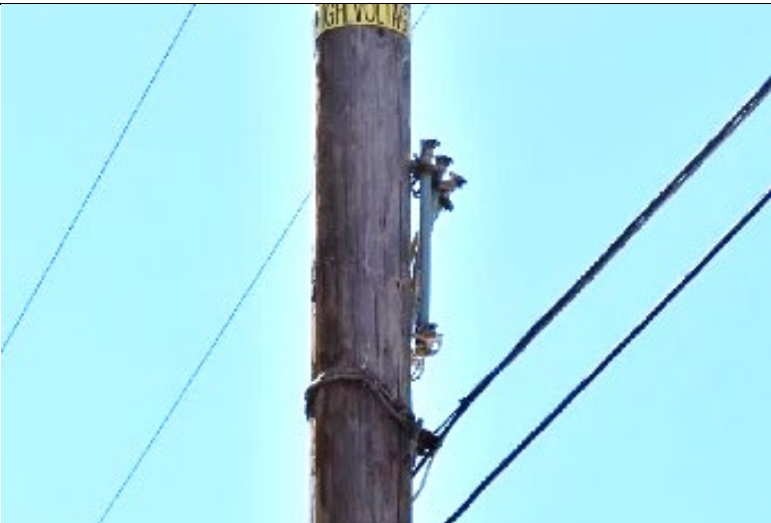
**IA11mg2:** Three fuses observed hanging from the pole.
