NOTICE OF NON-PERFORMANCE

INSPECTION REPORT

Electrical Corporation:	PacifiCorp
Report Number:	PAD_PC_IAG_20251008_1100
Inspector:	Ivan Garcia
WMP Year Inspected:	2025
Quarterly Data Report (QDR) Referenced:	Quarter 2 (Q2)
Inspection Selection:	Energy Safety viewed the contents of the Q2 QDR and performed an analysis that resulted in the selection of the WMP initiatives and locations referenced in this report.
Relevant WMP Initiative(s):	8.1.2.1 – Covered conductor installation
Date of Inspection:	October 8, 2025
City and/or County of Inspection:	Klamath River, Siskiyou County
Inspection Purpose:	Assess the accuracy of PacifiCorp's QDR data, completeness of its work, and performance of WMP requirements.

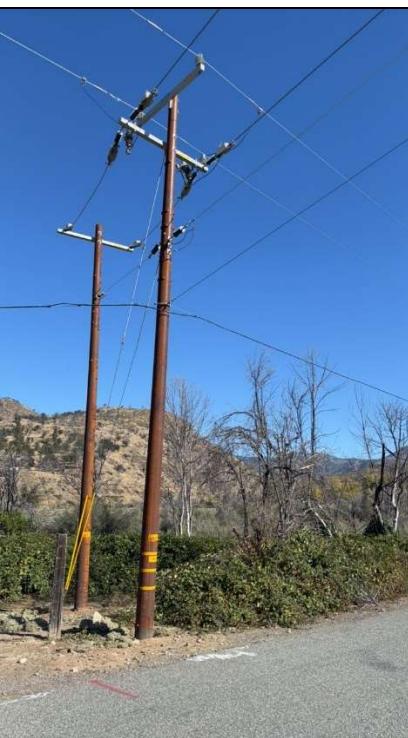
GImg1: Overall Structure	GImg2: Structure ID

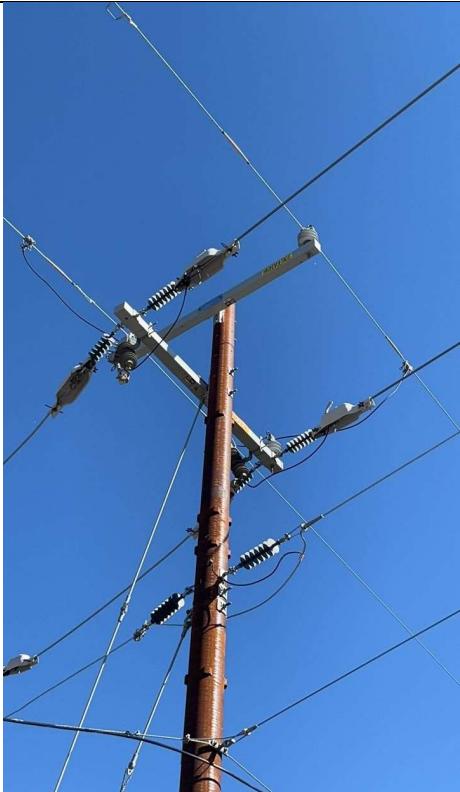
On Pole ID 06246009133401, Grid Hardening ID 7011447i at 21722-21998 Klamath River Rd, Klamath River, CA, 96050, USA, 41.83017052263573, -122.8464202100858, the inspector observed that no covered conductor was installed along the span east of the subject pole. The inspector's observation is documented in Deficiency 1 photographs, which are attachments to this report. Photo numbers IA1Img1, IA1Img2, IA1Img3, and IA1Img4, depict no covered on the east side span along Klamath River Road to next pole with Pole ID 06246009.133400. In the 2025 Q1 Quarterly Data Report submission, PC reported that work on WMP initiative 8.1.2.1 – Covered conductor installation was completed at this location.

1. The inspector did not observe covered conductor installed at the Pole ID 06246009133401 along the east side span to the next Pole ID 06246009.0133400.
2. The inspector observed bare conductor at the Pole ID 06246009133401 along the east side span to the next Pole ID 06246009.0133400.

IA1Img1: No covered conductor installed on the east side span of the pole.

Deficiency 1. Energy Safety observed that in implementing 2025 WMP initiative Covered conductor installation, PC failed to install covered conductor on Pole ID 06246009.133401, Grid Hardening ID 7011447i at coordinates 41.83017052263573, -122.8464202100858. Energy Safety considers this non-performance to be in the Minor risk category. PC must complete a corrective action for this deficiency by 12 months from date of this notice.¹

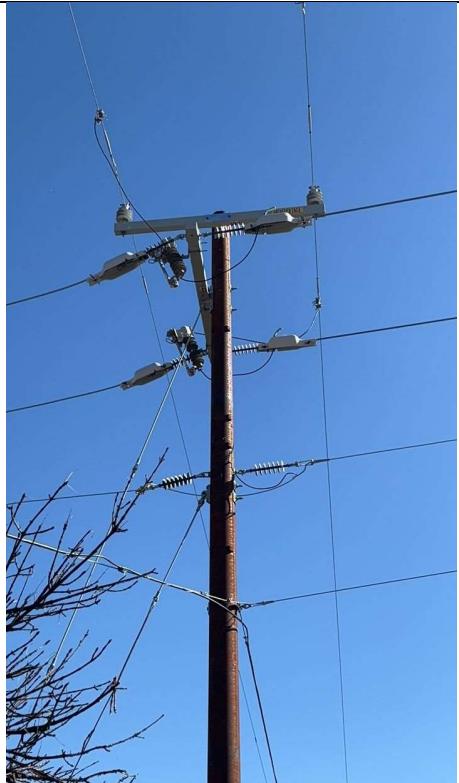
IA1Img2: No covered conductor on the east side span of the pole, bare conductor is observed.

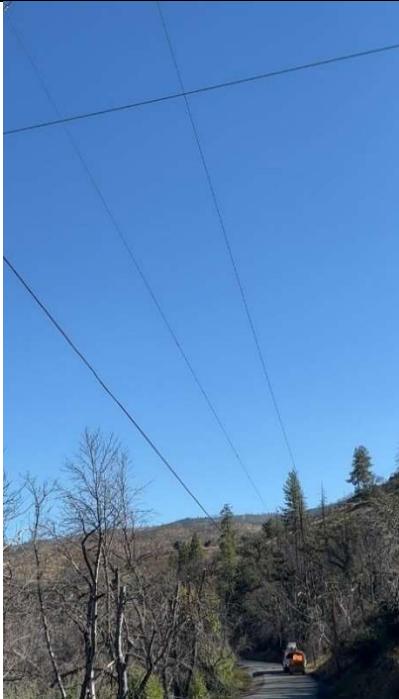
IA1Img3: No covered conductor installed on the east side span along Klamath River Road to next pole with Pole ID 06246009.133400.

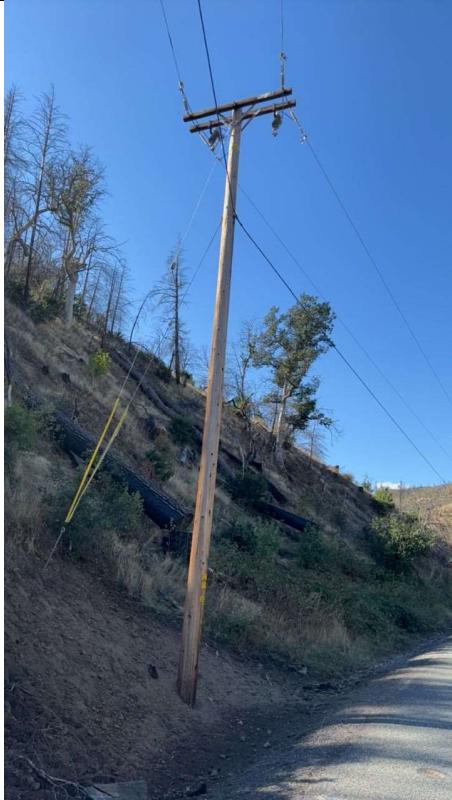
IA1Img4: The next pole, Pole ID 06246009.133400 with no covered conductor installed.
