NOTICE OF NON-PERFORMANCE

INSPECTION REPORT

Electrical Corporation:	PacifiCorp
Report Number:	PAD_PC_CYA_20251007_0930
Inspector:	Cecilia Yaniz
WMP Year Inspected:	2025
Quarterly Data Report (QDR) Referenced:	Quarter 1 (Q1)
Inspection Selection:	Energy Safety viewed the contents of the Q1 QDR and performed an analysis that resulted in the selection of the WMP initiatives and locations referenced in this report.
Relevant WMP Initiative(s):	8.1.2.12 - Expulsion Fuse Replacements
Date of Inspection:	October 7, 2025
City and/or County of Inspection:	Yreka, Siskiyou County
Inspection Purpose:	Assess the accuracy of PacifiCorp's QDR data, completeness of its work, and performance of WMP requirements.

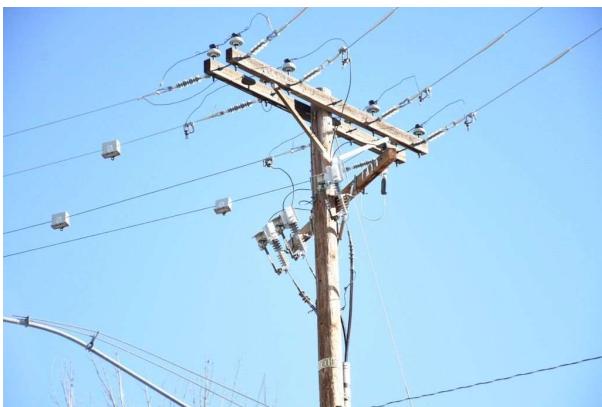
Deficiency #	Structure ID	Grid Hardening ID	Lat/Long	HFTD	Initiative Number	Severity	Deficiency Description
Deficiency 1	06245007.0275104	7074439	41.71645204223936, -122.6414627790075	Non-HFTD	8.1.2.12 - Expulsion Fuse Replacements	Minor	Failure to complete work on expulsion fuse replacement

On Pole ID 06245007.0275104, Grid Hardening ID 7074439 at 112 W Oberlin Rd, Yreka, CA, 96097, USA, 41.71645204223936, -122.6414627790075, the inspector observed that non-CAL FIRE-approved non expulsion fuses were installed. The inspector's observation is documented in Deficiency 1 photographs, which are attachments to this report. Photo number IA1Img1 depicts incomplete installation of CAL FIRE-approved non expulsion fuses. In the 2025 Q1 Quarterly Data Report submission, PC reported that work on WMP initiative 8.1.2.12 – Expulsion Fuse Replacements was completed at this location.

1. The inspector observed that three non-CAL FIRE-approved non expulsion fuses were installed.
2. Three solid blade disconnects were observed at the inspected location.

IA1Img1: Three solid blade disconnects were installed.

Deficiency 1. Energy Safety observed that in implementing 2025 WMP initiative 8.1.2.12 - Expulsion Fuse Replacements, PC failed to complete the installation of CAL FIRE-approved non expulsion fuses on Pole ID 06245007.0275104, Grid Hardening ID 7074439 at coordinates 41.71645204223936, -122.6414627790075. Energy Safety considers this non-performance to be in the Minor risk category. PC must complete a corrective action for this deficiency by 12 months from this date of notice.¹
