NOTICE OF NON-PERFORMANCE

INSPECTION REPORT

Electrical Corporation:	PG&E
Report Number:	NON_ESD_PGE_AKM_20260113_1448
Inspector:	Akiko Masuda
WMP Year Inspected:	2025
Quarterly Data Report (QDR) Referenced:	Quarter 3 (Q3) 2025
Inspection Selection:	Energy Safety inspected the locations based on PG&E’s Q3 QDR.
Relevant WMP Initiative(s):	8.2.3.2 Wood and Slash Management
Date of inspection:	January 13, 2026
City and/or County of Inspection:	Nevada City, Nevada County

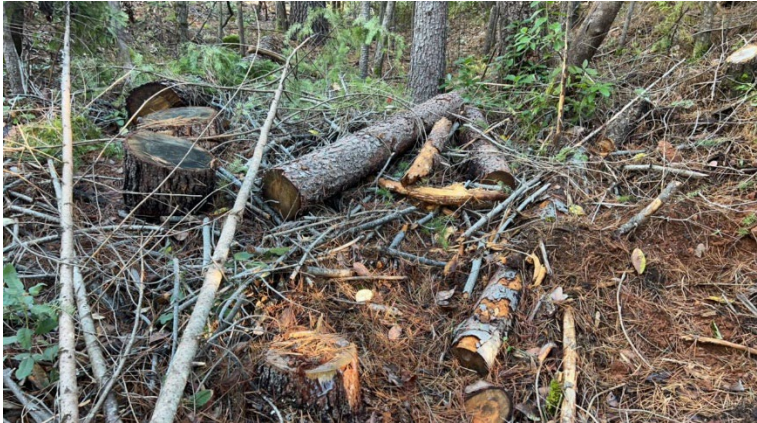
Energy Safety considers this deficiency as a "Moderate" because the slash pile is over 18-inches in height, creating a potential fuel source for wildfire.

At VMP IDs VP_AW114-M02_3814093_2022 and VP_AW114-M02_3814094_2022 near pole ID 103961342, PG&E reported it completed work under its Tree Removal Inventory program. PG&E's Q3 data reports that its crew removed a Douglas fir tree and a sugar pine tree on September 21, 2025. Energy Safety's inspector observed slash, wood chips, and woody debris from these trees. Additionally, the inspector observed a pile of slash debris was higher than 18 inches. The inspector's observation is documented in photos 1, 2 and 3, which are exhibits to this report.

Photo 1: Photo of pile of wood and slash debris left onsite.

Since Energy Safety's inspection, PG&E conducted a field visit and completed the clean-up and disposal of wood and slash at the location in this report. Therefore, Energy Safety considers NON
NON_ESD_PGE_AKM_20260113_1448 closed. No further action from PG&E is required in response to this
NON.

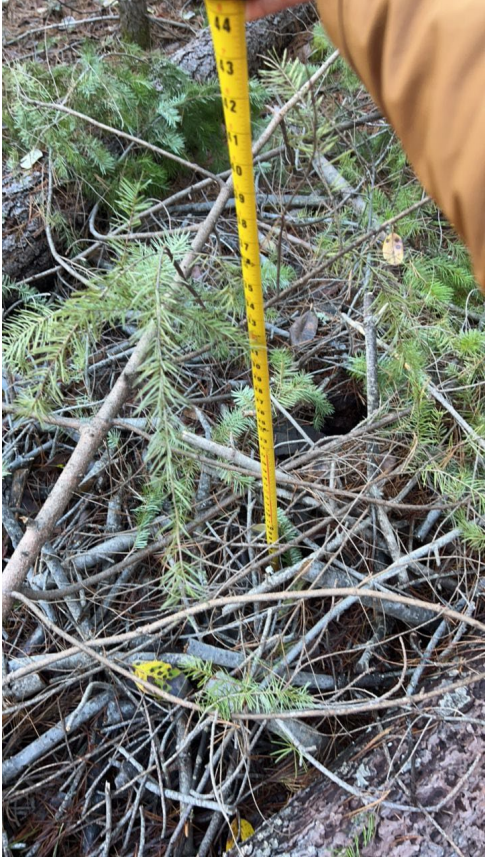
Photo 2: Photo of pile of wood and slash debris, with the pile measuring more than 41 inches in height.

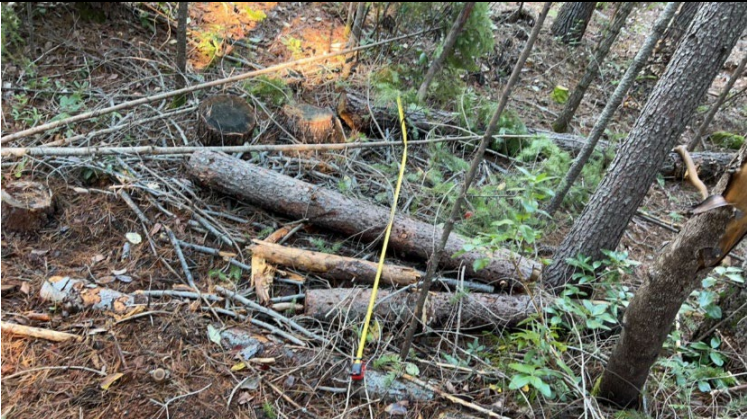
Photo 3: Top view of wood and slash left onsite showing a spread exceeding ten feet in width.
