NOTICE OF NON-PERFORMANCE

INSPECTION REPORT

Electrical Corporation:	SCE
Report Number:	NON_ESD_SCE_RGA_20260126_1339
Inspector:	Ricardo Garcia
WMP Year Inspected:	2025
Inspection Selection:	Energy Safety inspected the location based on it being in the 2025 Eaton Fire footprint.
Relevant WMP Initiative(s):	8.2.3.4.2 Dead and Dying Tree Removal
Date of inspection:	January 26, 2026
City and/or County of Inspection:	Altadena, California

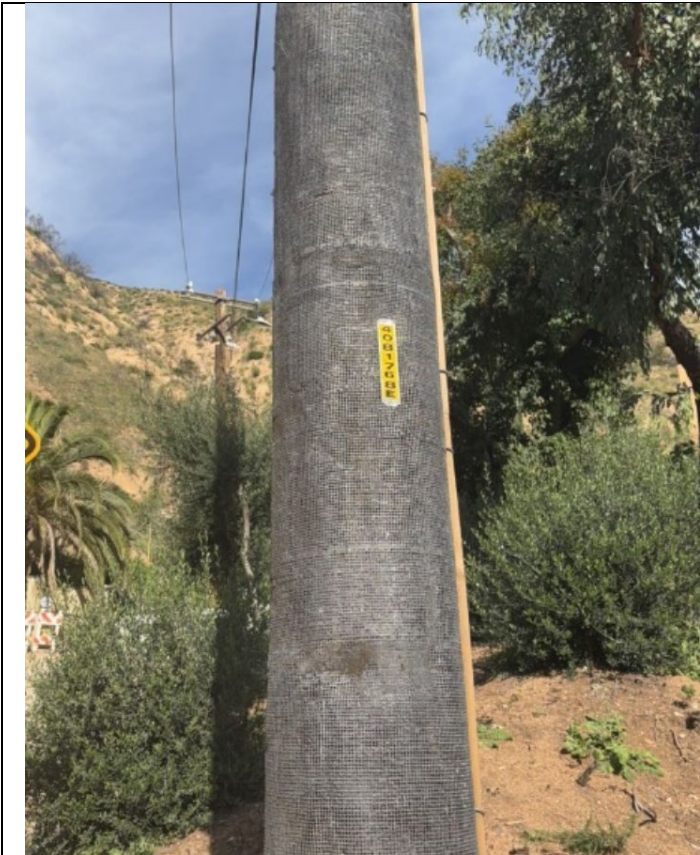
Photo 1: Photo of Structure ID 4081768E, located approximately 45 feet southeast of the subject tree.

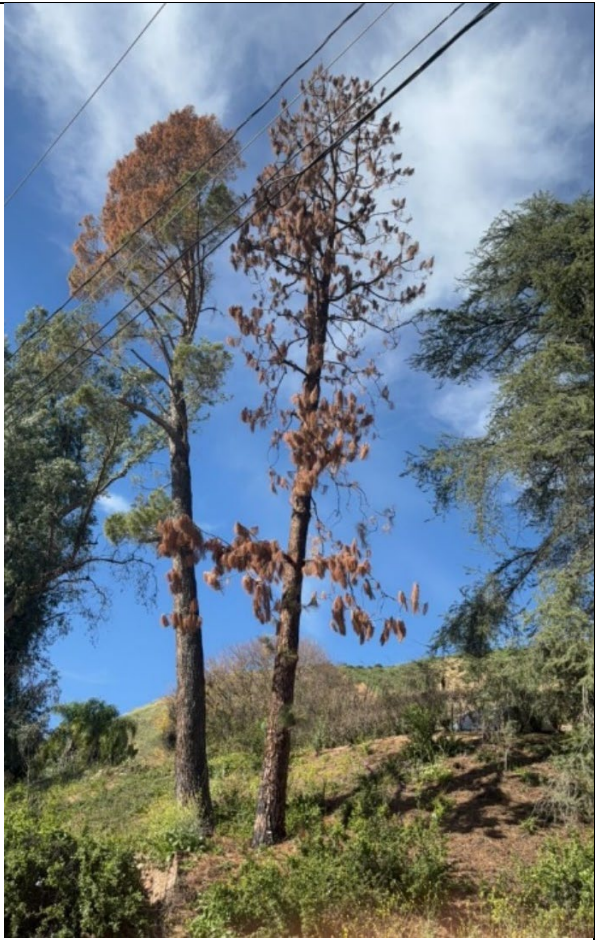
Energy Safety considers this deficiency "Moderate" because SCE has not removed the dying tree located within striking distance of conductors, consistent with the requirements of Public Resources Code section 4293. The continued presence of this tree presents an ongoing wildfire risk.

On January 26, 2026, Energy Safety conducted an inspection of SCE's WMP's initiatives in the vicinity of Altadena, California. During the inspection, Energy Safety identified a dying pine tree near support structure ID 4081768E near coordinates 34.1941, -118.112034 at the corner of E Loma Alta Drive and Glen Allen Lane. The pine tree has a diameter at breast height of 21 inches, is approximately 105 feet tall and is located 30 feet north of the conductors. The inspector's observation is document in Exhibit A photographs, which are attached to this report.

Photo 2: Photo of dying pine tree (right). See NON_ESD_SCE_RGA_20260126_1347 regarding the danger tree on the left.

Deficiency 1. Energy Safety observed that in implementing its 2025 WMP initiative 8.2.3.4.2, which requires compliance with Public Resources Code 4293, SCE failed to remove a dead, declining, or dying tree near coordinates 34.1941, -118.112034. Energy Safety considers this non-performance to be in the Moderate risk category. SCE must complete a corrective action for this non-performance by two months from the date of this notice.¹

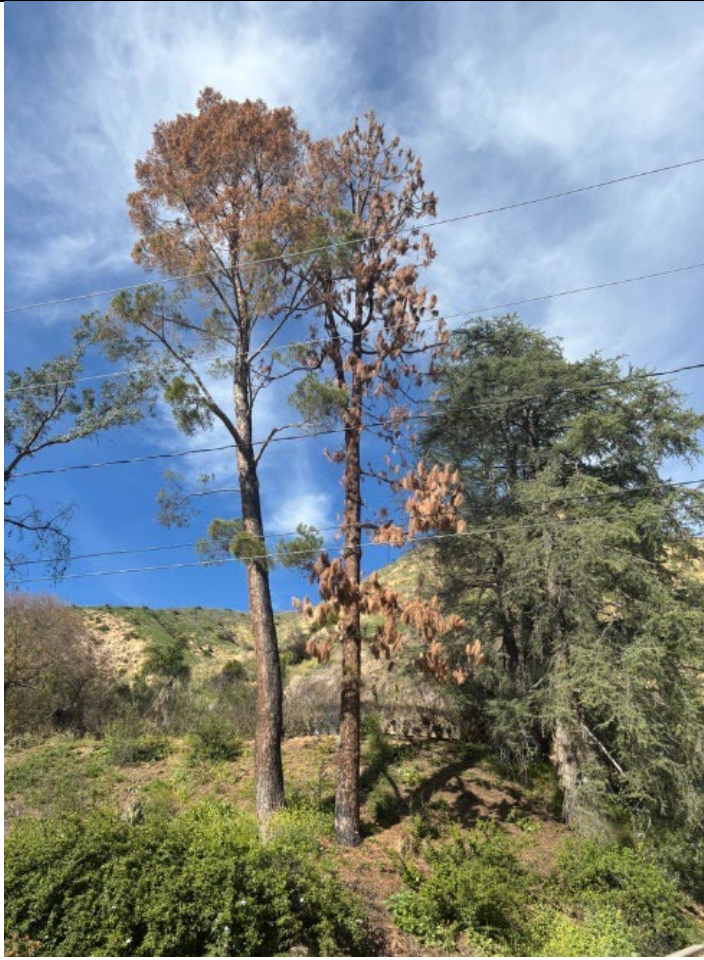
Photo 3: Additional photo of the same dying pine tree (right) taken from a different angle. See NON_ESD_SCE_RGA_20260126_1347 regarding the danger tree on the left.
