## NOTICE OF NON-PERFORMANCE

# INSPECTION REPORT

Electrical Corporation:	SCE
Report Number:	NON_ESD_SCE_RGA_20260126_1347
Inspector:	Ricardo Garcia
WMP Year Inspected:	2025
Inspection Selection:	Energy Safety inspected the location based on it being in the 2025 Eaton Fire footprint.
Relevant WMP Initiative(s):	8.2.3.4.2 Dead and Dying Tree Removal
Date of inspection:	January 26, 2026
City and/or County of Inspection:	Altadena, California

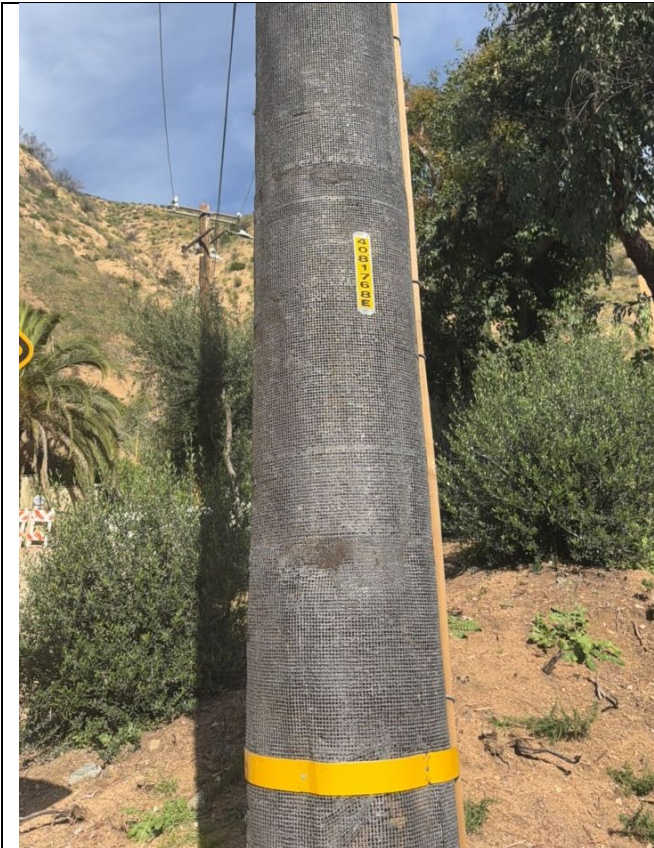
**Photo 1:** Photo of Structure ID 4081768E located approximately 45 feet southeast of the subject tree.

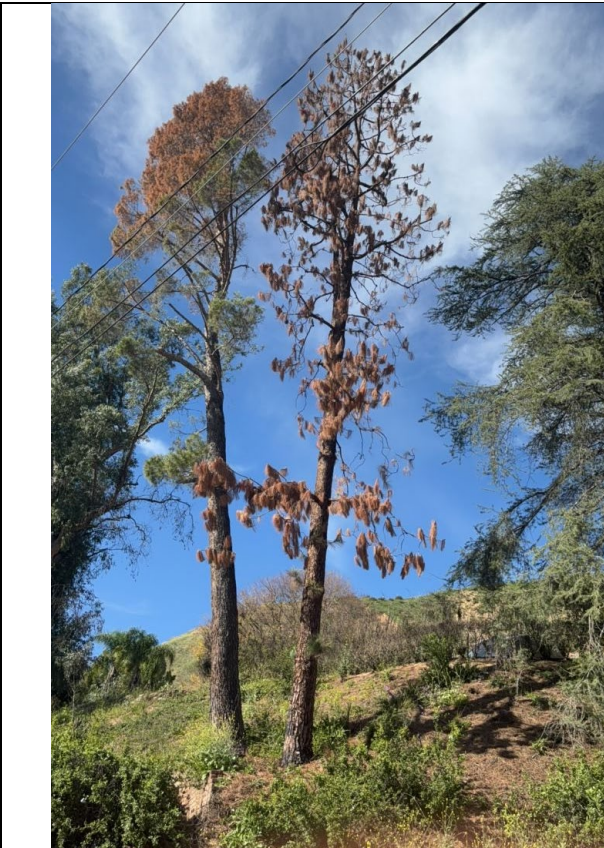
Energy Safety considers this deficiency "Moderate" because SCE has not removed the dying tree located within striking distance of conductors, consistent with the requirements of Public Resources Code section 4293. The continued presence of these trees presents an ongoing wildfire risk.

On January 26, 2026, Energy Safety conducted an inspection of SCE's WMP's initiatives in the vicinity of Altadena, California. During the inspection, Energy Safety identified a dying pine tree near support structure ID 4081768E near coordinates 34.1941, -118.112034 at the corner of E Loma Alta Drive and Glen Allen Lane. The pine tree has a diameter at breast height of 25 inches, is approximately 90 feet tall and is located 30 feet north of the conductors. The pine tree is also located above a deteriorating retaining wall, adding an additional risk of tree failure. The inspector's observation is document in Exhibit A photographs, which are attached to this report.

**Photo 2:** Photo of dying pine tree (left). See NON\_ESD\_SCE\_RGA\_20260126\_1339 regarding the danger tree on the right.

Deficiency 1. Energy Safety observed that in implementing its 2025 WMP initiative 8.2.3.4.2, which requires compliance with Public Resource Code 4293, SCE failed to remove a dead, declining, or dying tree near coordinates 34.1941, -118.112034. Energy Safety considers this non-performance to be in the Moderate risk category. SCE must complete a corrective action for this nonperformance by two months from the date of this notice.<sup>1</sup>

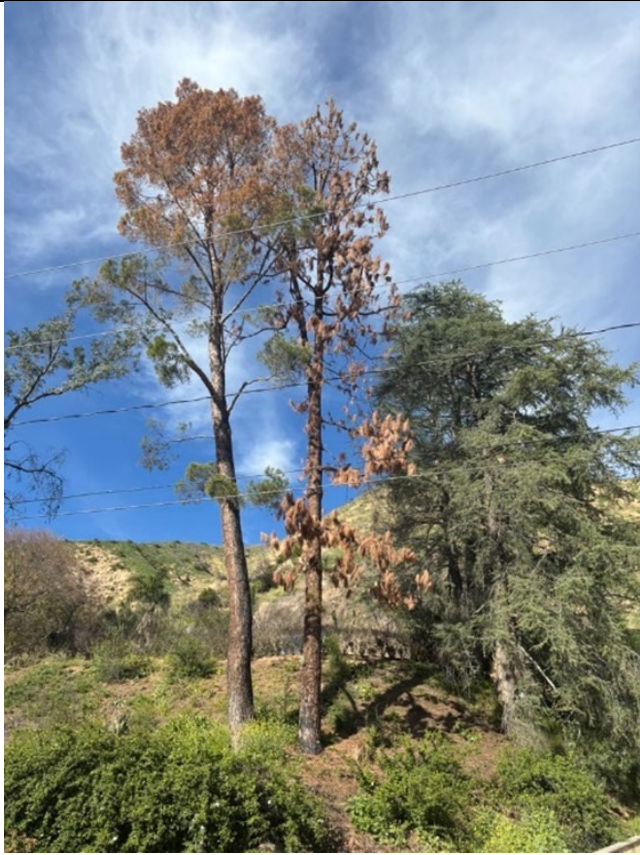
**Photo 3:** Additional photo of the same dying pine tree (left) taken from a different angle. See [NON\\_ESD\\_SCE\\_RGA\\_20260126\\_1339](#) regarding the danger tree on the right.
