NOTICE OF NON-PERFORMANCE

INSPECTION REPORT

Electrical Corporation:	Southern California Edison Company
Report Number:	PAD_SCE_YLO_20251119_1039_2
Inspector:	Yana Loginova
WMP Year Inspected:	2025
Quarterly Data Report (QDR) Referenced:	Quarter 2 (Q2)
Inspection Selection:	Energy Safety viewed the contents of the Q2 QDR and performed an analysis that resulted in the selection of the WMP initiatives and locations referenced in this report.
Relevant WMP Initiative(s):	8.1.3.1 - Distribution Detailed Inspections and Remediations (IN-1.1)
Date of inspection:	November 19, 2025
City and/or County of Inspection:	Calimesa, Riverside County
Inspection Purpose:	Assess the accuracy of Southern California Edison Company's QDR data, completeness of its work, and performance of requirements.

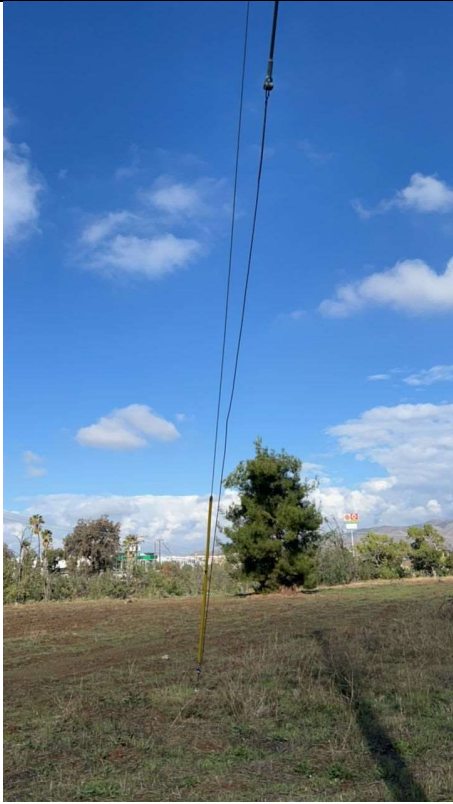
On Pole ID 2114637E, Grid Hardening ID 413113623-2114637E at 991 7th Pl, Calimesa, CA, 92320, USA, 34.001276074715, -117.065463685533, the inspector observed that a down guy was loose. The inspector's observation is documented in Deficiency 1 photographs, which are attachments to this report. Photo numbers IA1Img1, IA1Img2 and IA1Img3 depict a loose down guy.

1. Southern California Edison Company's 2025 WMP initiative number 8.1.3.1 Distribution Detailed Inspections and Remediations work identified that remediation of slack in down guys was complete at this location.
2. One down guy had slack during the inspection.

IA1Img1: View showing slack in down guy

Deficiency 1. Energy Safety observed that in implementing 2025 WMP initiative 8.1.3.1 - Distribution High Fire Risk-Informed (HFRI) Inspections and Remediations (IN-1.1), SCE failed to complete the remediation of slack in down guys on Pole ID 2114637E, Grid Hardening ID 413113623-2114637E at coordinates 34.001276074715, -117.065463685533. Energy Safety considers this non-performance to be in the Minor risk category. SCE must complete corrective action for this deficiency by 12 months from date of this notice.¹

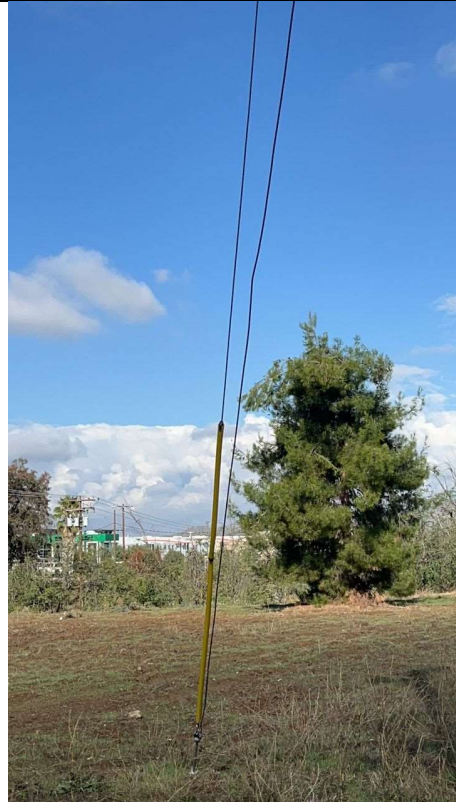
IA1Img2: View showing slack in down guy

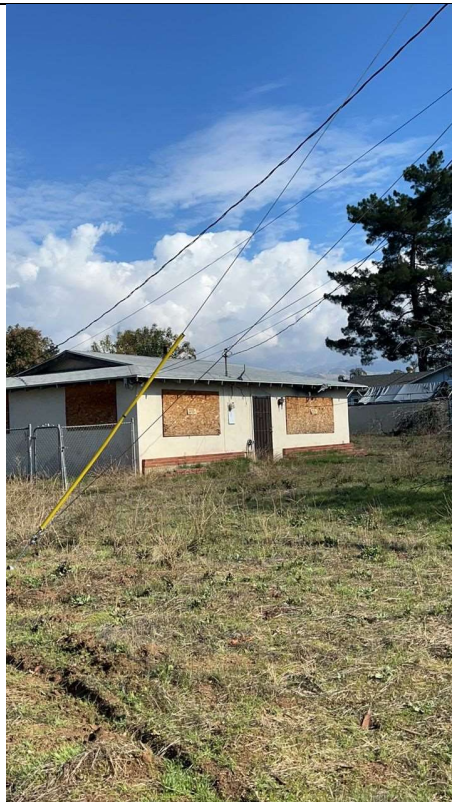
IA1Img3: View showing slack in down guy
