NOTICE OF NON-PERFORMANCE

INSPECTION REPORT

Electrical Corporation:	Southern California Edison Company
Report Number:	PAD_SCE_SIS_20260114_1300
Inspector:	Samuel Isaiah
WMP Year Inspected:	2025
Quarterly Data Report (QDR) Referenced:	Quarter 3 (Q3)
Inspection Selection:	Energy Safety viewed the contents of the Q3 QDR and performed an analysis that resulted in the selection of the WMP initiatives and locations referenced in this report.
Relevant WMP Initiative(s):	8.1.3.1 - Distribution Detailed Inspections and Remediations (IN-1.1)
Date of inspection:	January 14, 2026
City and/or County of Inspection:	Rancho Palos Verdes, Los Angeles County
Inspection Purpose:	Assess the accuracy of Southern California Edison Company's QDR data, completeness of its work, and performance of requirements.

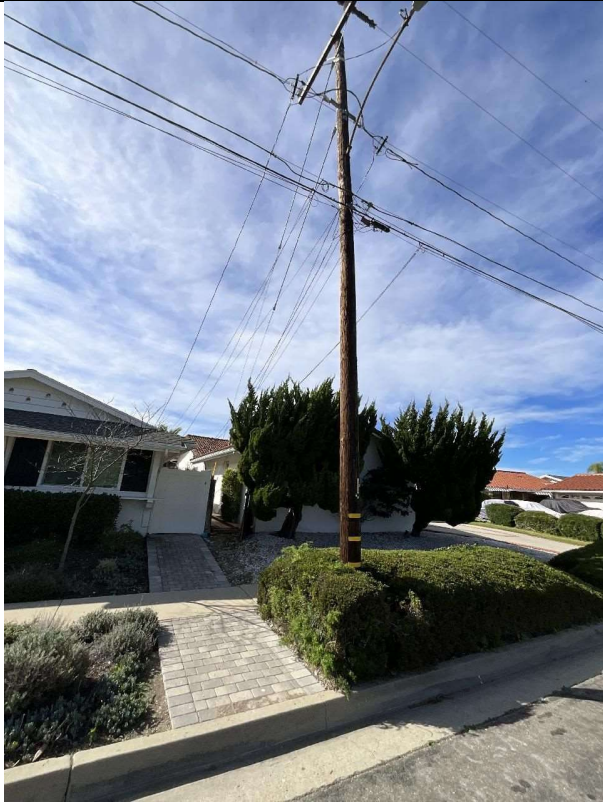
On Pole ID 1392823E, Grid Hardening ID 414093121-1392823E at 28049 Ella Rd, Rancho Palos Verdes, CA, 90275, 33.7797146678882, -118.395505159758, the inspector observed that three down guy wires were rubbing against the house gutter. The inspector's observation is documented in Deficiency 1 photographs, which are attached to this report. Photo numbers IA1Img2, IA1Img3 and IA1Img4 depict three down guy wires rubbing against a house gutter at the inspection location.

2. Despite the reported completion, Energy Safety observed that three down guy wires remain in continuous mechanical contact with the house gutter.
3. CPUC General Order 95 requires that supporting structures and associated equipment be constructed and maintained in a condition that is safe.

4. Facilities that remain in continuous mechanical contact with a residential structure result in ongoing abrasion and load transfer to building components, which is unsafe.

5. Based on the continuous mechanical contact between the down guy wires and the house gutter, Energy Safety concludes that the facility is not being maintained in a condition consistent with CPUC General Order 95, Rule 31.1.

IA1img1: All three down guy wires are rubbing against house gutter

Deficiency 1. Energy Safety observed that in implementing 2025 WMP initiative 8.1.3.1 - Distribution High Fire Risk-Informed (HFRI) Inspections and Remediations (IN-1.1), SCE failed to complete clearance of down guy on Pole ID 1392823E, Grid Hardening ID 414093121-1392823E at coordinates 33.7797146678882, -118.395505159758. Energy Safety considers this non-performance to be in the Minor risk category. SCE must complete a corrective action for this deficiency by 12 months from the date of this notice.¹

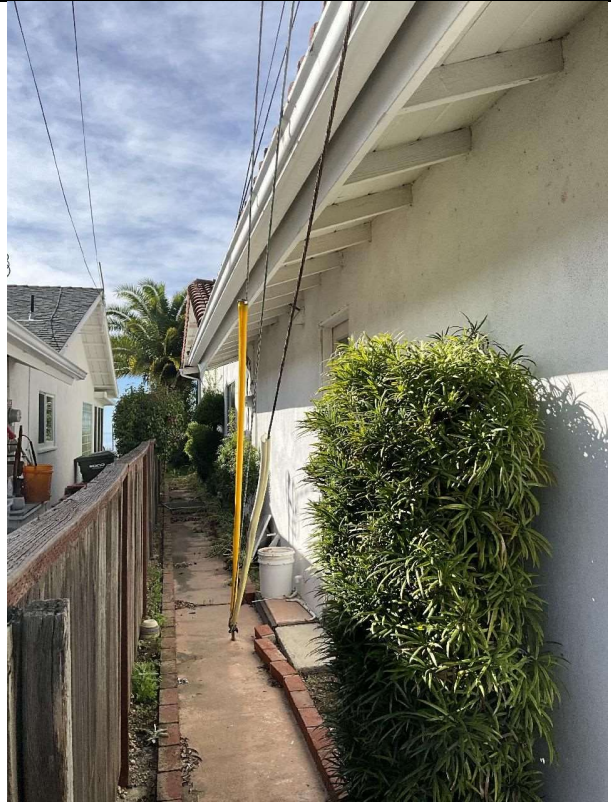
IA1img2: All three down guy wires are rubbing against house gutter

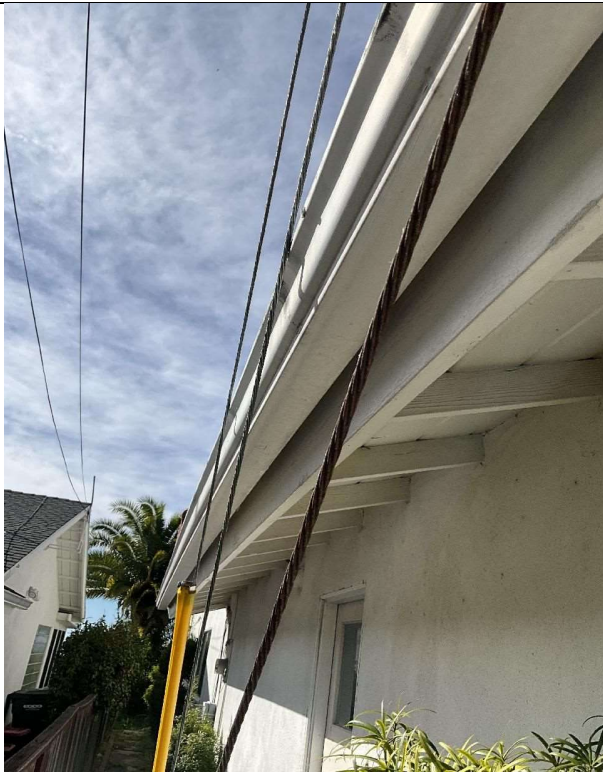
IA1img3: All three down guy wires are rubbing against house gutter

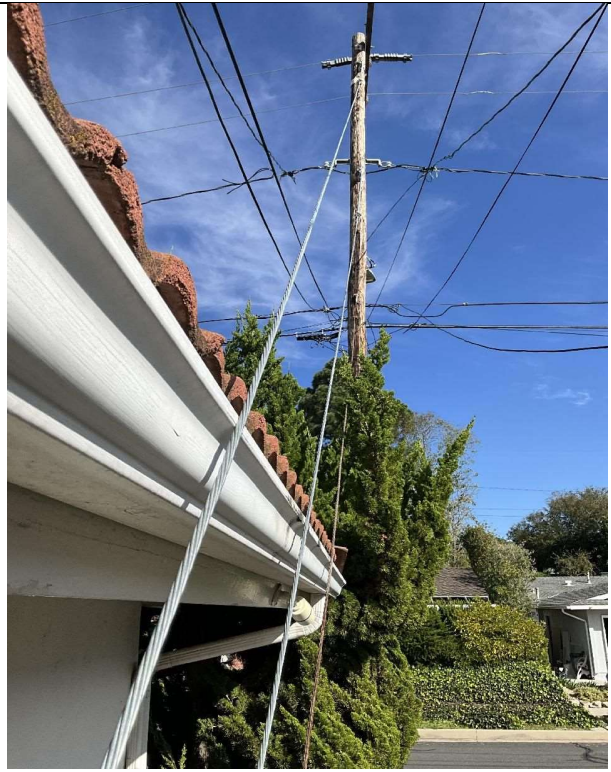
IA1img4: All three down guy wires are rubbing against house gutter
