NOTICE OF NON-PERFORMANCE

INSPECTION REPORT

Electrical Corporation:	Southern California Edison Company
Report Number:	PAD_SCE_SIS_20260112_1222
Inspector:	Samuel Isaiah
WMP Year Inspected:	2025
Quarterly Data Report (QDR) Referenced:	Quarter 3 (Q3)
Inspection Selection:	Energy Safety viewed the contents of the Q3 QDR and performed an analysis that resulted in the selection of the WMP initiatives and locations referenced in this report.
Relevant WMP Initiative(s):	8.1.3.1 - Distribution Detailed Inspections and Remediations (IN-1.1)
Date of inspection:	January 12, 2026
City and/or County of Inspection:	Rancho Palos Verdes, Los Angeles County
Inspection Purpose:	Assess the accuracy of Southern California Edison Company's QDR data, completeness of its work, and performance of requirements.

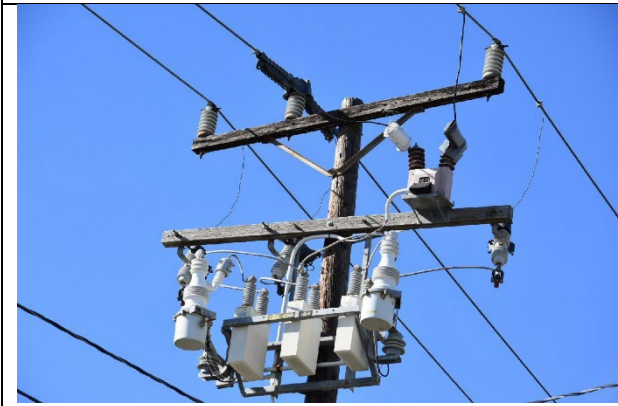
On Pole ID 1157204E, Grid Hardening ID 414164307-1157204E at 2697-2881 Calle Aventura, Rancho Palos Verdes, CA, 90275, 33.7351225874564, -118.3269464985, the inspector observed that capacitor bank's avian protection cover was dislodged and the connection was exposed. The inspector's observation is documented in the Deficiency 1 photographs, which are attached to this report. Photo numbers IA1Img1, IA1Img2, IA1Img3 and IA1Img4 depict that the capacitor bank's avian cover was dislodged.

1. Southern California Edison Company's 2025 WMP initiative number 8.1.3.1 Distribution Detailed Inspections and Remediations work identified that remediation of capacitor bank's avian cover was complete at this location.
2. One of the capacitor bank's avian protection covers was dislodged and the connection was exposed.

IA1img1: Capacitor bank avian protection cover dislodged

Deficiency 1. Energy Safety observed that in implementing 2025 WMP initiative 8.1.3.1 - Distribution High Fire Risk-Informed (HFRI) Inspections and Remediations (IN-1.1), SCE failed to complete replacement of a capacitor's avian guard on Pole ID 1157204E, Grid Hardening ID 414164307-1157204E at coordinates 33.7351225874564, -118.3269464985. Energy Safety considers this non-performance to be in the Minor risk category. SCE must complete a corrective action for this deficiency by 12 months from the date of this notice.¹

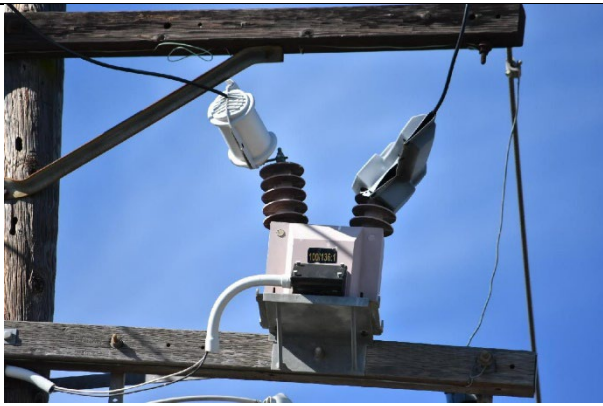
IA1img2: Capacitor bank avian protection cover dislodged

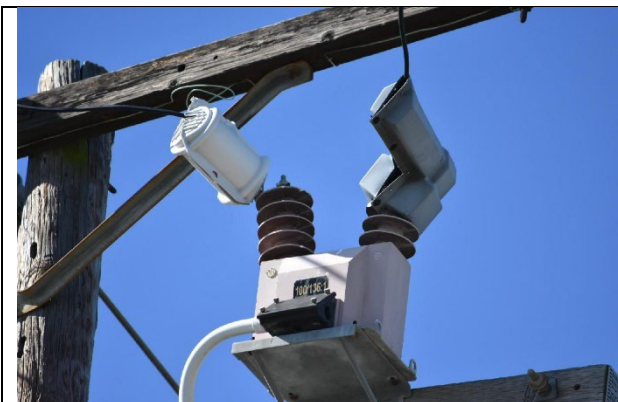
IA1Img3: Capacitor bank avian protection cover dislodged

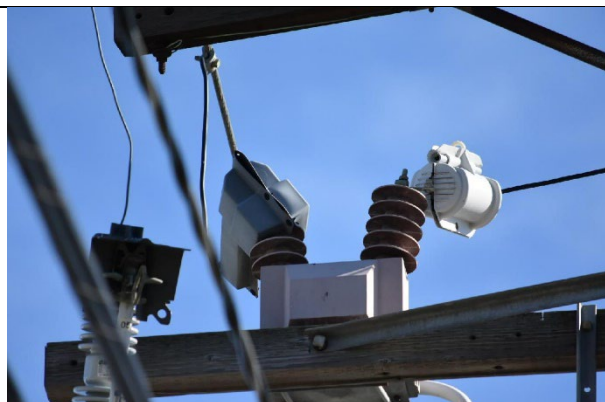
IA1Img4: Capacitor bank avian protection cover dislodged
