**SUBJECT:** Southern California Edison Company's Response to Notice of Non-Performance (NON\_PAD\_SCE\_YLO\_20251119\_1355)

Notice	#	Structures
NON_PAD_SCE_YLO_20251119_1355	1	4804671E

Energy Safety’s Notice states that in implementing 2025 WMP initiative 8.1.3.1 - Distribution High Fire Risk-Informed (HFRI) Inspections and Remediations (IN-1.1), SCE failed to complete the remediation of missing connector covers on Pole ID 4804671E, Grid Hardening ID 414065037-4804671E at coordinates 33.9706958300596, -116.954069974971.

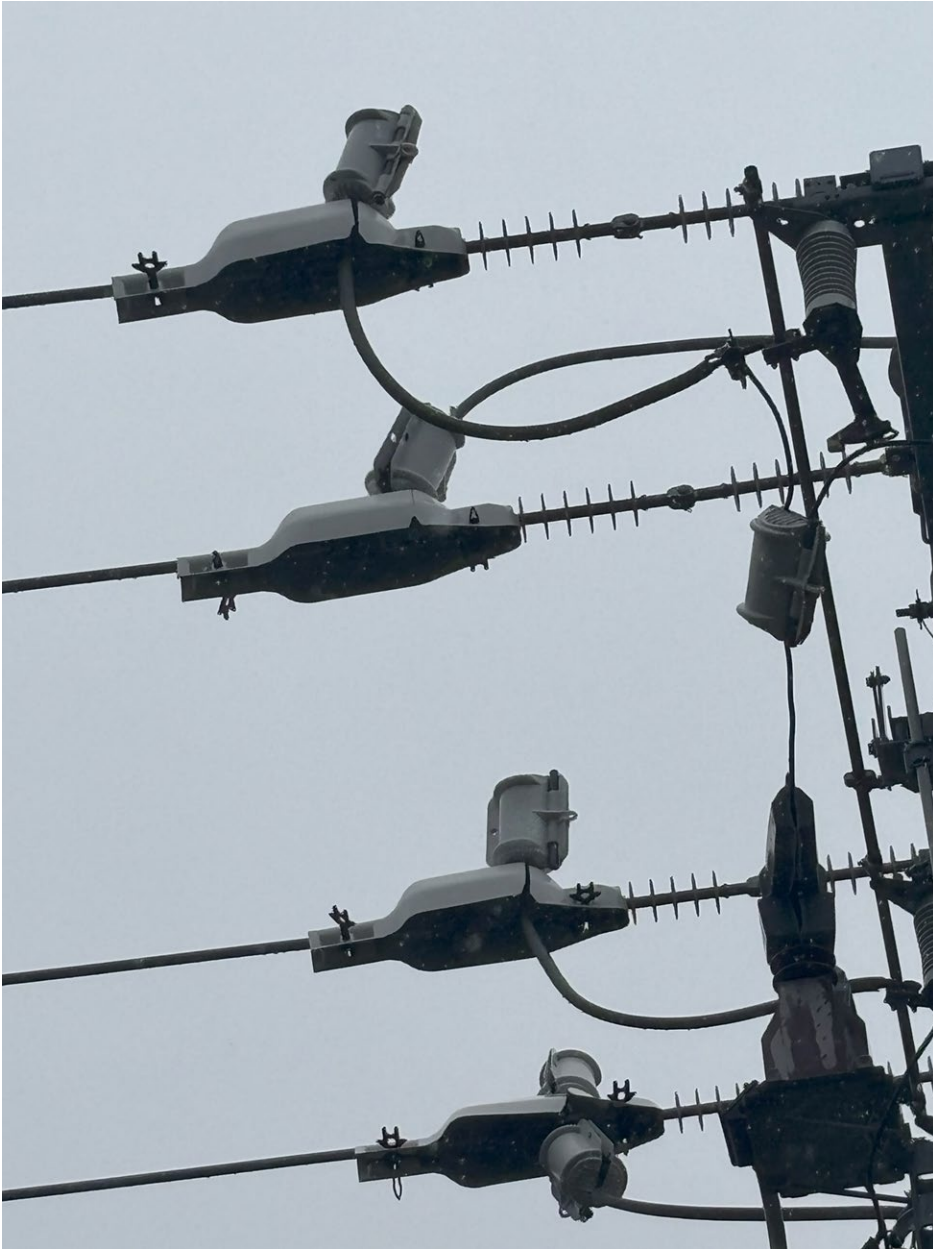
Although the Notice describes the wildlife cover as “opened”, the gap in the cover depicted in the photo below is part of the wildlife cover design to allow ventilation and drainage, and its installation is consistent with SCE’s Distribution Overhead Construction Standards (DOH). Section 535 of SCE’s DOH (sheet 17 of 35) states that: “(s)ome wildlife covers have small gaps or seams as part of the covering design. Installation of the cover should be considered in order to allow moisture to drain through

said gaps or openings.” A screenshot of the relevant section of the DOH is pasted below.

Some wildfire covers have small gaps or seams as part of the covering design. Installation of the cover should be considered in order to allow moisture to drain through said gaps or openings.

Additionally, orientation of the gap/seam should be pointed away from other energized or grounded parts in the immediate vicinity (typically 18 inches).

SCE confirms that the wildlife cover on structure ID 4804671E was remediated on April 11, 2025. During an inspection on February 19, 2026, in response to this Notice, SCE’s Field Operations team verified that the wildlife cover is in compliance with SCE’s construction standards as it is properly secured and continues to protect the exposed connector. Please find photo evidence below from SCE’s February 19, 2026, inspection, documenting the wildlife cover in its secured condition.
