NOTICE OF NON-PERFORMANCE

INSPECTION REPORT

Electrical Corporation:	Pacific Gas and Electric Company
Report Number:	PAD_PGE_RMA_20251216_1412
Inspector:	Romeo Marroquin Ajcac
WMP Year Inspected:	2025
Quarterly Data Report (QDR) Referenced:	Quarter 2 (Q2)
Inspection Selection:	Energy Safety viewed the contents of the Q2 QDR and performed an analysis that resulted in the selection of the WMP initiatives and locations referenced in this report.
Relevant WMP Initiative(s):	8.1.2.10.5 - Non-Exempt Expulsion Fuses
Date of Inspection:	December 16, 2025
City and/or County of Inspection:	250-376 Cold Springs Rd, Angwin, CA, 94508, USA, Napa County
Inspection Purpose:	Assess the accuracy of Pacific Gas and Electric Company’s QDR data, completeness of its work, and performance of requirements.

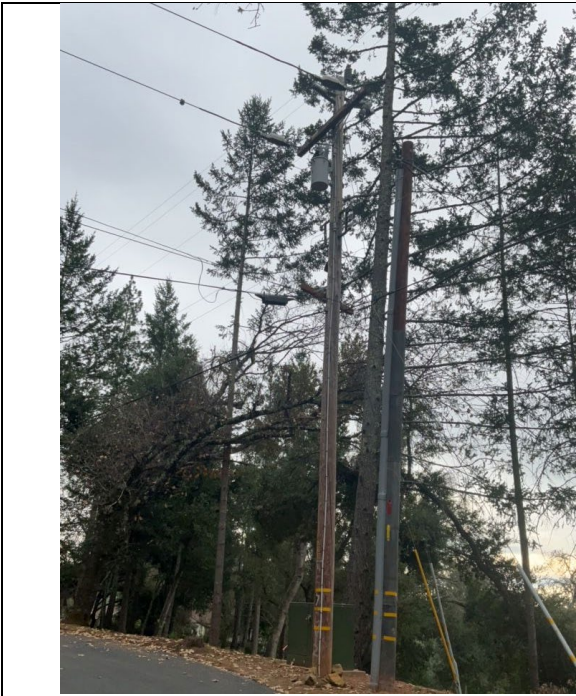
G1mg1: Overall structure

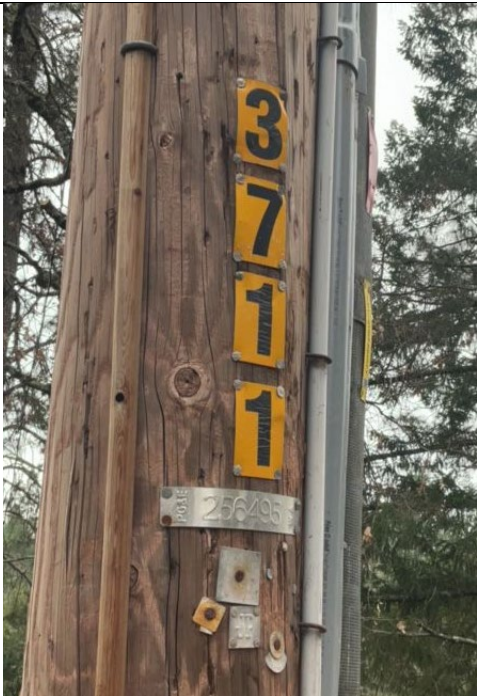
G1mg2: Structure ID

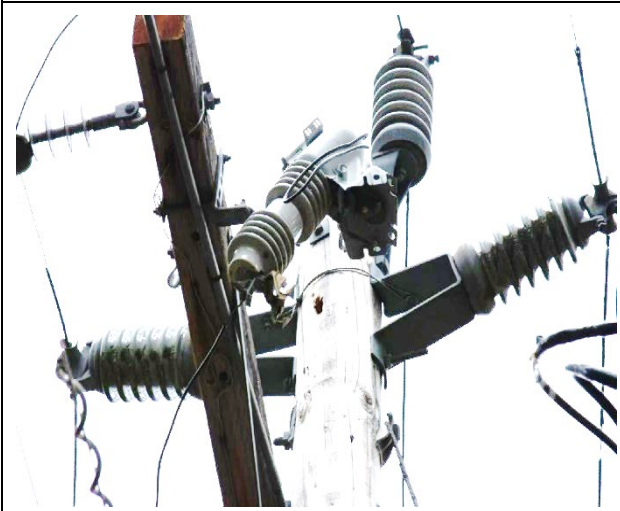
On Pole ID 256495, Grid Hardening ID 31699597 at 250-376 Cold Springs Rd, Angwin, CA, 94508, USA, 38.5593907604486, -122.433882999691, the inspector observed that an exempt fuse was not installed at the subject pole. The inspector's observation is documented in Deficiency 1 photographs, which are attached to this report. Photo numbers IA1Img1 and IA1Img2 depict incomplete installation of exempt equipment. In the 2025 Q2 Quarterly Data Report submission, PG&E reported that work on WMP initiative 8.1.2.10.5 - Non-Exempt Expulsion Fuses was completed at this location.

1. The inspector observed that an exempt fuse was not installed in the cutout at the subject pole.

IA1mg1: Empty cutout.

Deficiency 1. Energy Safety observed that in implementing the 2025 WMP initiative - 8.1.2.10.5 - Non-Exempt Expulsion Fuses, PG&E failed to complete the installation of a non-exempt expulsion fuse on Pole ID 256495, Grid Hardening ID 31699597 at coordinates 38.5593907604486, -122.433882999691. Energy Safety considers this non-performance to be in the Minor risk category. PG&E must complete a corrective action for this deficiency by 12 months of this notice.

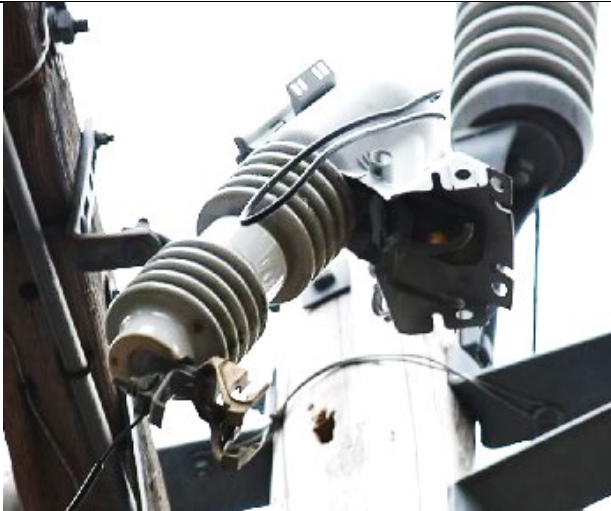
IA1mg2: Empty cutout (close view).
