NOTICE OF NON-PERFORMANCE

INSPECTION REPORT

Electrical Corporation:	PacifiCorp
Report Number:	PAD_PC_BKA_20251009_1100
Inspector:	Babak Kaviani
WMP Year Inspected:	2025
Quarterly Data Report (QDR) Referenced:	Quarter 2 (Q2)
Inspection Selection:	Energy Safety viewed the contents of the Q2 QDR and performed an analysis that resulted in the selection of the WMP initiatives and locations referenced in this report.
Relevant WMP Initiative(s):	8.1.2.12 - Expulsion Fuse Replacements
Date of Inspection:	October 9, 2025
City and/or County of Inspection:	Lakehead, Shasta County
Inspection Purpose:	Assess the accuracy of PacifiCorp’s QDR data, completeness of its work, and performance of requirements.

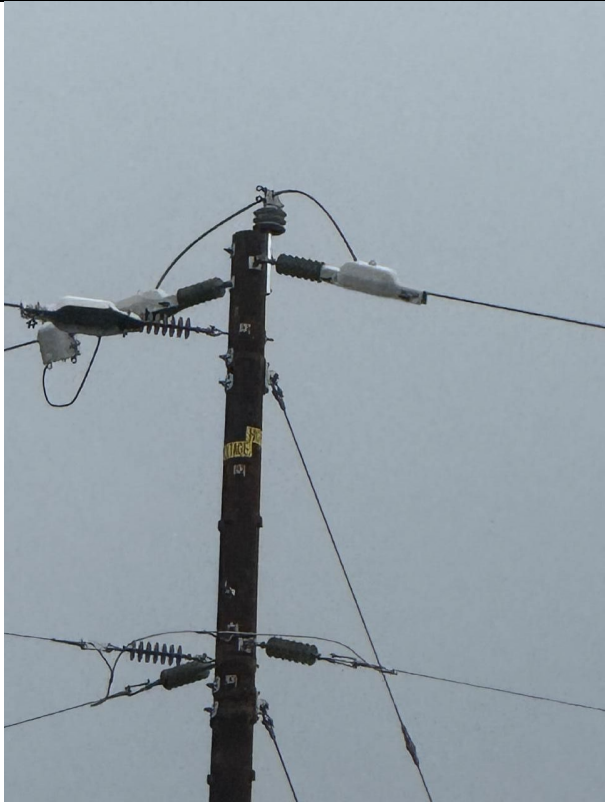
Deficiency #	Structure ID	Grid Hardening ID	Lat/Long	HFTD	Initiative Number	Severity	Deficiency Description
Deficiency 1	06237005.0354900	7171378	41.0288816033331, -122.413074	Tier 2	8.1.2.12 - Expulsion Fuse Replacements	Minor	Failure to complete work on expulsion fuse replacement

On Pole ID 06237005.0354900, Grid Hardening ID 7171378 at 41.0288816033331, -122.413074, the inspector observed that CAL FIRE-approved non-expulsion fuses were not installed. The inspector's observation is documented in Deficiency 1 photographs, which are attachments to this report. Photo numbers IA1Img1 depicts incomplete installation of CAL FIRE-approved non-expulsion fuses. In the 2025 Q2 Quarterly Data Report submission, PC reported that work on WMP initiative 8.1.2.12 – Expulsion Fuse Replacements was completed at this location.

1. CAL FIRE-approved non-expulsion fuses were not installed at the subject pole.

IA1mg1: Close-up view showing no CAL FIRE-approved non-expulsion fuses installed on the pole

Deficiency 1. Energy Safety observed that in implementing 2025 WMP initiative 8.1.2.12 - Expulsion Fuse Replacements, PC failed to complete the installation of CAL FIRE-approved non expulsion fuses on Pole ID 06237005.0354900, Grid Hardening ID 7171378 at coordinates 41.0288816033331, -122.413074. Energy Safety considers this non-performance to be in the Minor risk category. PC must complete a corrective action for this deficiency by 12 months from this date of notice.
