NOTICE OF NON-PERFORMANCE

INSPECTION REPORT

Electrical Corporation:	PacifiCorp
Report Number:	PAD_PC_BKA_20251008_1344
Inspector:	Babak Kaviani
WMP Year Inspected:	2025
Quarterly Data Report (QDR) Referenced:	Quarter 2 (Q2)
Inspection Selection:	Energy Safety viewed the contents of the Q2 QDR and performed an analysis that resulted in the selection of the WMP initiatives and locations referenced in this report.
Relevant WMP Initiative(s):	8.1.2.12 - Expulsion Fuse Replacements
Date of Inspection:	October 8, 2025
City and/or County of Inspection:	Weed, Siskiyou County
Inspection Purpose:	Assess the accuracy of PacifiCorp’s QDR data, completeness of its work, and performance of requirements.

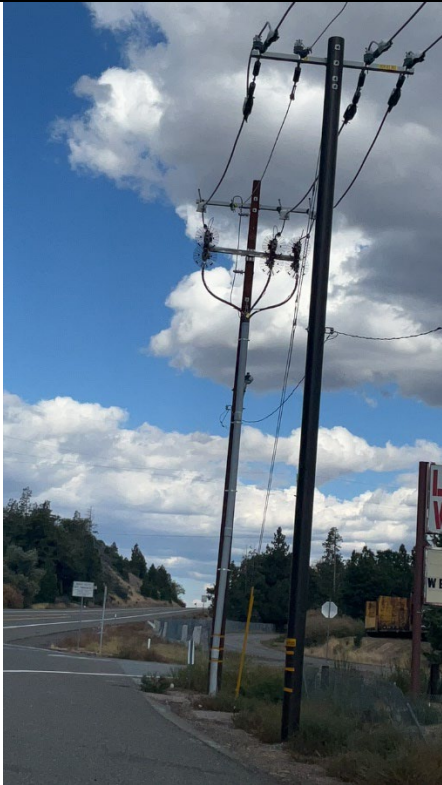
On Pole ID 06241005.026600, Grid Hardening ID 8077661 at Mile 0.6 US Hwy 97 S, Weed, CA, 96094, USA, 41.4293338392048, -122.388872, the inspector observed that CAL FIRE-approved non-expulsion fuses were not installed. The inspector's observation is documented in Deficiency 1 photographs, which are attachments to this report. Photo numbers IA2Img1, IA2Img2, IA2Img3, and IA2Img depict incomplete installation of CAL FIRE-approved non-expulsion fuses. In the 2025 Q2 Quarterly Data Report submission, PC reported that work on WMP initiative 8.1.2.12 – Expulsion Fuse Replacements were completed at this location.

1. CAL FIRE-approved non-expulsion fuses were not installed at the subject pole.
2. The inspector observed disconnect switch and surge arresters on the subject pole.

G1mg1: Overall Structure

Deficiency 1. Energy Safety observed that in implementing 2025 WMP initiative 8.1.2.12 - Expulsion Fuse Replacements, PC failed to complete the installation of CAL FIRE-approved non-expulsion fuse on Pole ID 06241005.026600, Grid Hardening ID 8077661, at coordinates 41.4293338392048, -122.388872. Energy Safety considers this non-performance to be in the Minor risk category. PC must complete a corrective action for this deficiency by 12 months from this date of notice.

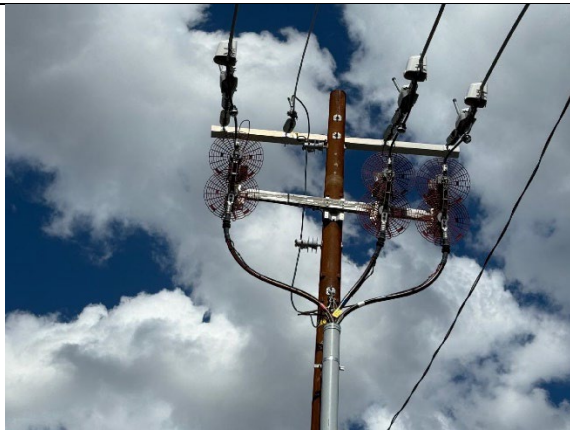
IA1mg1: Closer view of the pole

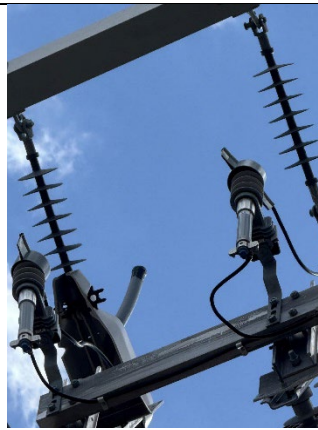
IA1mg2: Surge/Lightning arresters on the other side of the pole

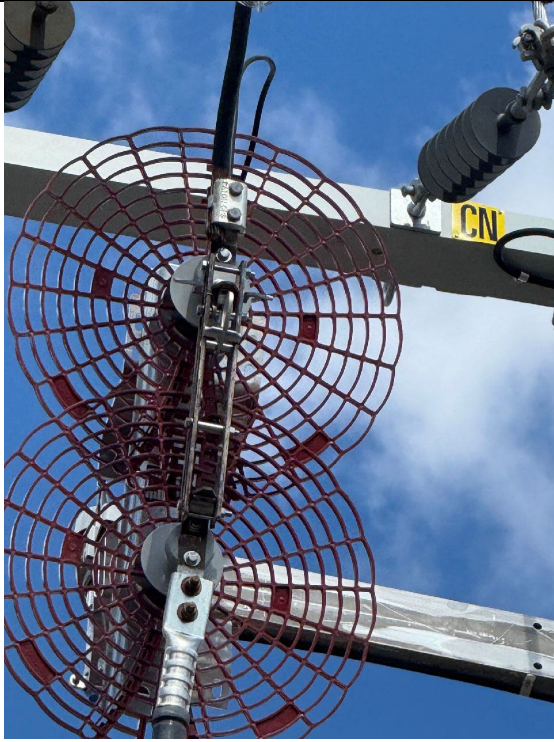
IA1Img3: Disconnect switch

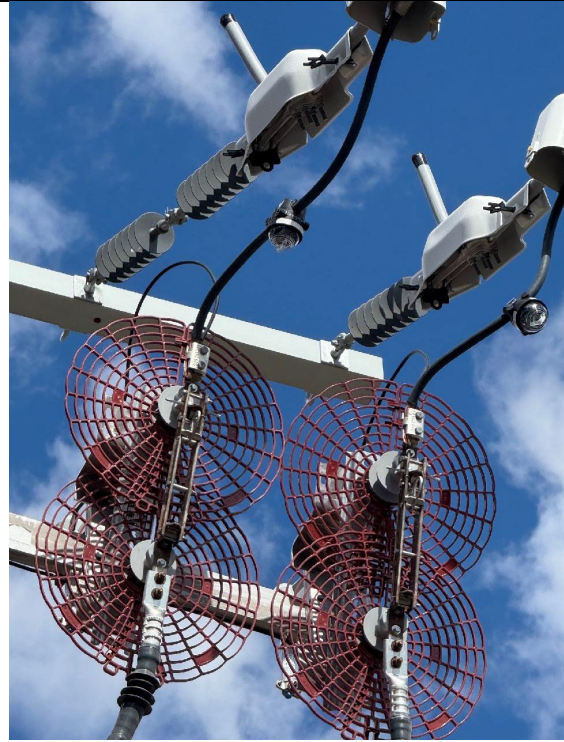
IA1Img4: Disconnect switches
