## **NOTICE OF NON-PERFORMANCE**

# INSPECTION REPORT

Electrical Corporation:	PacifiCorp
Report Number:	PAD_PC_BKA_20251007_1414
Inspector:	Babak Kaviani
WMP Year Inspected:	2025
Quarterly Data Report (QDR) Referenced:	Quarter 2 (Q2)
Inspection Selection:	Energy Safety viewed the contents of the Q2 QDR and performed an analysis that resulted in the selection of the WMP initiatives and locations referenced in this report.
Relevant WMP Initiative(s):	8.1.2.12 – Expulsion Fuse Replacements
Date of Inspection:	October 7, 2025
City and/or County of Inspection:	Yreka, Siskiyou County
Inspection Purpose:	Assess the accuracy of PacifiCorp’s QDR data, completeness of its work, and performance of requirements.

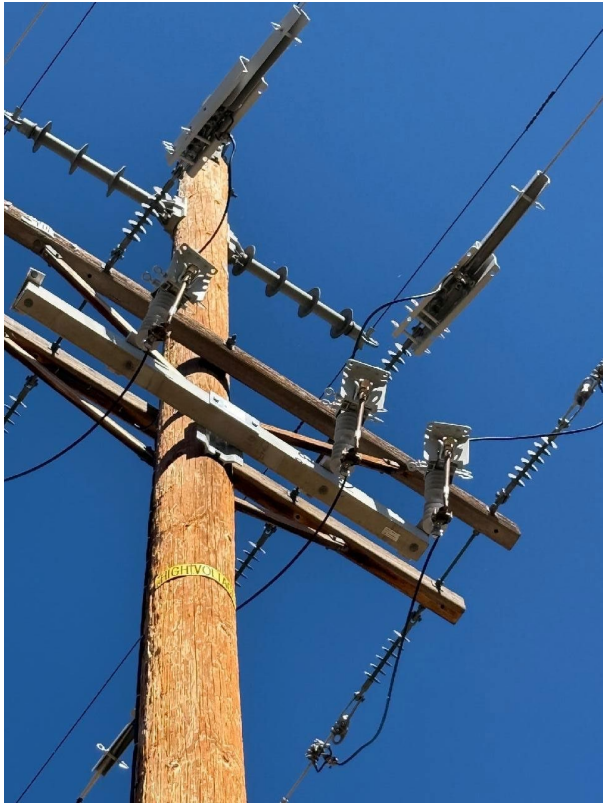
On Pole ID 20/7X, Grid Hardening ID 7112939 at 41.7383054840344, -122.615714, the inspector observed that CAL FIRE-approved non-expulsion fuses were not installed. The inspector's observation is documented in Deficiency 1 photographs, which are attachments to this report. Photo numbers IA1Img1, IA1Img2, IA1Img3, and IA1Img4 depict incomplete installation of CAL FIRE-approved non-expulsion fuses. In the 2025 Q2 Quarterly Data Report submission, PC reported that work on WMP initiative 8.1.2.12 – Expulsion Fuse Replacements were completed at this location.

**IA1mg1:** Overall fuses

Deficiency 1. Energy Safety observed that in implementing 2025 WMP initiative 8.1.2.12 – Expulsion Fuse Replacements, PC failed to complete the installation of CAL FIRE-approved non-expulsion fuses on pole ID 20/7X, Grid Hardening ID 7112939 at coordinates 41.7383054840344, -122.615714. Energy Safety considers this non-performance to be in the Minor risk category. PC must complete a corrective action for this deficiency by 12 months from the date of this notice.

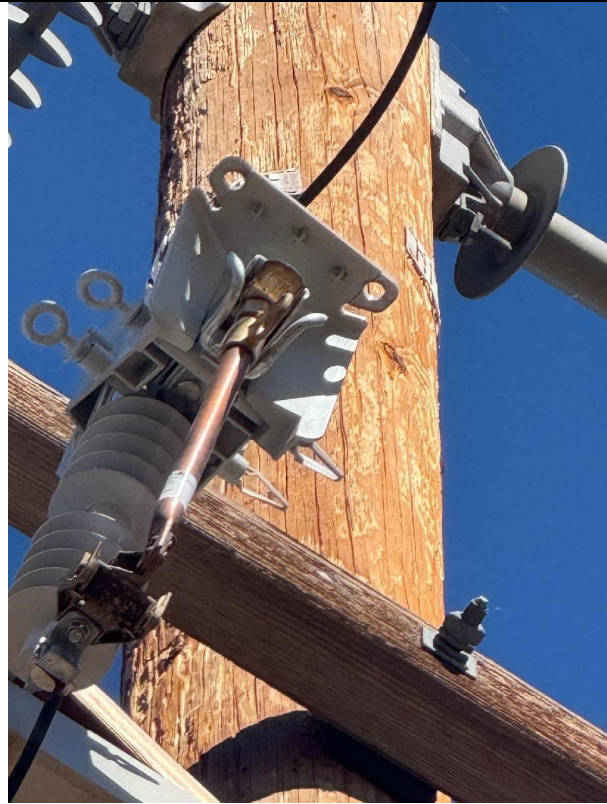
**IA1mg2:** Overall fuses

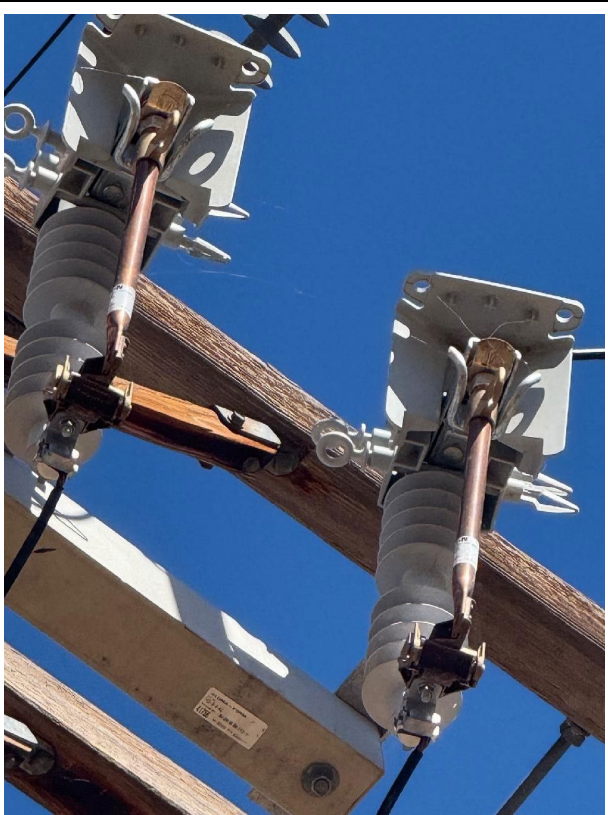
1. CAL FIRE-approved non-expulsion fuses were not installed at the subject pole.
2. The inspector observed solid blade disconnects on the subject pole.
3. No reclosers, sectionalizers, or voltage regulators were observed at the subject pole.

**IA1mg3:** One of three solid blades
