NOTICE OF DATA INACCURACY

INSPECTION REPORT

Electrical Corporation:	PacifiCorp
Report Number:	PAD_PC_BKA_20251008_1550
Date of Inspection:	October 8, 2025
City and/or County of Inspection:	Weed, Siskiyou County
Inspector:	Babak Kaviani
WMP Year Inspected:	2025
Quarterly Data Report (QDR) Referenced:	Quarter 2 (Q2)
Inspection Selection:	Energy Safety viewed the contents of the Q2 QDR and performed an analysis that resulted in the selection of the WMP initiatives and locations referenced in this report.
Relevant WMP Initiative(s):	8.1.2.12 Expulsion Fuse Replacements
Inspection Purpose:	Assess the accuracy of PacifiCorp’s QDR data, completeness of its work, and performance of WMP requirements.

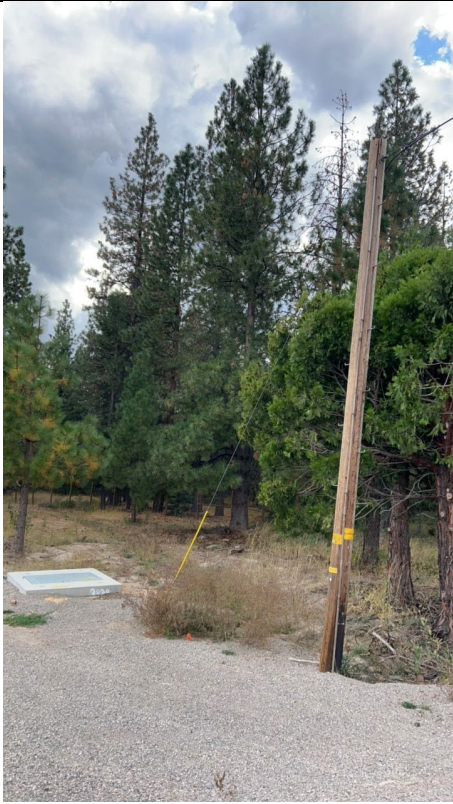
On Pole ID 06241005.025601, Grid Hardening ID 8077661 at 41.430728439176896, -122.38954876481279, the inspector did not observe that CAL FIRE-approved non-expulsion fuses were replaced. The inspector's observation is documented in Data Inaccuracy 1 photographs, which are attached to this report as Exhibit A.

1. In the 2025 Q2 Quarterly Data Report submission, PC reported that work on WMP initiative 8.1.2.12 – Expulsion Fuse Replacements was completed at this location.
2. CAL FIRE-approved non-expulsion fuses were not installed at the subject pole.

IA1Img1: South-facing view showing no CAL FIRE-approved non-expulsion fuses installed on Pole ID 06241005.025601

Within 30 days from the issuance date of this NODI, PC should provide a response advising Energy Safety of corrective actions taken or planned to remedy the identified data inaccuracy or inaccuracies.
