NOTICE OF NON-PERFORMANCE

INSPECTION REPORT

Electrical Corporation:	PG&E
Report Number:	NON_ESD_PGE_RIB_20260113_1511
Inspector:	Ramzi Ibrahim
WMP Year Inspected:	2025
Quarterly Data Report (QDR) Referenced:	Quarter 3 (Q3) 2025
Inspection Selection:	Energy Safety inspected the locations based on PG&E’s Q3 QDR.
Relevant WMP Initiative(s):	8.2.3.2 Wood and Slash Management
Date of inspection:	January 13, 2026
City and/or County of Inspection:	Hurleton, California

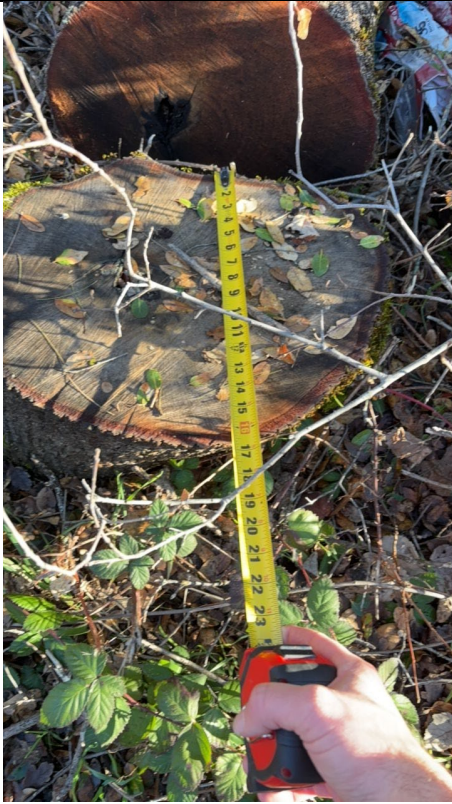
At VMP ID VP_AT114-B17_1050016_2019 near pole ID 100380208, PG&E reported it completed work under its VMOM program. PG&E's Q3 data reports that its crew removed a tan oak tree on August 18, 2025. Energy Safety's inspector observed slash, wood chips, and woody debris from the tree piled approximately 31-inches at its tallest point. The inspector's observation is documented in photos 1, 2 and 3, which are exhibits to this report.

Photo 1: Photo of the tan oak stump matching the description of VP_AT114-B17_1050016_2019.

Deficiency 1. Energy Safety observed that in implementing 2025 WMP initiative 8.2.2.2.3 Vegetation Management for Operational Mitigations (VMOM), PG&E failed to adhere to its protocol of wood and slash management approximately 10 feet from pole ID 100380208 and Vegetation Management ID VP_AT114-B17_1050016_2019 at coordinates 39.5036481805997, -121.432124243375. Energy Safety considers this non-performance to be in the Moderate risk category. PG&E must complete a corrective action for this non-performance by six months from date of this notice.¹

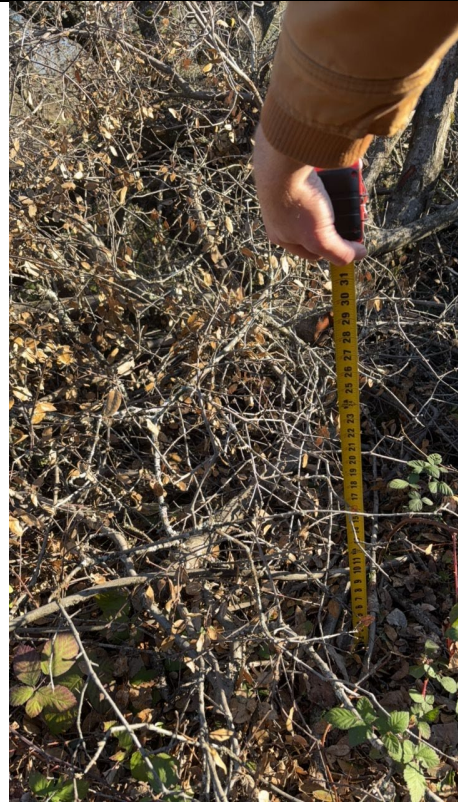
Energy Safety considers this deficiency "Moderate" because the slash pile is over 18-inches in height, creating a potential fuel source for wildfire.

Photo 2: Photo of the pile of tan oak wood and slash debris, measuring approximately 31 inches in height.

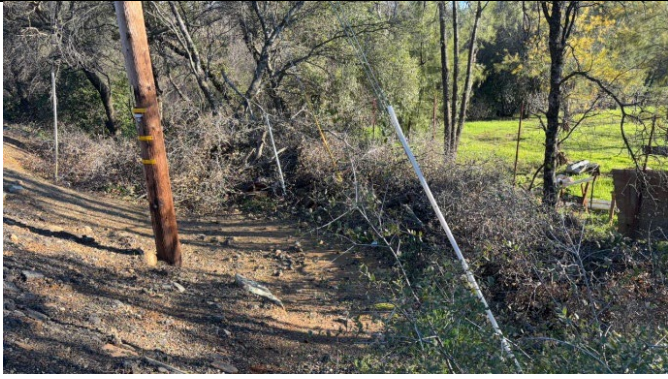
Energy Safety found a “Moderate” deficiency near VMP ID VP_AT114-B17_1050016_2019 near pole ID 100380208 in HFTD Tier 2. PG&E did not perform its Wood and Slash Management (WMP Initiative 8.2.3.2) program as required in the WMP, instead slash was left piled on site.

Photo 3: Photo of the tan oak wood and slash debris, accumulated along the outer ring of the structure Pole ID 100380208.
