NOTICE OF NON-PERFORMANCE

INSPECTION REPORT

Electrical Corporation:	PG&E
Report Number:	NON_ESD_PGE_MAZ_20260114_1444
Inspector:	Max Zazzeron
WMP Year Inspected:	2025
Quarterly Data Report (QDR) Referenced:	Quarter 3 (Q3) 2025
Inspection Selection:	Energy Safety inspected the locations based on PG&E’s Q3 QDR.
Relevant WMP Initiative(s):	8.2.3.2 Wood and Slash Management
Date of inspection:	January 14, 2026
City and/or County of Inspection:	Oroville, Butte County

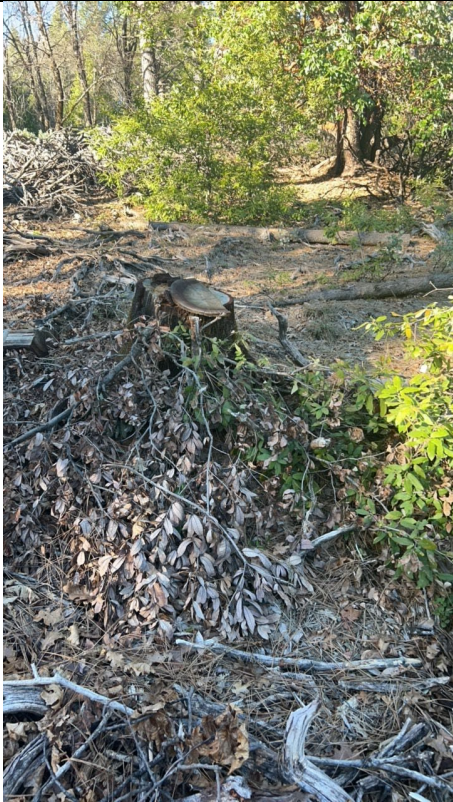
At VMP ID VP_AU114-A22_4208329_2022 near pole ID 121273750, PG&E reported it completed work under its Tree Removal Program. PG&E's Q3 data reports that its crew removed a 19-inch Diameter at Breast Height, 72-foot tall black oak on July 2, 2025. Energy Safety's inspector observed slash and woody debris from the tree piled approximately 4-feet at its tallest point. The inspector's observation is documented in photos 1, 2, 3, and 4, which are exhibits to this report.

Photo 1: Photo of the removed black oak.

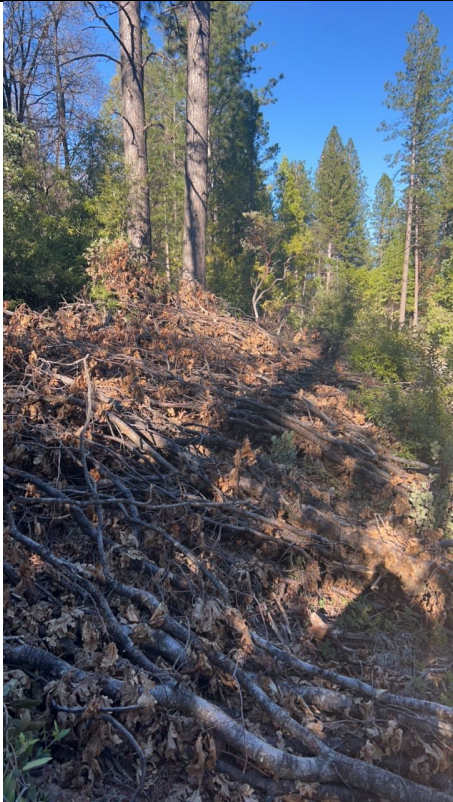
Energy Safety considers this deficiency "Moderate" because the slash pile is over 18-inches in height, creating a potential fuel source for wildfire.

Photo 2: Photo of the pile of wood and slash debris.

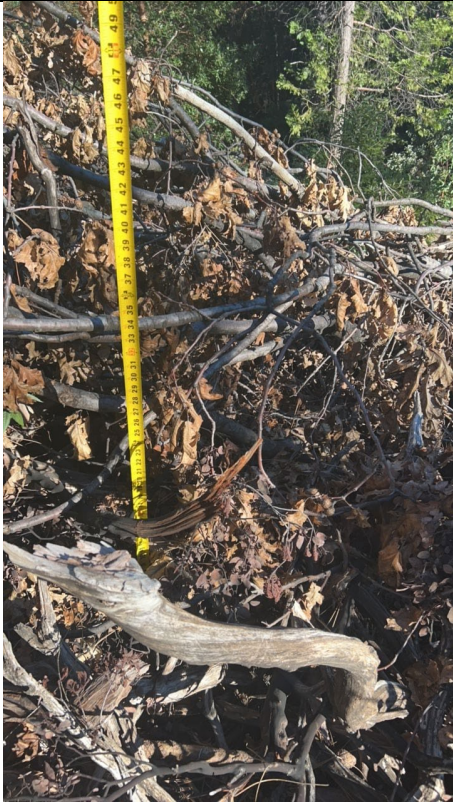
Photo 3: Photo of the pile of wood and slash debris measuring approximately four feet in height.

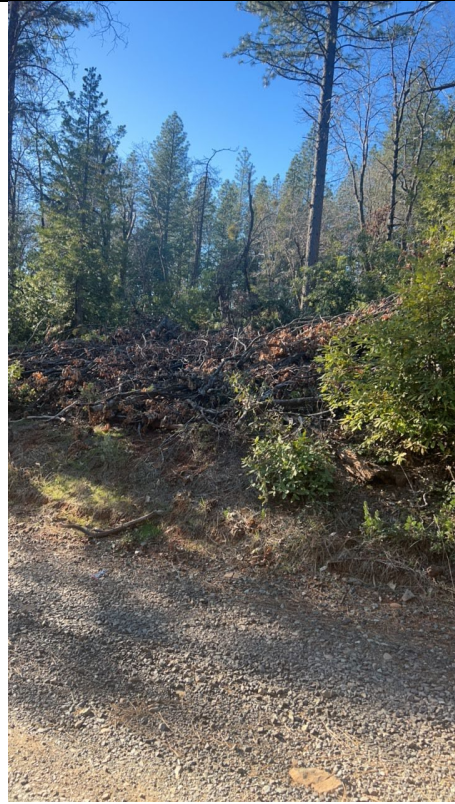
Photo 4: Photo of secondary view of wood and slash debris from roadway.
