NOTICE OF NON-PERFORMANCE

INSPECTION REPORT

Energy Safety found a “Moderate” deficiency near pole ID 121273751 in HFTD Tier 3. PG&E did not perform its Wood and Slash Management (WMP Initiative 8.2.3.2) program as required in the WMP, instead slash was left piled on site.

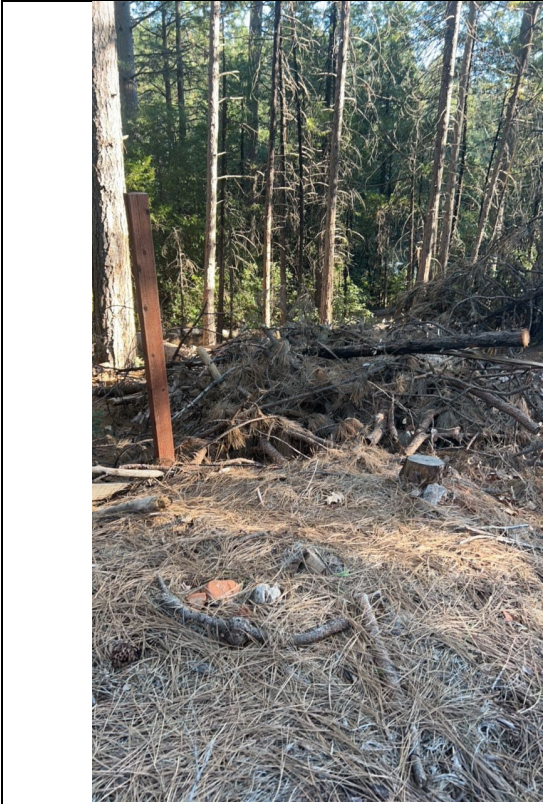
Energy Safety considers this deficiency "Moderate" because the slash pile is over 18-inches in height, creating a potential fuel source for wildfire.

At VMP ID VP_AU114-A23_4542996_2022 near pole ID 121273751, PG&E reported it completed work under its Tree Removal Program. PG&E's Q3 data reports that its crew removed a 28-inch diameter at breast height, 115-foot tall ponderosa pine on July 6, 2025. Energy Safety's inspector observed slash and woody debris piled approximately 36-inches at its tallest point. The inspector's observation is documented in photos 1, 2, 3, and 4, which are exhibits to this report.

Photo 1: Photo of wood and slash debris from roadway.

Deficiency 1. Energy Safety observed that in implementing 2025 WMP initiative VM-04 Tree Removal Inventory, PG&E failed to adhere to its protocol of wood and slash management near pole ID 121273751 and Vegetation Management ID VP_AU114-A23_4542996_2022 at coordinates 39.4886805683248, -121.305716198816. Energy Safety considers this non-performance to be in the Moderate risk category. PG&E must complete a corrective action for this non-performance by two months from the date of this notice.¹

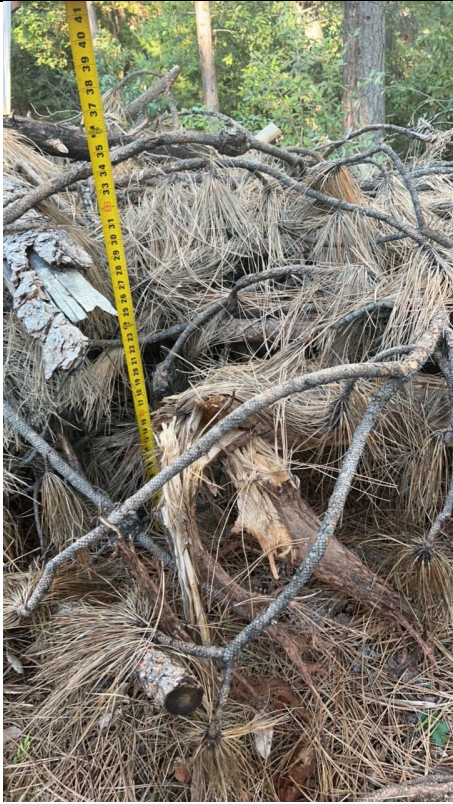
Photo 2: Photo of the pile of wood and slash debris measuring approximately 36 inches in height.

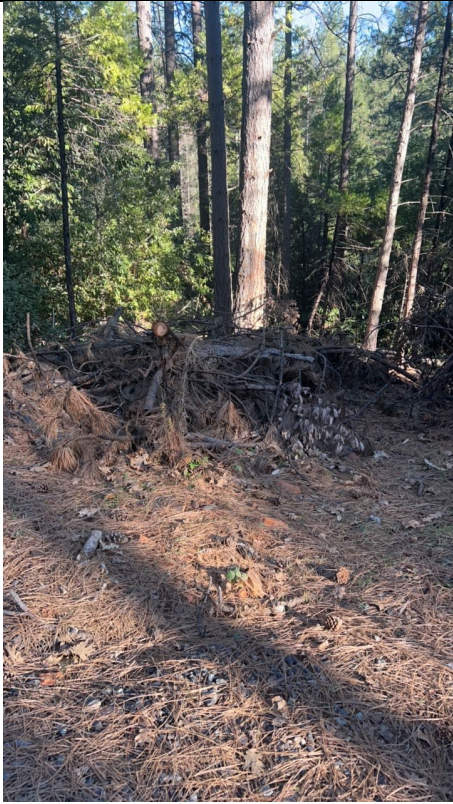
Photo 3: Secondary photo of wood and slash debris from roadway.
