NOTICE OF NON-PERFORMANCE

INSPECTION REPORT

| Report Number: | NON_ESD_PGE_RIB_20260113_1358 |

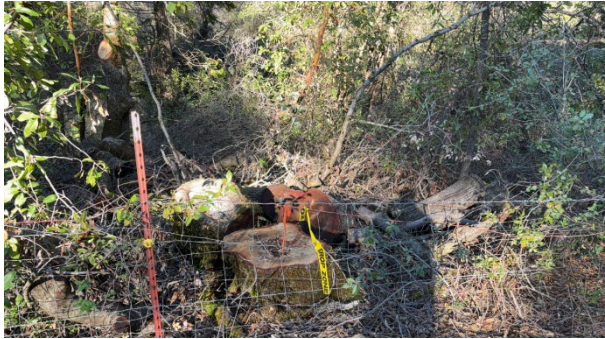
At VMP ID VP_AT114-B10_1086513_2019 near pole ID 100429855, PG&E reported it completed work under its VMOM program. PG&E's Q3 data reports that its crew removed a live oak tree on August 11, 2025. Energy Safety's inspector observed slash, wood chips, and woody debris from the oak trees piled rather than lopped and scattered. The inspector's observation is documented in photos 1, 2 and 3, which are exhibits to this report.

| <p>Photo 1: Live oak stump and logs associated with VP_AT114-B10_1086513_2019.</p> | <p>Photo 2: Additional photo of the live oak stump and logs.</p> |

Deficiency 1. Energy Safety observed that in implementing 2025 WMP initiative 8.2.2.2.3 Vegetation Management for Operational Mitigations (VMOM), PG&E failed to adhere to its protocol of wood and slash management approximately 130 feet northwest of pole ID 100429855 and Vegetation Management ID VP_AT114-B10_1086513_2019 at coordinates 39.5139856171174, -121.405248344553. Energy Safety considers this non-performance to be in the Moderate risk category. PG&E must complete a corrective action for this non-performance by six months from date of this notice.¹

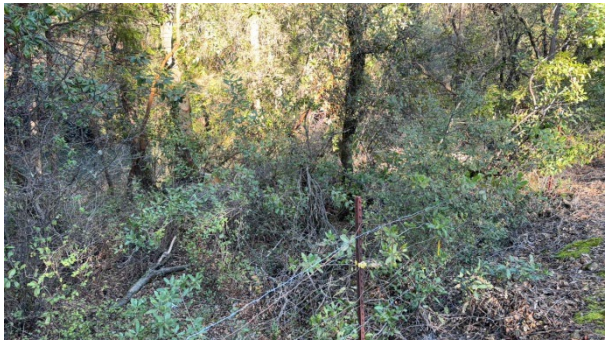
Energy Safety considers this deficiency as "Moderate" because the slash is piled, creating a potential fuel source for wildfire.

| <p>Photo 3: Photo of the live oak wood and slash debris piled behind a fence.</p> | |
