NOTICE OF NON-PERFORMANCE

On January 28, 2026, Energy Safety conducted an inspection of Southern California Edison Company's WMP initiatives in the vicinity of the city of Lake Arrowhead, California. The inspection report is enclosed herewith. Energy Safety found the following deficiencies:

INSPECTION REPORT

| Report Number: | PAD_SCE_AXS_20260128_1425 |

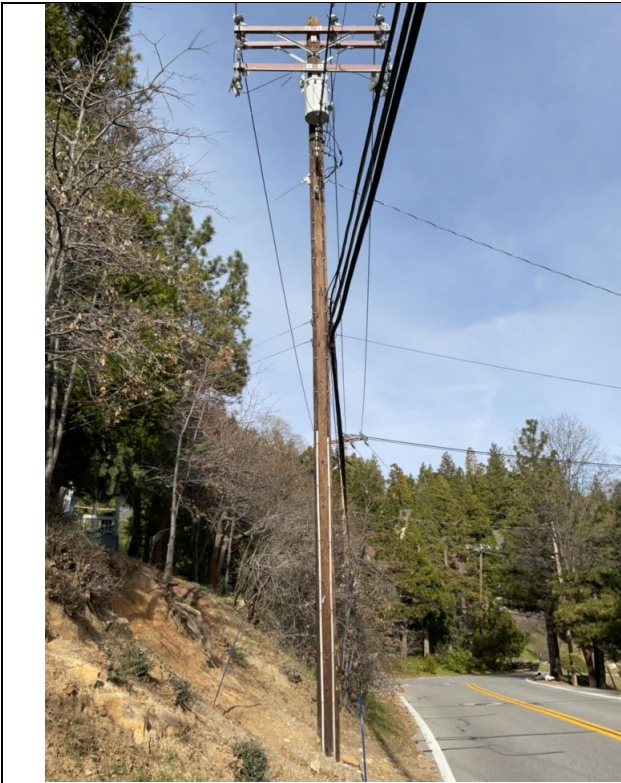
G1mg1: Overall structure

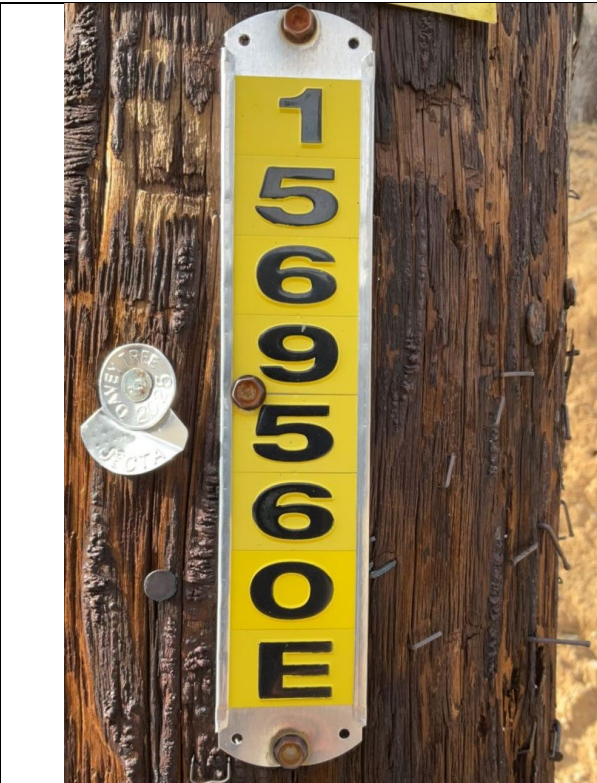
G1mg2: Structure ID

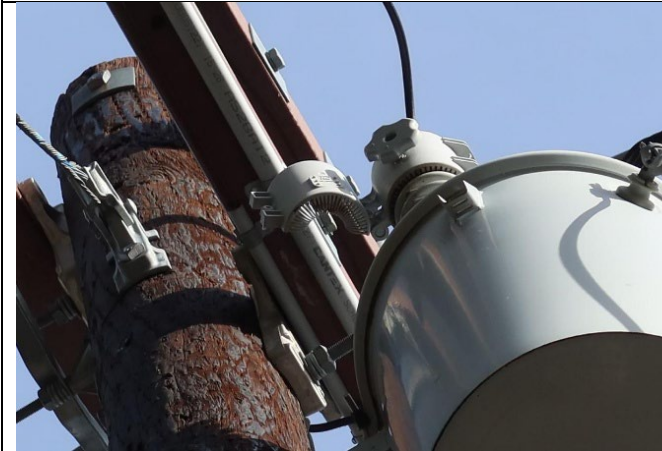
| Deficiency # | Structure ID | Grid Hardening ID | Lat/Long | HFTD | Initiative Number | Severity | Deficiency Description |
|---|---|---|---|---|--|---|---|
| Deficiency 1 | 1569560E | 414768411-1569560E | 34.2616914415583, -117.207866243973 | Tier 3 | 8.1.3.1 - Distribution HFRI Inspections and Remediations | Minor | Failure to complete the remediation of primary bushing avian protection |

On Pole ID 1569560E, Grid Hardening ID 414768411-1569560E at 27300 Peninsula Dr, Lake Arrowhead, CA, 92352, USA, 34.2616914415583, -117.207866243973, the inspector observed that primary bushing avian protection was open. The inspector's observation is documented in Deficiency 1 photographs, which are attachments to this report. Photo numbers IA1Img1, IA1Img2, depict the open primary bushing avian protection.

IA1mg1: View showing primary bushing avian protection open

Deficiency 1. Energy Safety observed that in implementing 2025 WMP initiative 8.1.3.1 - Distribution High Fire Risk-Informed (HFRI) Inspections and Remediations (IN-1.1), SCE failed to complete the remediation of a primary bushing avian protection on Pole ID 1569560E, Grid Hardening ID 414768411-1569560E at coordinates 34.2616914415583, -117.207866243973. Energy Safety considers this non-performance to be in the Minor risk category. SCE must complete a corrective action for this deficiency by 12 months from date of this notice.¹

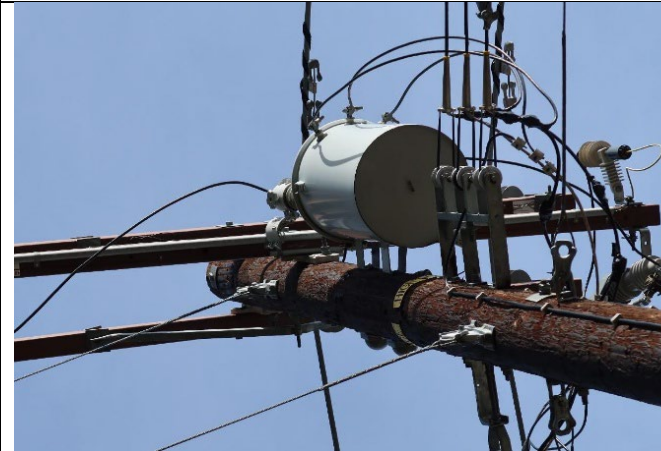
IA1mg2: View showing primary bushing avian protection open
