NOTICE OF NON-PERFORMANCE

INSPECTION REPORT

Electrical Corporation:	SDG&E
Report Number:	NON_ESD_SDGE_RGA_20260210_1144
Inspector:	Ricardo Garcia
WMP Year Inspected:	2025
Quarterly Data Report (QDR) Referenced:	Quarter 3 (Q3) 2025
Inspection Selection:	Energy Safety inspected the locations based on SDG&E’s Q3 QDR.
Relevant WMP Initiative(s):	8.2.3.1 Pole Clearing (WMP.512)
Date of inspection:	February 10, 2026
City and/or County of Inspection:	Ramona, California

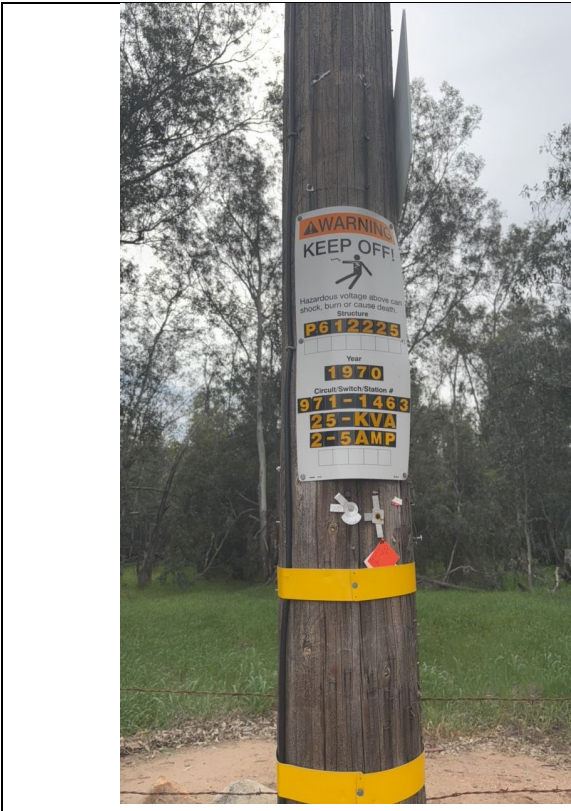
Photo 1: Pole ID P612225.

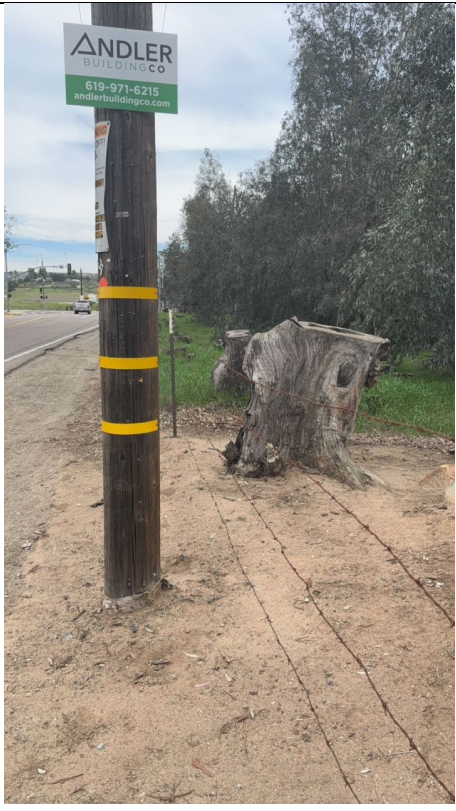
Energy Safety considers this deficiency "Moderate" because a dead and desiccated eucalyptus stump remains within 10 feet of pole ID P612225. The continued presence of a dry, flammable stump poses an ongoing wildfire risk.

Photo 2: The eucalyptus stump within the 10-foot radius of the pole.

Deficiency 1. Energy Safety observed that in implementing 2025 WMP initiative 8.2.3.1 Pole Clearing (WMP.512), which requires compliance with Public Resources Code section 4292, SDG&E failed to remove all vegetation down to bare mineral soil within a 10-foot radius of pole ID P612225, near coordinates 33.01475, -116.86764. Energy Safety considers this non-performance to be in the Moderate risk category. SDG&E must complete a corrective action for this non-performance by six months from the date of this notice.¹

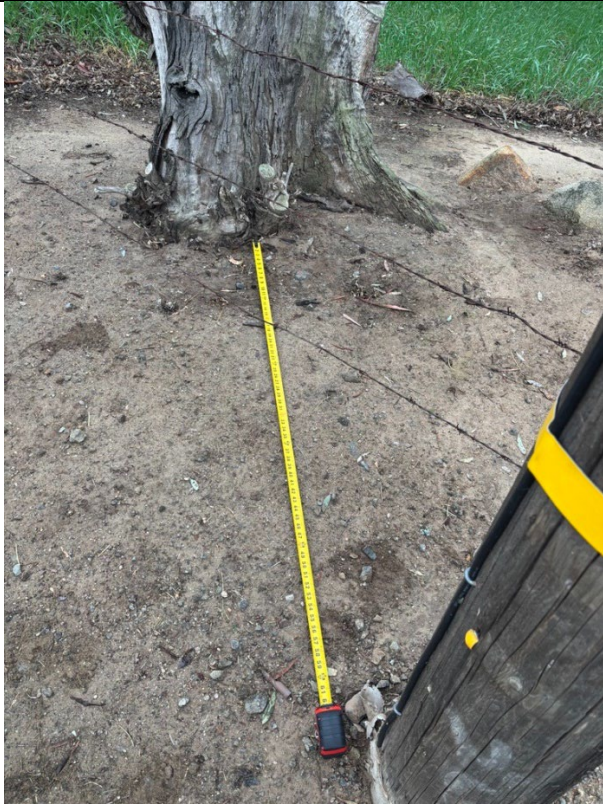
Photo 3: Measurement shows the eucalyptus stump is approximately five feet from the base of the pole.

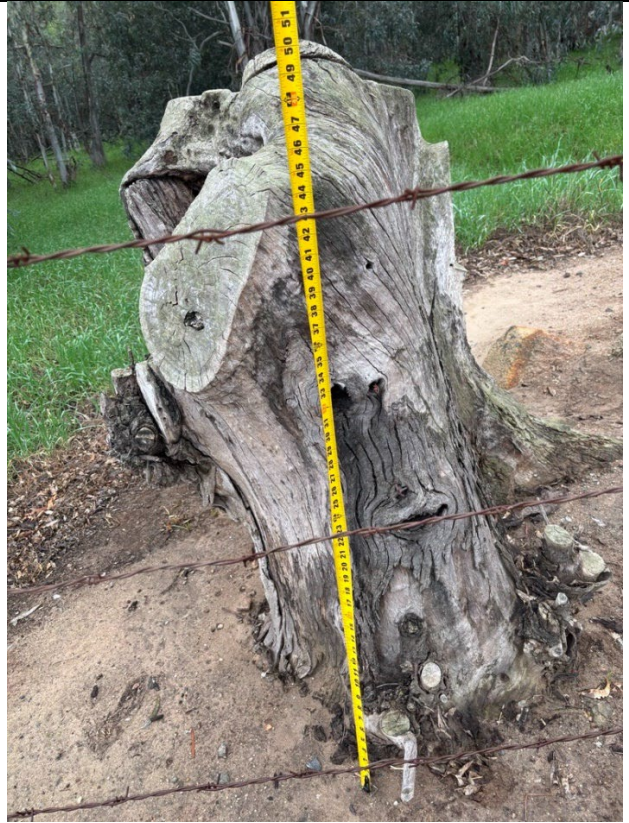
Photo 4: Measurement shows the eucalyptus stump is approximately four feet in height.

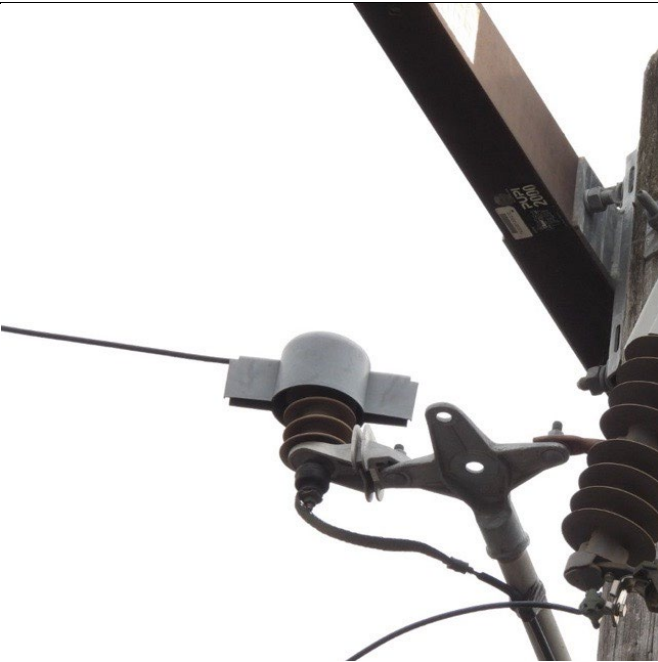
Photo 5: Close-up image of non-exempt surge arrester on the pole.
