## **NOTICE OF NON-PERFORMANCE**

# INSPECTION REPORT

Electrical Corporation:	Pacific Gas and Electric Company
Report Number:	PAD_PGE_BKA_20251119_0952
Inspector:	Babak Kaviani
WMP Year Inspected:	2025
Quarterly Data Report (QDR) Referenced:	Quarter 2 (Q2)
Inspection Selection:	Energy Safety viewed the contents of the Q2 QDR and performed an analysis that resulted in the selection of the WMP initiatives and locations referenced in this report.
Relevant WMP Initiative(s):	8.1.2.10.5 - Non-Exempt Expulsion Fuses
Date of Inspection:	November 19, 2025
City and/or County of Inspection:	Cambria, San Luis Obispo County
Inspection Purpose:	Assess the accuracy of Pacific Gas and Electric Company’s QDR data, completeness of its work, and performance of requirements.

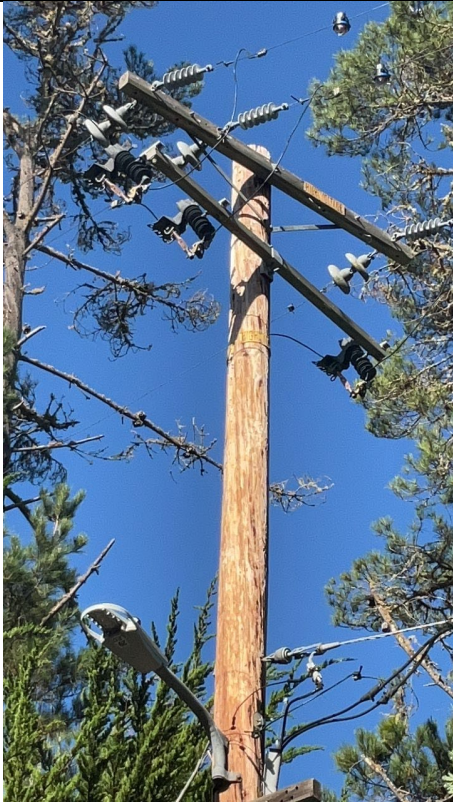
On Pole ID 121349323, Grid Hardening ID 31700048 at 6359 Charing Ln, Cambria, CA, 93428, USA, 35.5742353504259, -121.103773500051, the inspector observed that Solid Blade disconnects were installed without a 10ft firebreak clearance, and without the presence of reclosers, sectionalizers, or voltage regulators on the pole. The inspector's observation is documented in Deficiency 1 photographs, which are attachments to this report. Photo number IA1Img2 depicts Solid Blade disconnects without reclosers, sectionalizers, or voltage regulators located the pole. In the 2025 Q2 Quarterly Data Report submission, PG&E reported that work on WMP initiative 8.1.2.10.5 - Non-Exempt Expulsion Fuses were completed at this location.

1. Exempt fuses were not installed at the subject pole.
2. The inspector observed Solid Blade disconnects on the subject pole.
3. The inspector did not observe a 10ft firebreak clearance around the subject pole.
4. No reclosers, sectionalizers, or voltage regulators were observed at the subject pole.

**IA1Img2:** Solid blade disconnects without reclosers, sectionalizers, or voltage regulators also on the pole.

Deficiency 1. Energy Safety observed that in implementing 2025 WMP initiative 8.1.2.10.5 - Non-Exempt Expulsion Fuses, PG&E failed to complete the installation of non-exempt expulsion fuses on Pole ID 121349323, Grid Hardening ID 31700048 at coordinates 35.5742353504259, -121.103773500051. Energy Safety considers this non-performance to be in the Minor risk category. PG&E must complete a corrective action for this deficiency by 12 months of this notice.<sup>1</sup>
