NOTICE OF NON-PERFORMANCE

INSPECTION REPORT

Electrical Corporation:	Pacific Gas and Electric Company
Report Number:	PAD_PGE_BKA_20251105_1405
Inspector:	Babak Kaviani
WMP Year Inspected:	2025
Quarterly Data Report (QDR) Referenced:	Quarter 2 (Q2)
Inspection Selection:	Energy Safety viewed the contents of the Q2 QDR and performed an analysis that resulted in the selection of the WMP initiatives and locations referenced in this report.
Relevant WMP Initiative(s):	8.1.2.10.5 - Non-Exempt Expulsion Fuses
Date of Inspection:	November 5, 2025
City and/or County of Inspection:	Auburn, Placer County
Inspection Purpose:	Assess the accuracy of Pacific Gas and Electric Company’s QDR data, completeness of its work, and performance of requirements.

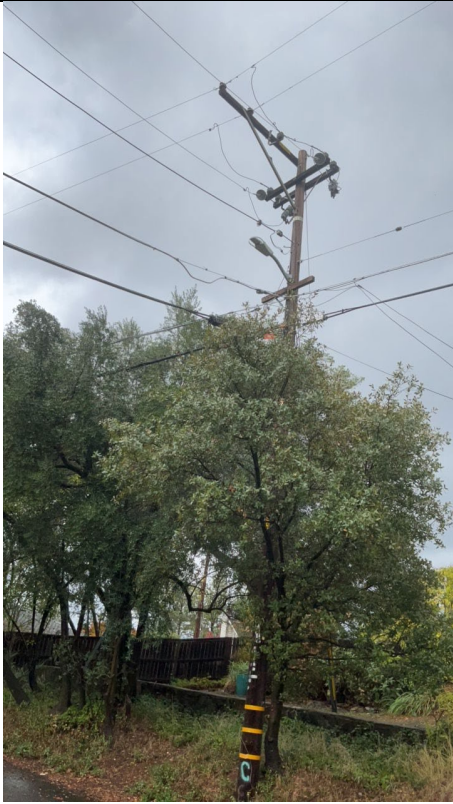
A close-up photograph of a utility pole with several white identification tags attached. The tags display the numbers 4, 9, 1, 6, 5, 4, 7, and a small white circle at the bottom.
<p>G1mg1: Overall structure</p>	<p>G1mg2: Structure ID</p>

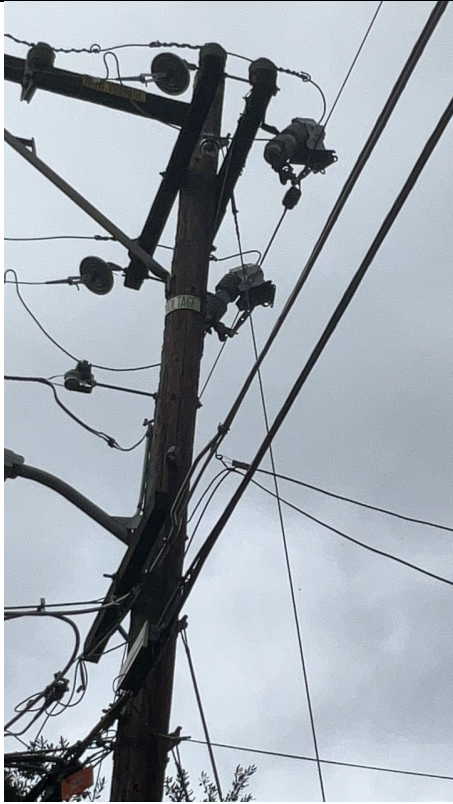
On Pole ID 228375, Grid Hardening ID 31700012 at 103-107 Robie Dr, Auburn, CA, 95603, USA, 38.8936432596489, -121.061130400367, the inspector observed that Solid Blade disconnects were installed without a 10 foot firebreak clearance and without reclosers, sectionalizers, or voltage regulators installed at the pole. The inspector's observation is documented in Deficiency 1 photographs, which are attachments to this report. In the 2025 Q2 Quarterly Data Report submission, PG&E reported that work on WMP initiative 8.1.2.10.5 - Non-Exempt Expulsion Fuses was completed at this location.

1. Exempt fuses were not installed at the subject pole.
2. The inspector observed Solid Blade disconnects on the subject pole.
3. The inspector did not observe a 10 foot firebreak clearance around the subject pole.
4. No reclosers, sectionalizers, or voltage regulators were observed at the subject pole.

G1mg3: Solid Blade Disconnects and lack of reclosers, sectionalizers, or voltage regulators

Deficiency 1. Energy Safety observed that in implementing 2025 WMP initiative 8.1.2.10.5 - Non-Exempt Expulsion Fuses, PG&E failed to complete the installation of non-exempt expulsion fuses on Pole ID 228375, Grid Hardening ID 31700012 at coordinates 38.8936432596489, -121.061130400367. Energy Safety considers this non-performance to be in the Minor risk category. PG&E must complete a corrective action for this deficiency by 12 months of this notice.

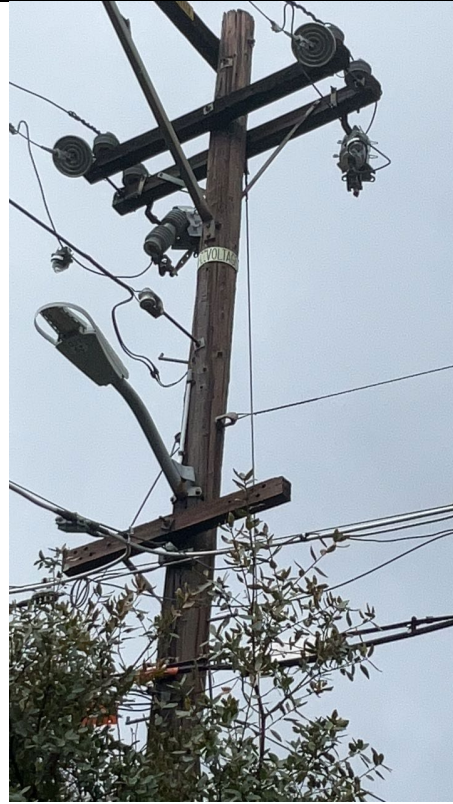
G1mg4: Solid Blade Disconnects and lack of reclosers, sectionalizers, or voltage regulators

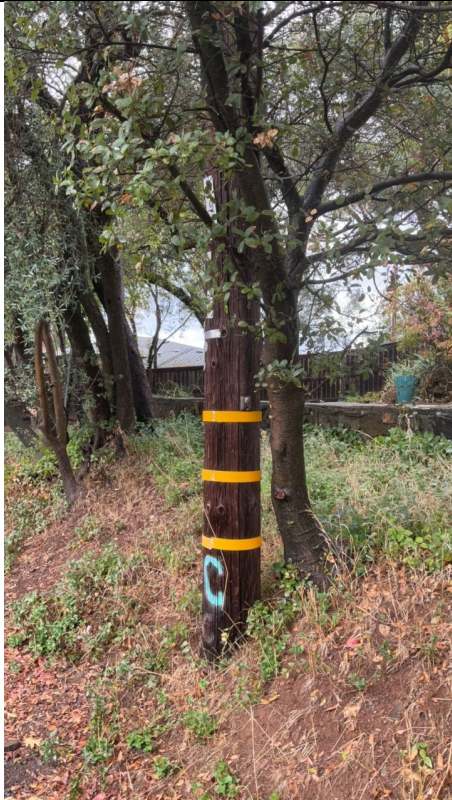
IA1mg2: Vegetation within 10 ft of the base of the pole

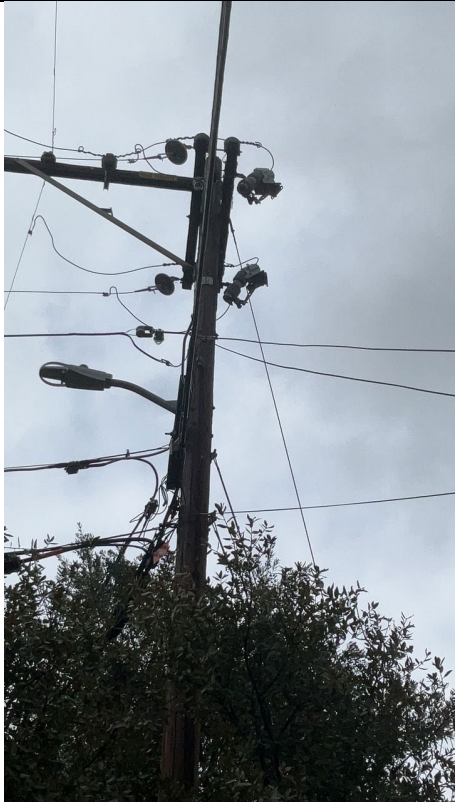
IA1Img3: Solid Blade Disconnects and lack of reclosers, sectionalizers, or voltage regulators.
