NOTICE OF NON-PERFORMANCE

INSPECTION REPORT

Electrical Corporation:	SDG&E
Report Number:	NON_ESD_SDGE_RGA_20260210_1149
Inspector:	Ricardo Garcia
WMP Year Inspected:	2025
Quarterly Data Report (QDR) Referenced:	Quarter 3 (Q3) 2025
Inspection Selection:	Energy Safety inspected the locations based on SDG&E’s Q3 QDR.
Relevant WMP Initiative(s):	8.2.3.1 Pole Clearing (WMP.512)
Date of inspection:	February 10, 2026
City and/or County of Inspection:	Ramona, California

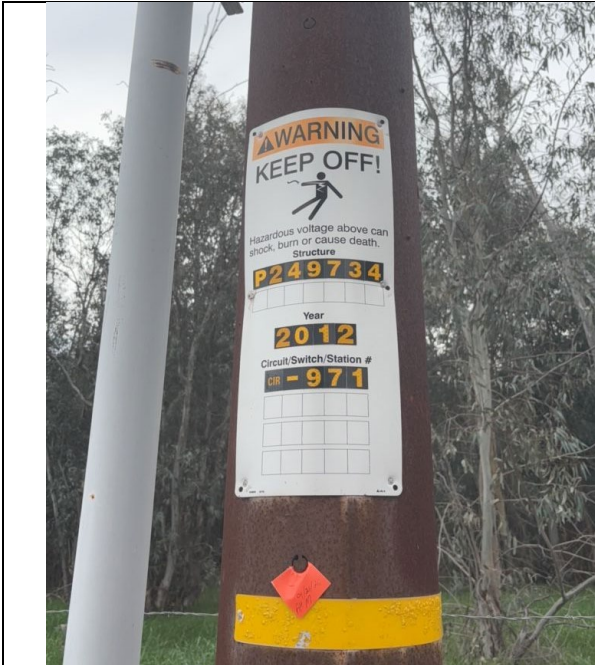
Photo 1: Pole ID P249734.

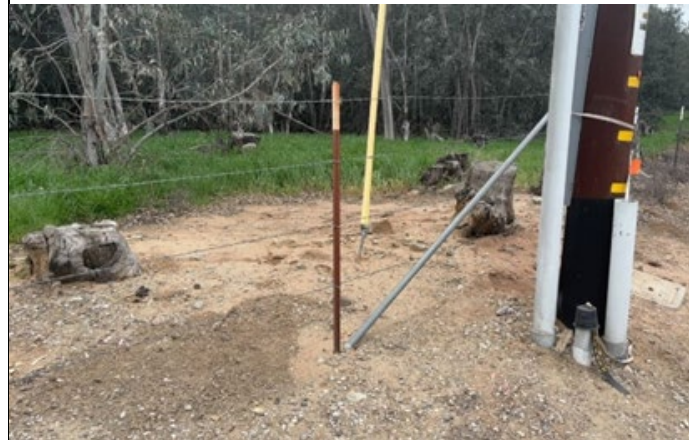
Energy Safety considers this deficiency "Moderate" because two dead and desiccated eucalyptus stumps remain within 10 feet of pole ID P249734. The continued presence of dry, flammable stumps poses an ongoing wildfire risk.

Photo 2: Two eucalyptus stumps within the 10-foot radius of the pole.

Deficiency 1. Energy Safety observed that in implementing 2025 WMP initiative 8.2.3.1 Pole Clearing (WMP.512) which requires compliance with Public Resources Code section 4292, SDG&E failed to remove all vegetation down to bare mineral soil within a 10-foot radius of pole ID P249734, near coordinates 33.01475, -116.86707. Energy Safety considers this non-performance to be in the Moderate risk category. SDG&E must complete a corrective action for this non-performance by six months from the date of this notice.¹

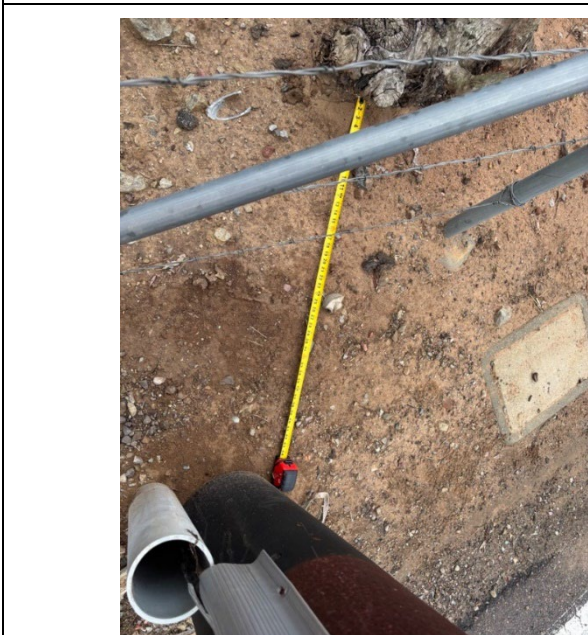
Photo 3: Measurement shows one of the two eucalyptus stumps located approximately four feet from the base of the pole.

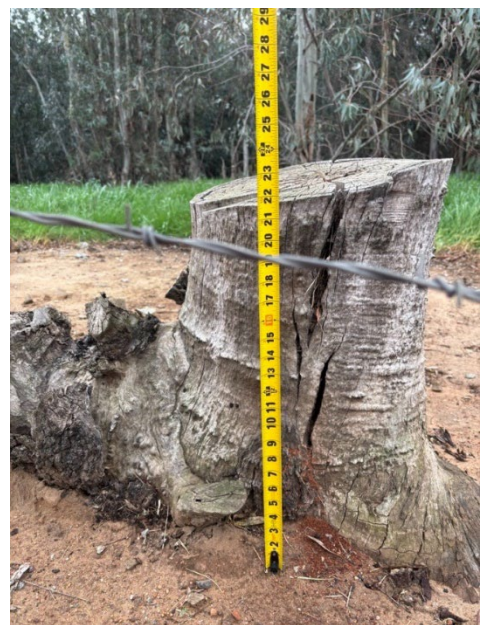
Photo 4: Measurement shows the eucalyptus stump is approximately two feet in height.

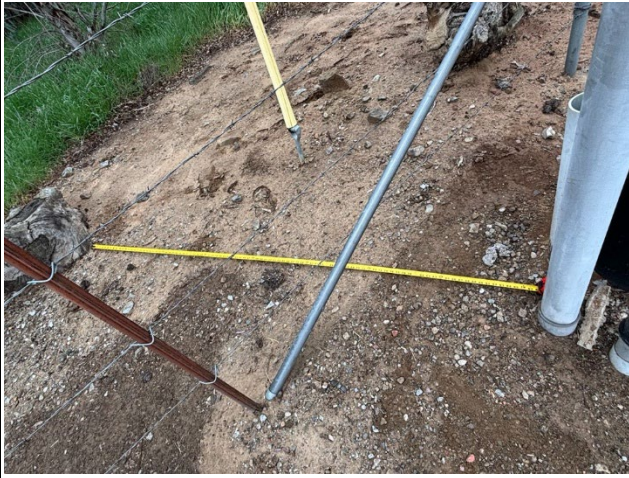
Photo 5: Measurement indicates the second eucalyptus stump is approximately eight feet from the base of the pole.

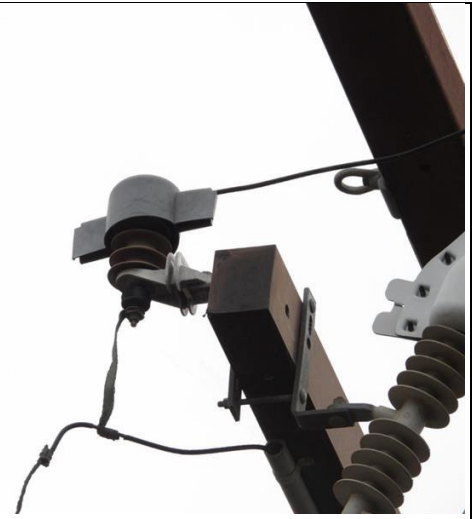
Photo 6: Close-up image of non-exempt surge arrester on the pole.
