NOTICE OF NON-PERFORMANCE

INSPECTION REPORT

Electrical Corporation:	Southern California Edison Company
Report Number:	PAD_SCE_AXS_20260128_0957
Inspector:	Alexander Scott
WMP Year Inspected:	2025
Quarterly Data Report (QDR) Referenced:	Quarter 3 (Q3)
Inspection Selection:	Energy Safety viewed the contents of the Q3 QDR and performed an analysis that resulted in the selection of the WMP initiatives and locations referenced in this report.
Relevant WMP Initiative(s):	8.1.3.1 - Distribution Detailed Inspections and Remediations (IN-1.1)
Date of Inspection:	January 28, 2026
City and/or County of Inspection:	Lake Arrowhead, San Bernardino County
Inspection Purpose:	Assess the accuracy of Southern California Edison Company’s QDR data, completeness of its work, and performance of requirements.

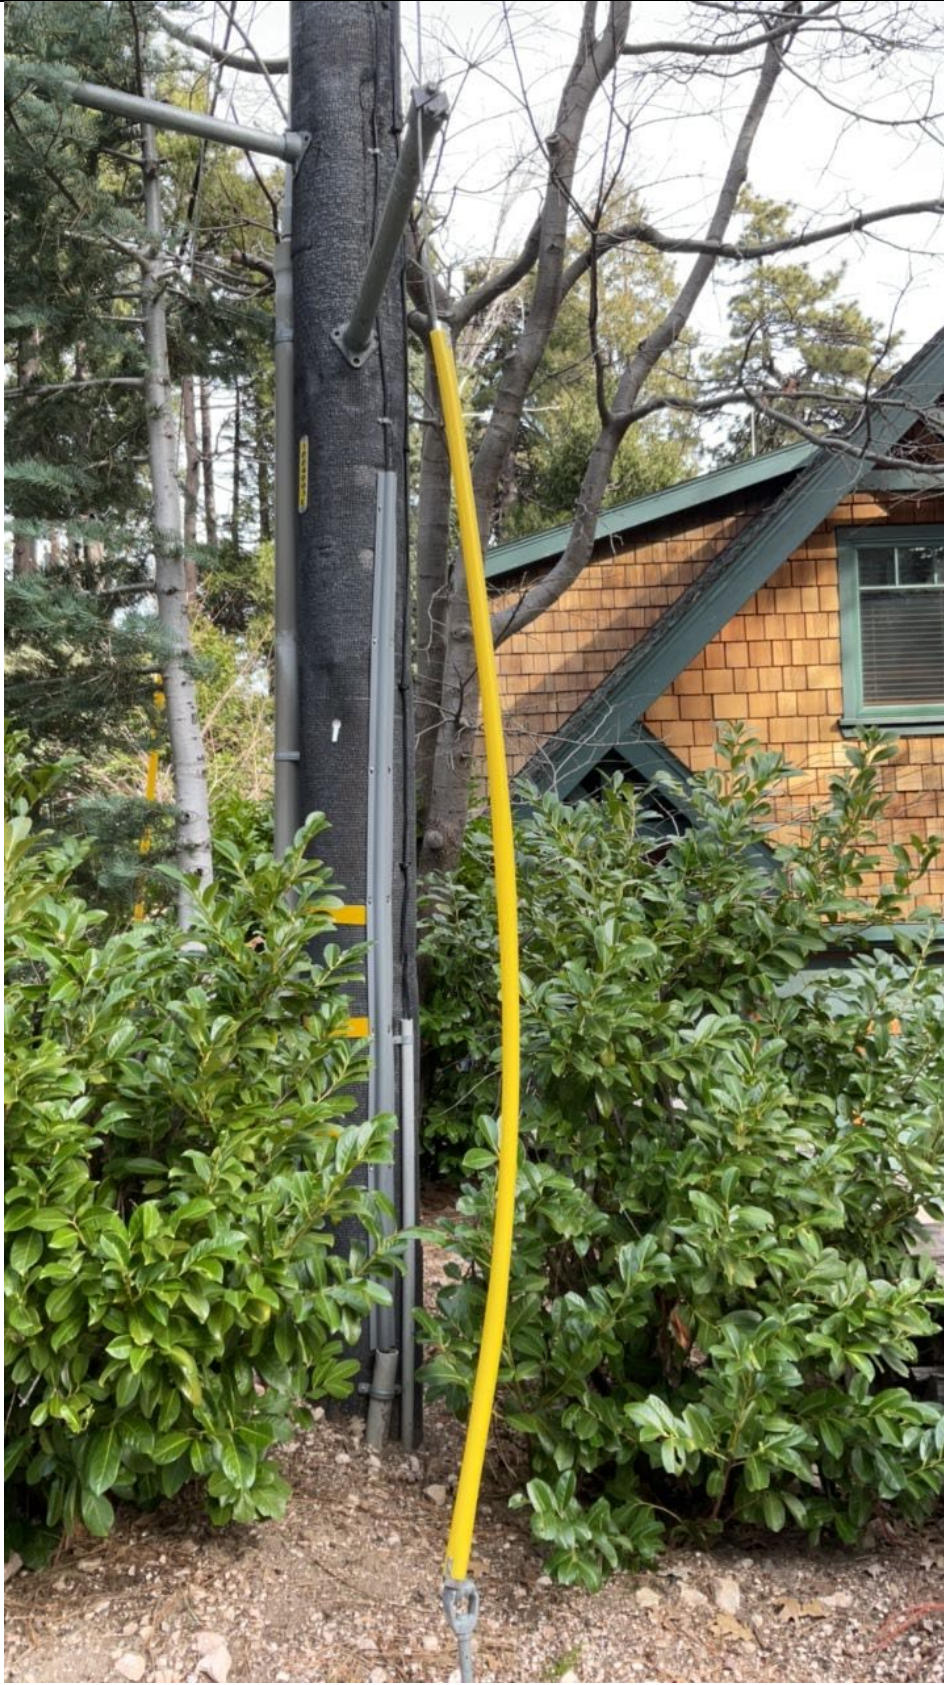
On Pole ID1884993E, Grid Hardening ID 414749115-1884993E at 733-797 Crest Estates Dr, Lake Arrowhead, CA, 92352, USA, 34.2394618615618, -117.193960227401, the inspector observed a sagging communication down guy. The inspector's observation is documented in Deficiency 1 photographs, which are attachments to this report. Photo number IA1Img1 depicts sagging communication down guy.

1. Southern California Edison Company's 2025 WMP initiative number 8.1.3.1, Distribution Detailed Inspections and Remediations, work identified that remediation of a sagging communication down guy was completed at this location.
2. SCE personnel apparently communicated the condition to a communications company, but has not confirmed that work was done to address the condition.
3. The inspector observed the communication down guy was still sagging at the time of inspection.

IA1Img1: Sagging communication down guy

Deficiency 1. Energy Safety observed that in implementing 2025 WMP initiative 8.1.3.1 - Distribution High Fire Risk-Informed (HFRI) Inspections and Remediations (IN-1.1), SCE failed to validate the remediation of sagging communication down guy wire prior to closing the work order on Pole ID1884993E, Grid Hardening ID 414749115-1884993E at coordinates 34.2394618615618, -117.193960227401. Energy Safety considers this non-performance to be in the Minor risk category. SCE must complete a corrective action for this deficiency by 12 months from the date of this notice.
