NOTICE OF NONPERFORMANCE

INSPECTION REPORT

Electrical Corporation:	PG&E
Report Number:	NON_ESD_PGE_RGA_20260311_1117
Inspector:	Ricardo Garcia
WMP Year Inspected:	2025
Quarterly Data Report (QDR) Referenced:	Quarter 4 (Q4) 2025
Inspection Selection:	Energy Safety inspected the locations based on PG&E’s Q4 QDR.
Relevant WMP Initiative(s):	8.2.2.2 Vegetation Inspections - Distribution
Date of inspection:	March 11, 2026
City and/or County of Inspection:	Mokelumne Hill, California

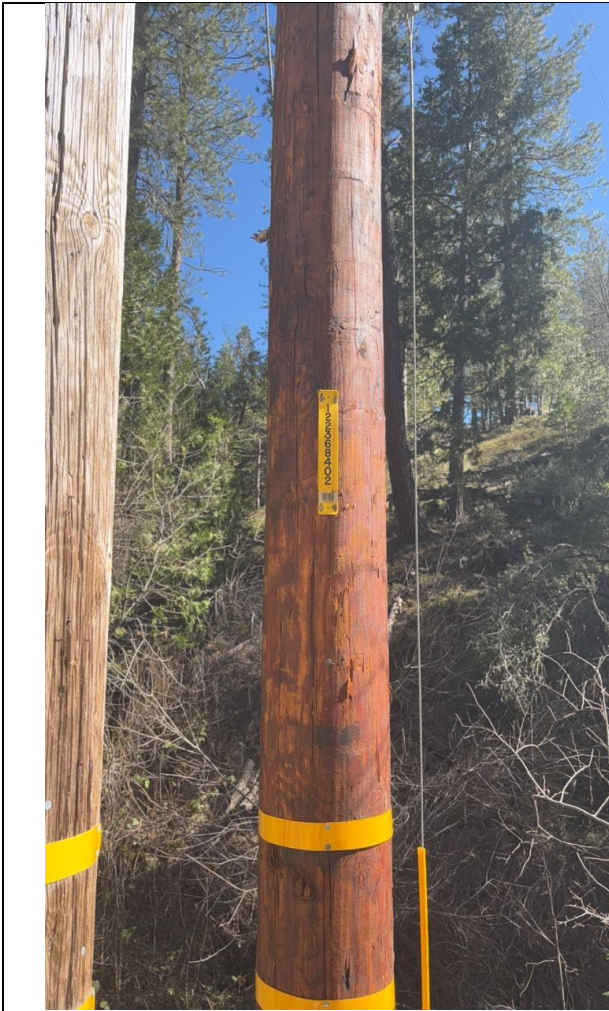
Photo 1: Photo of pole ID 122368402 located approximately 27 feet south of the subject tree.

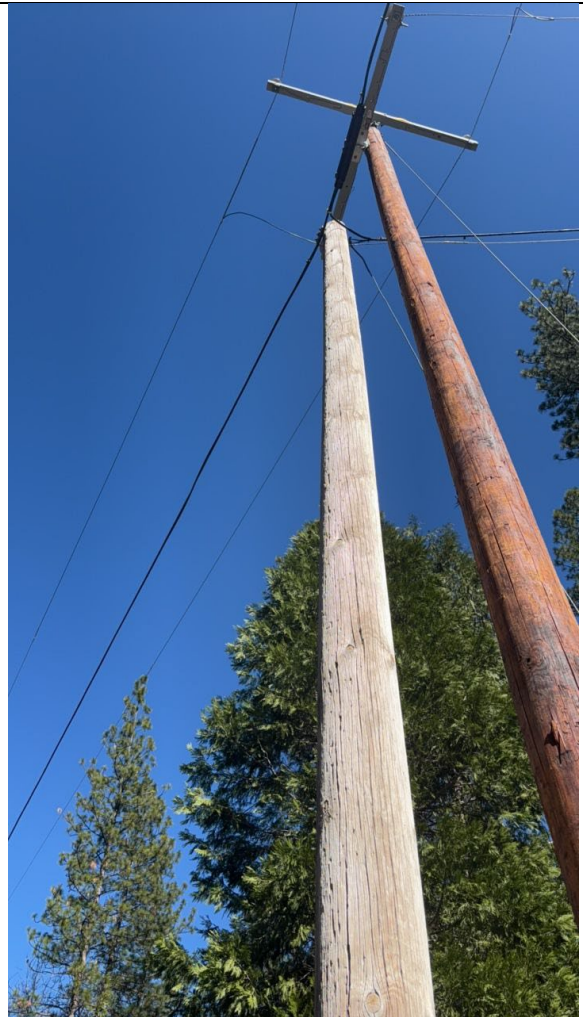
Energy Safety considers this deficiency as a “Moderate” because PG&E failed to maintain the required minimum clearance distance between vegetation and its conductors, consistent with the requirements of Public Resources Code section 4293. A cedar tree was growing within the four-foot clearance distance, and the continued encroachment presents a wildfire risk.

On March 11, 2026, Energy Safety conducted an inspection of PG&E's WMP initiatives in the vicinity of Mokelumne Hill, California. During the inspection, Energy Safety identified a cedar tree growing within the four-foot minimum clearance distance near pole ID 122368402 and near coordinates 38.30124, -120.50330 along Railroad Flat Road. The cedar tree is located within the SRA. The inspector measured the distance between the primary conductors and the closest branches of the cedar tree using a Nikon Forestry Pro II laser range finder. The measured distance was no more than 3.5 feet, which is less than the required four-foot clearance. According to the asset ArcGIS layer provided by PG&E, the operating voltage of the primary conductors is 12,000 volts. The cedar tree has a diameter at breast height of 15 inches, is approximately 40 feet tall, and is located approximately 27 feet north of the pole ID 122368402. The inspector's observations are documented in Exhibit A photographs, which are attached to this report. Photo 1 depicts pole ID 122368402. Photos 2, 3, and 4 depict the cedar tree encroaching into the four-foot minimum clearance distance.

Photo 2: Photo of the cedar tree encroaching within the four-foot minimum clearance distance from the primary conductor.

Deficiency 1. Energy Safety observed that PG&E failed to implement its 2025 WMP initiative 8.2.2.2, which requires compliance with Public Resource Code 4293, by not maintaining a four-foot clearance distance around the primary conductors near coordinates 38.30124, -120.50330. Energy Safety considers this non-performance to be in the Moderate risk category. PG&E must complete a corrective action for this non-performance by six months from the date of this notice.¹

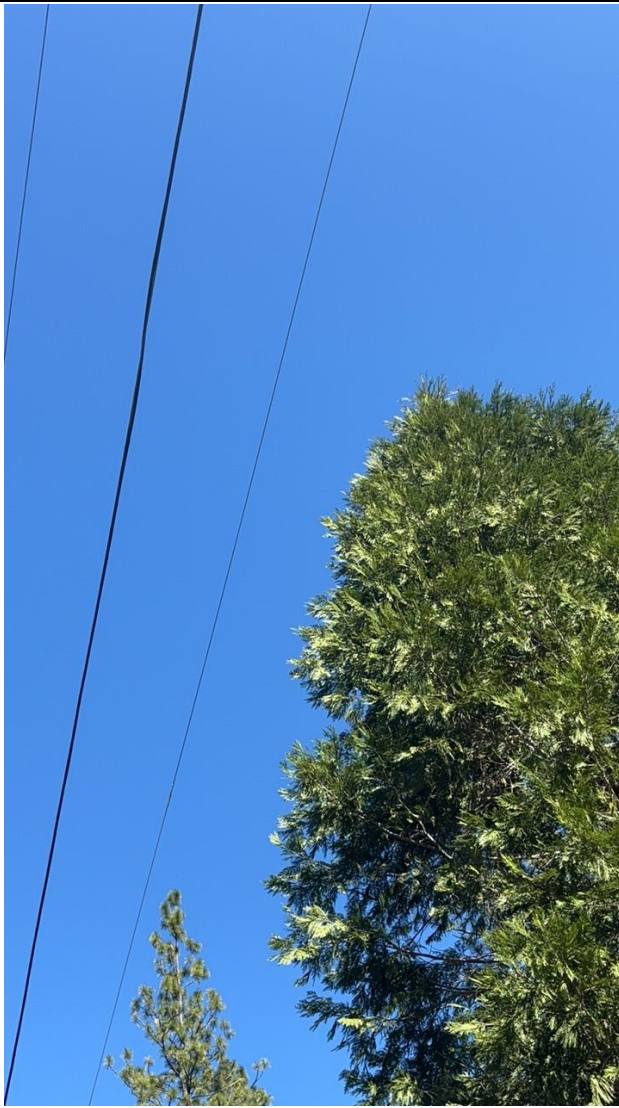
Photo 3: Close-up photo of the same cedar tree encroaching within the four-foot minimum clearance distance from the primary conductor.

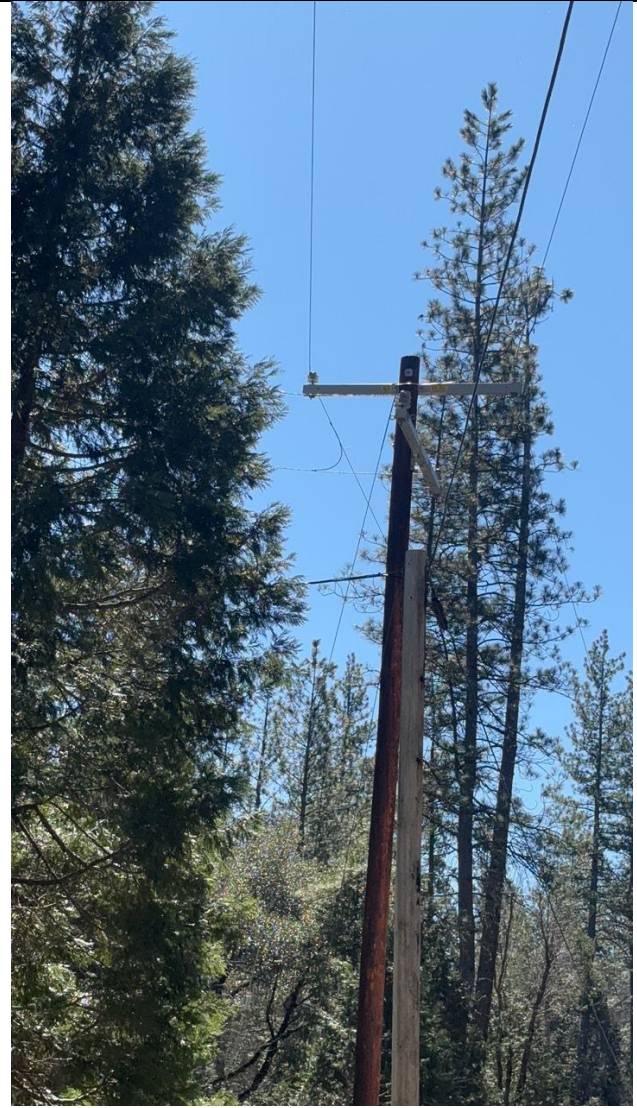
Photo 4: Additional photo of the same cedar tree encroaching within the four-foot minimum clearance distance from the primary conductor. Photo taken north of the tree and pole looking south.
