SUBJECT: Southern California Edison’s (SCE’s) 2024 Vegetation Management Audit (VMA) Report

OFFICE OF ENERGY INFRASTRUCTURE SAFETY
2024 VEGETATION MANAGEMENT
AUDIT REPORT
SOUTHERN CALIFORNIA EDISON

March 27, 2026

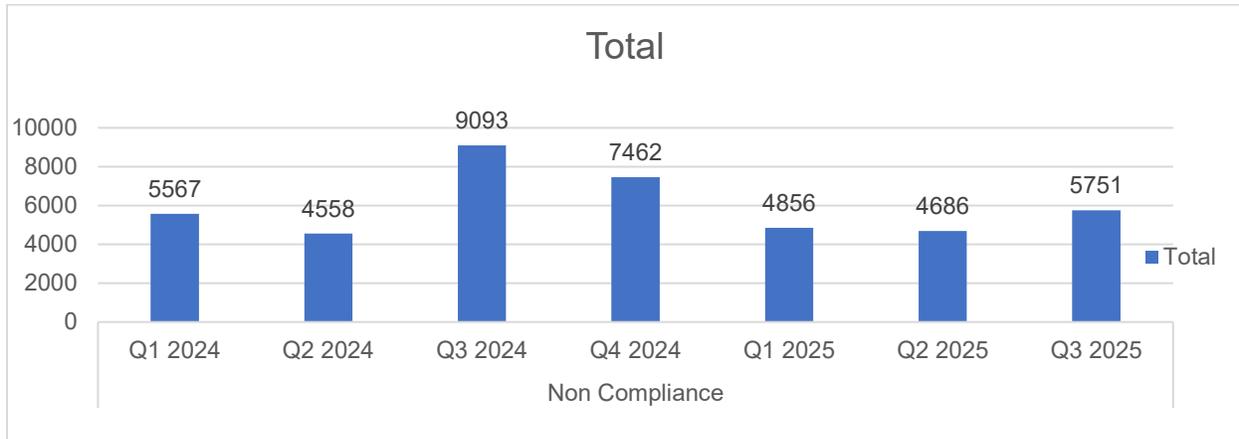
P2s where vegetation is closer than the RCD (four feet) but beyond 18 inches (30 days): In addition to performing monitoring to provide reasonable assurance the P2s do not become P1s, SCE sends weekly P1/P2 backlog and aging reports in an Excel spreadsheet to all VM schedulers and VM Managers to provide visibility and focus. The report contains all P2 noncompliant (<RCD) conditions throughout the SCE service territory, not just in HFRA, and not just those that are older than 30 days. Although sent on a weekly basis, below is a trend report of P2 noncompliance (< RCD) conditions for each quarter from 1Q24 through 3Q25.

In addition to the above trends, the weekly Excel report tracks the number of days in constraint status and classifies each work point by the number of days between creation and completion (e.g., < 5 days, 5-14 days, 15-30 days, > 30 days). This helps SCE to zero in on those P2 conditions that are aging and work to identify delays and resolve constraints. The reports are sent to contractors, and the contractors are expected to provide updates regarding when re-visits were performed to provide assurance the unmitigated work does not become a P1.
