NOTICE OF NON-PERFORMANCE

INSPECTION REPORT

Electrical Corporation:	SCE
Report Number:	NON_ESD_SCE_MAZ_20260223_1048
Inspector:	Max Zazzeron
WMP Year Inspected	2025
Inspection Selection:	Energy Safety inspected the location based on SCE’s Q4 2025 QDR.
Relevant WMP Initiative(s):	8.2.3.4.2 Dead and Dying Tree Removal
Date of inspection:	February 23, 2026
City and/or County of Inspection:	Santa Barbara, California

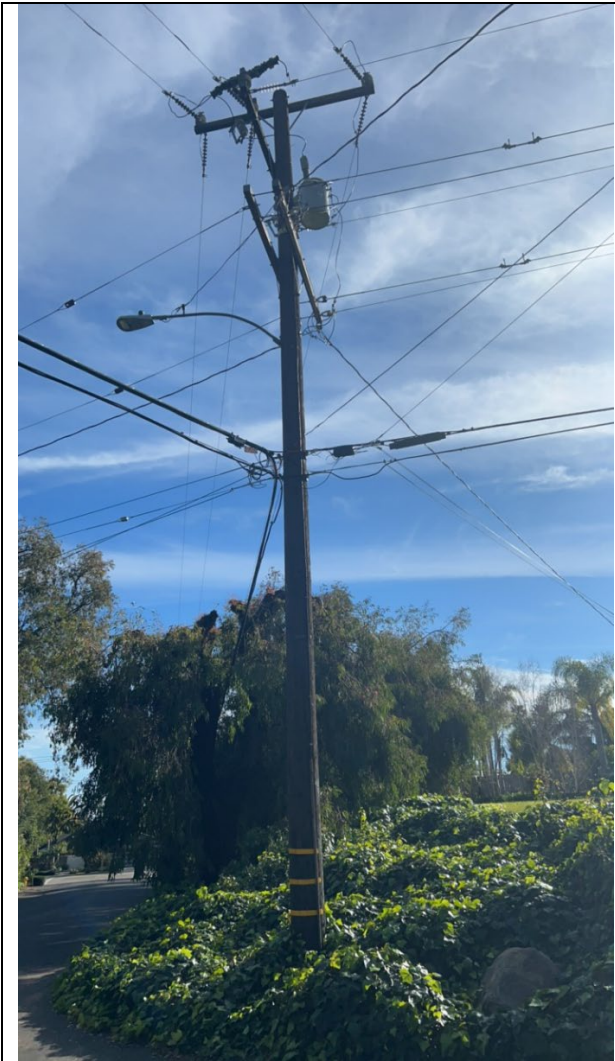
Photo 1: Photo of structure ID 207498530 located approximately 40 feet southwest of the dying eucalyptus tree.

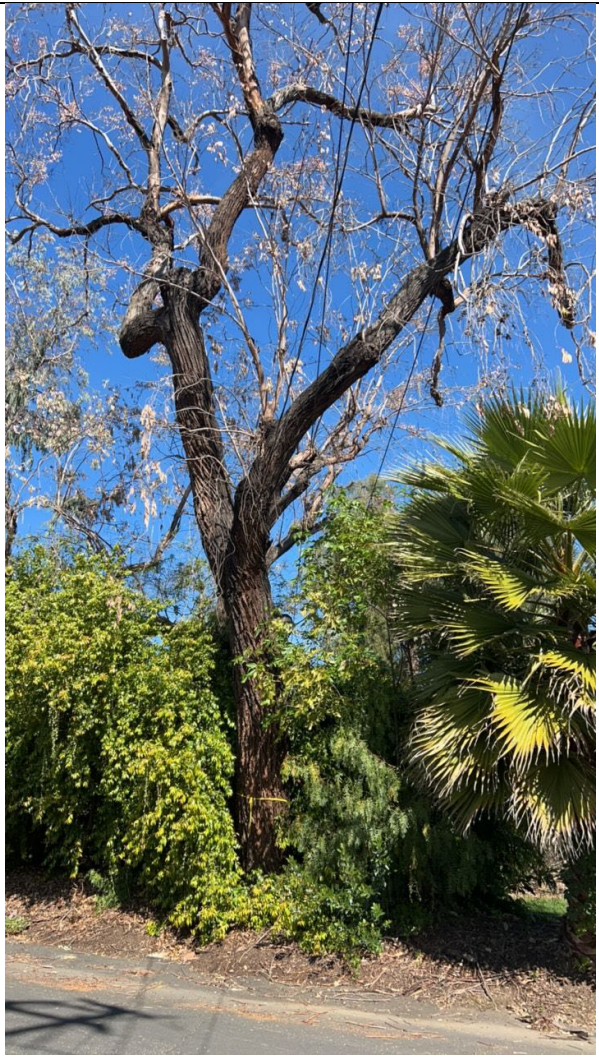
Energy Safety considers this deficiency "Moderate" because SCE has not removed the dying tree located within striking distance of conductors, consistent with the requirements of Public Resources Code section 4293 and SCE's WMP. The continued presence of this tree presents an ongoing wildfire risk.

On February 23, 2026, Energy Safety conducted an inspection of SCE's WMP initiatives in the vicinity of Santa Barbara, California. During the inspection, Energy Safety identified a dying eucalyptus tree with its canopy foliage declining more than 75 percent near support structure ID 207498530 and near coordinates 34.4598, -119.8163 at the north corner of Camino Cerralvo and Camino Meleno. The eucalyptus tree has a diameter at breast height of 25 inches, is approximately 60 feet tall, and is located 20 feet west of the conductors. The inspector's observations are documented in Exhibit A photographs, which are attached to this report. Photo 1 depicts support structure ID 207498530. Photos 2, 3 and 4 depict the dying eucalyptus tree.

Photo 2: Photo of the dying eucalyptus tree.

Deficiency 1. Energy Safety observed that SCE failed to implement its 2025 WMP initiative 8.2.3.4.2, which requires compliance with Public Resource Code section 4293, by not removing a dead, declining, or dying tree near coordinates 34.4598, -119.8163. Energy Safety considers this non-performance to be in the Moderate risk category. SCE must complete a corrective action for this non-performance by two months from the date of this notice.¹

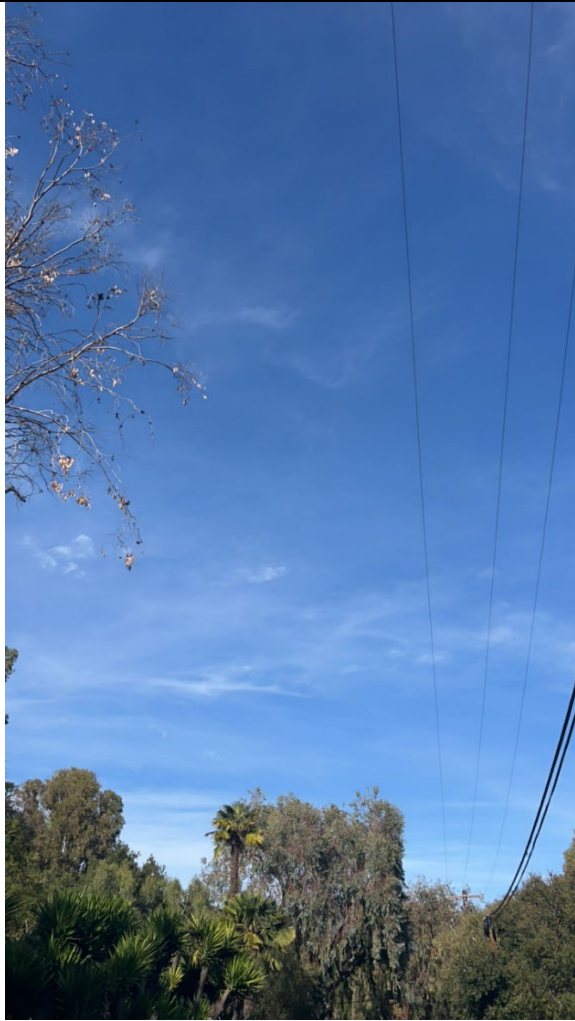
Photo 3: Photo showing the proximity of the dying eucalyptus tree branches (left) to the conductors (right).

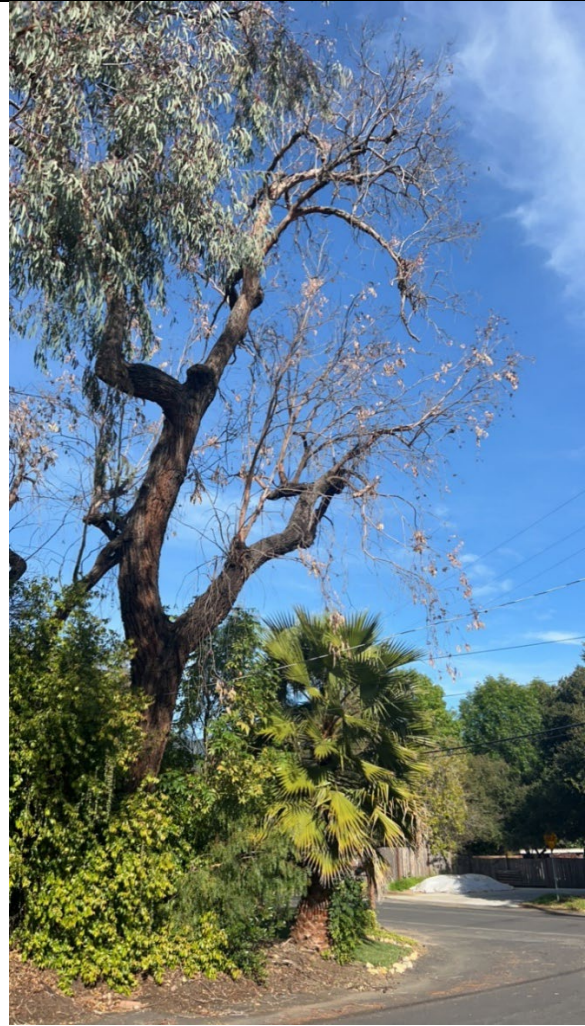
Photo 4: Additional photo of the dying eucalyptus tree near the conductors.
