IID 2021 IID Service Territory Field Survey

Introduction and Summary

Rough field notes and pictures – numbers represent pole numbers when they were visible

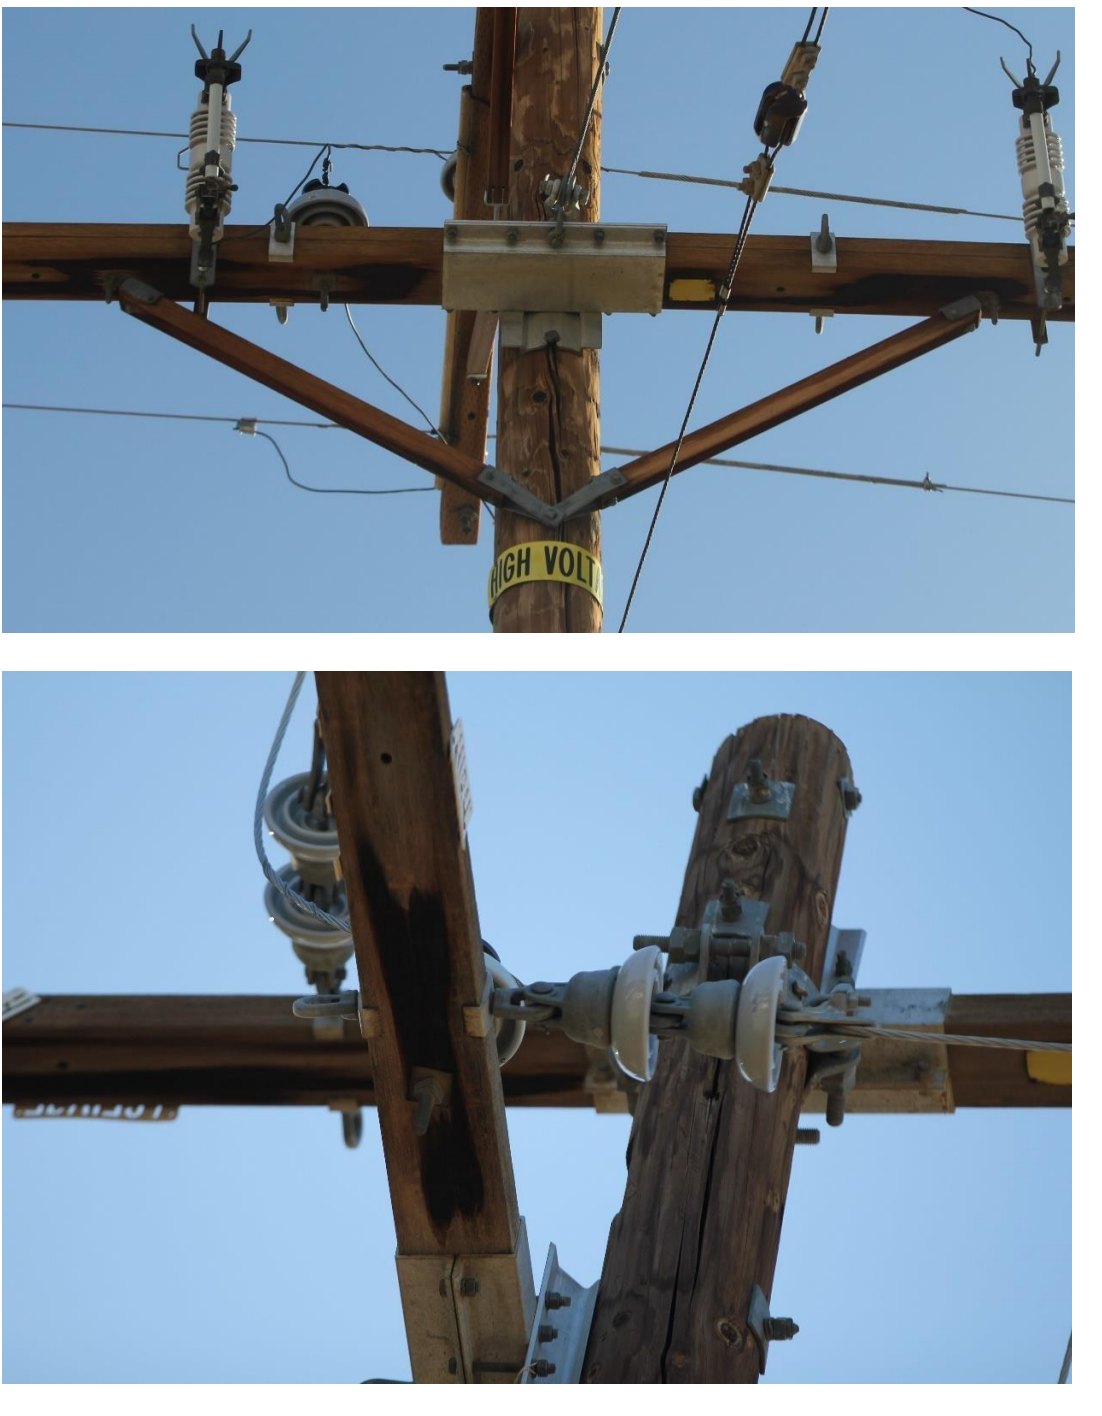
Observation / Issue	Sample Photo(s)
1. Tracking on crossarms & poles

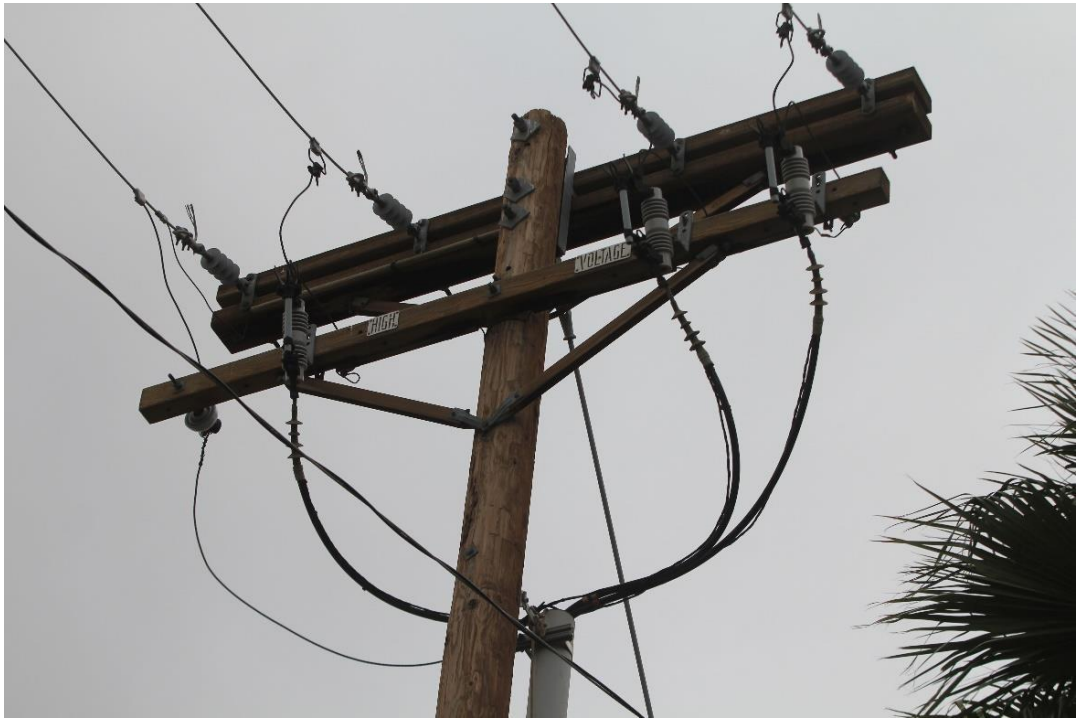
2. Missing load break cutouts

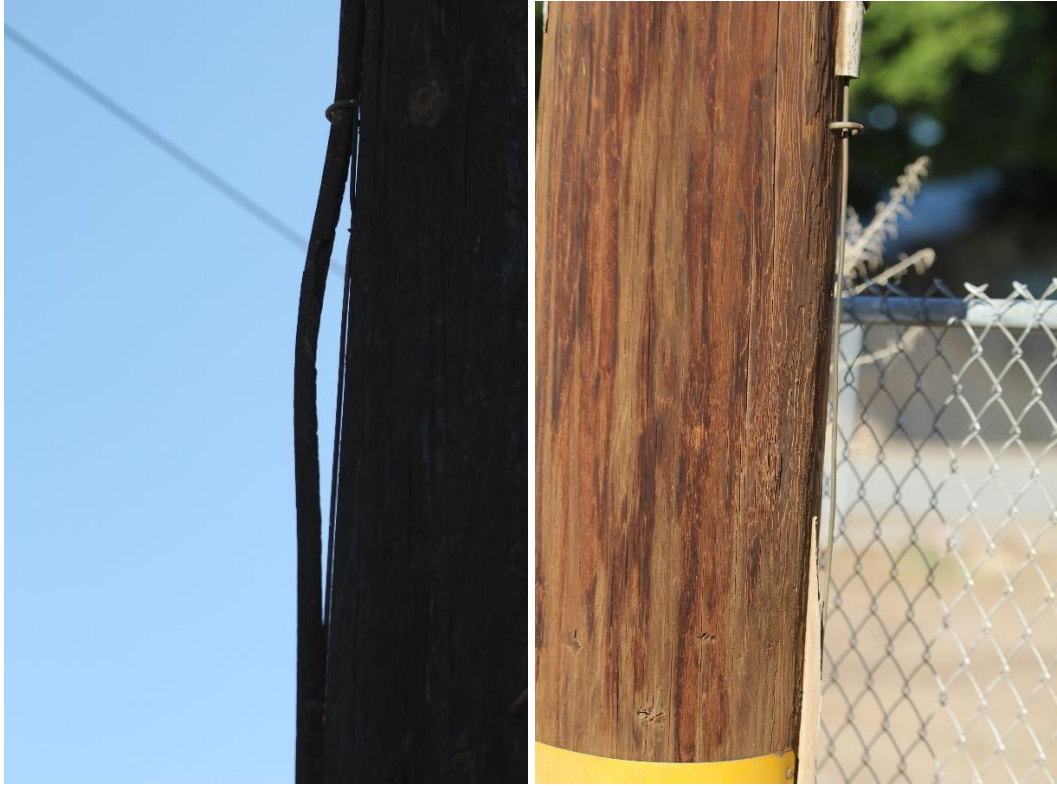
3. Missing / damaged ground molding

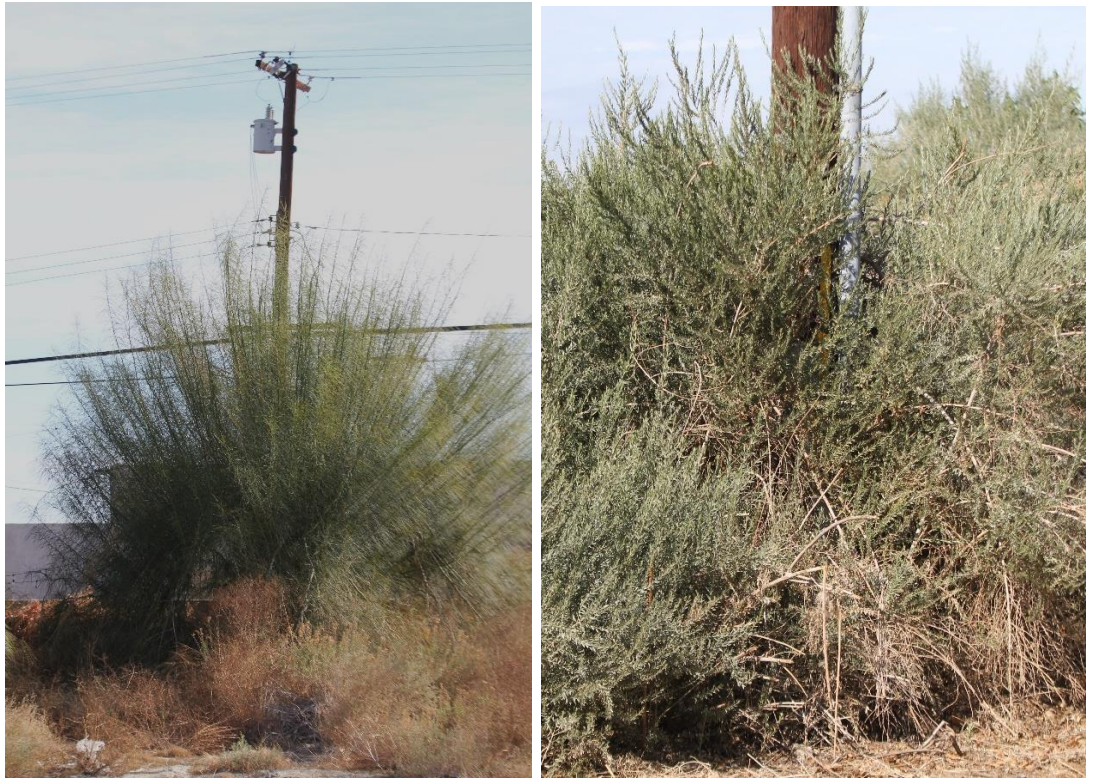
4. Vegetation encroachment

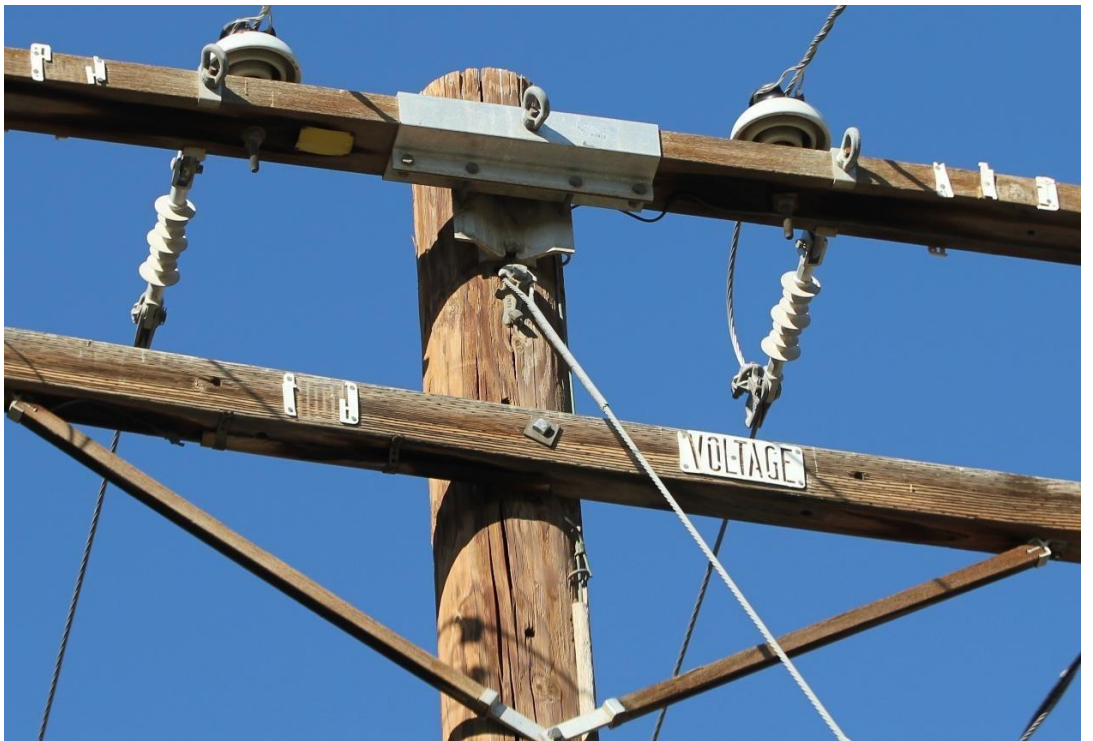
5. Missing / damaged high voltage signs

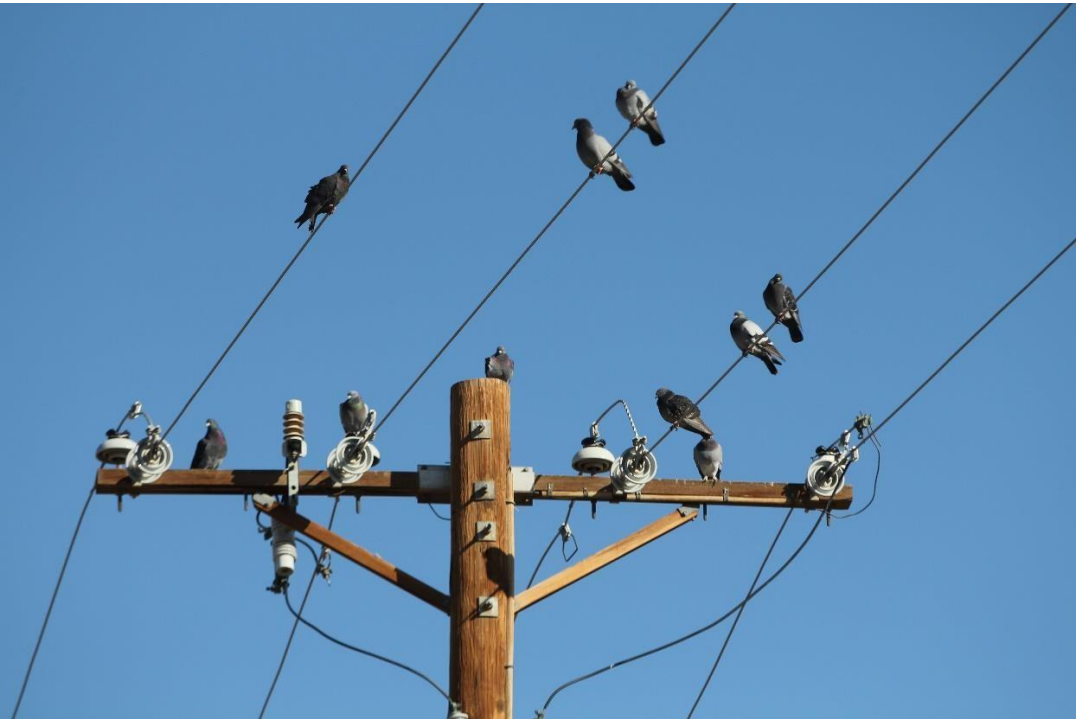
6. Bird contamination

- 11) Regarding bird contamination and the IID Avian Protection program: Install appropriate devices to deter birds from landing on poles. There were numerous areas of avian contamination and bird nests in high voltage equipment.

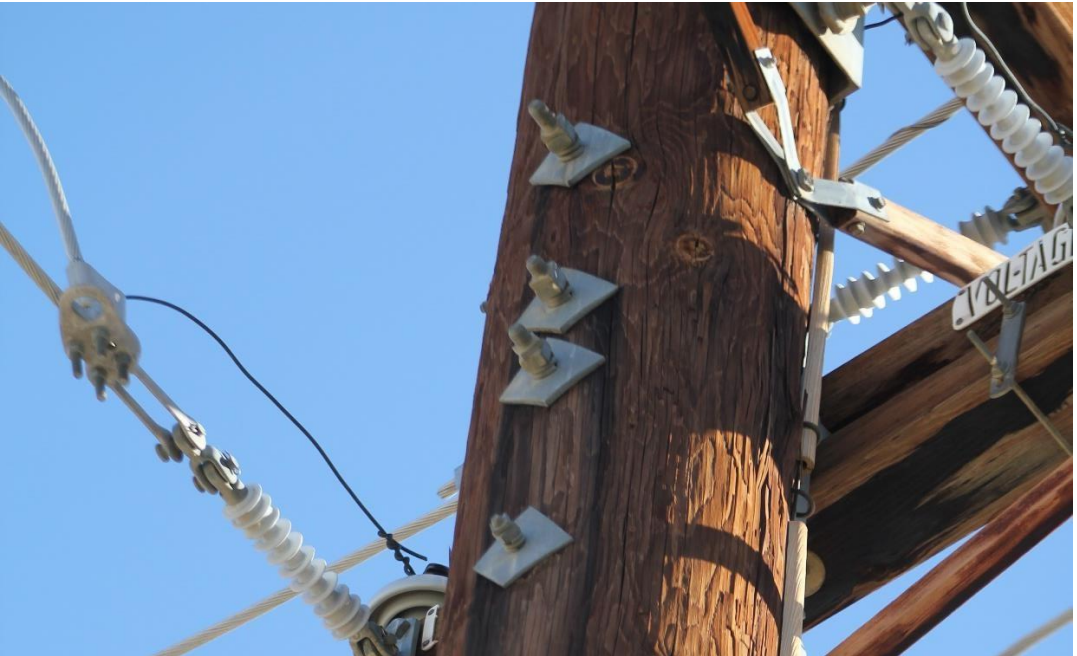
7. Missing bolt covers

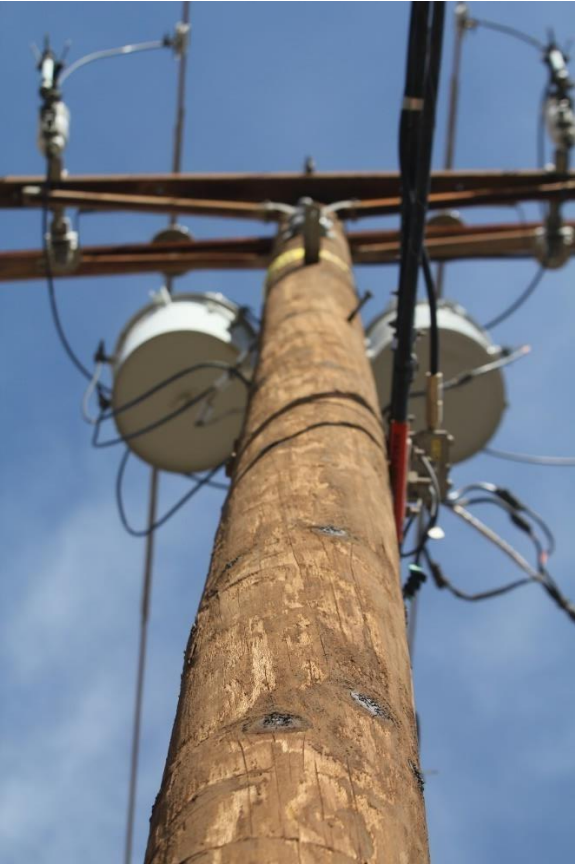
Observation / Issue	Sample Photo(s)
8. Missing pole steps

- 10) Regarding pole steps: These should be added where required. The position of the steps should be in line with the conductors. This is especially true in alleys where trucks can make contact with them while driving.

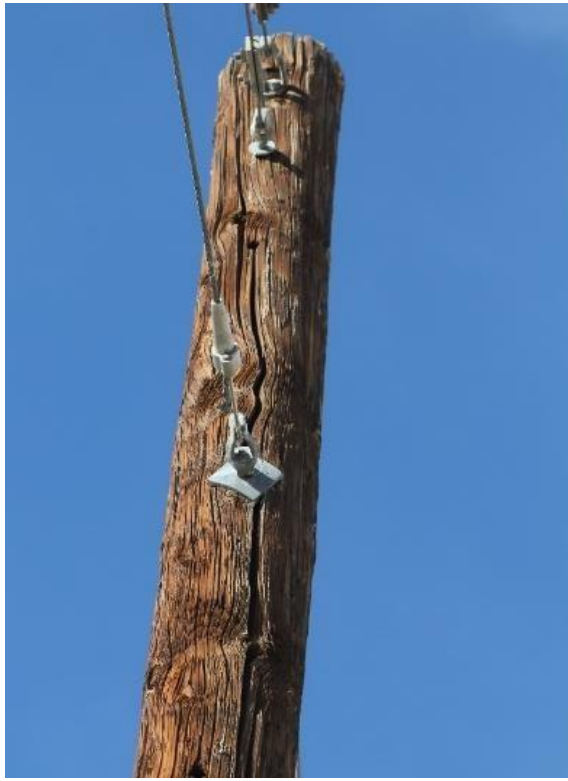
9. Split poles

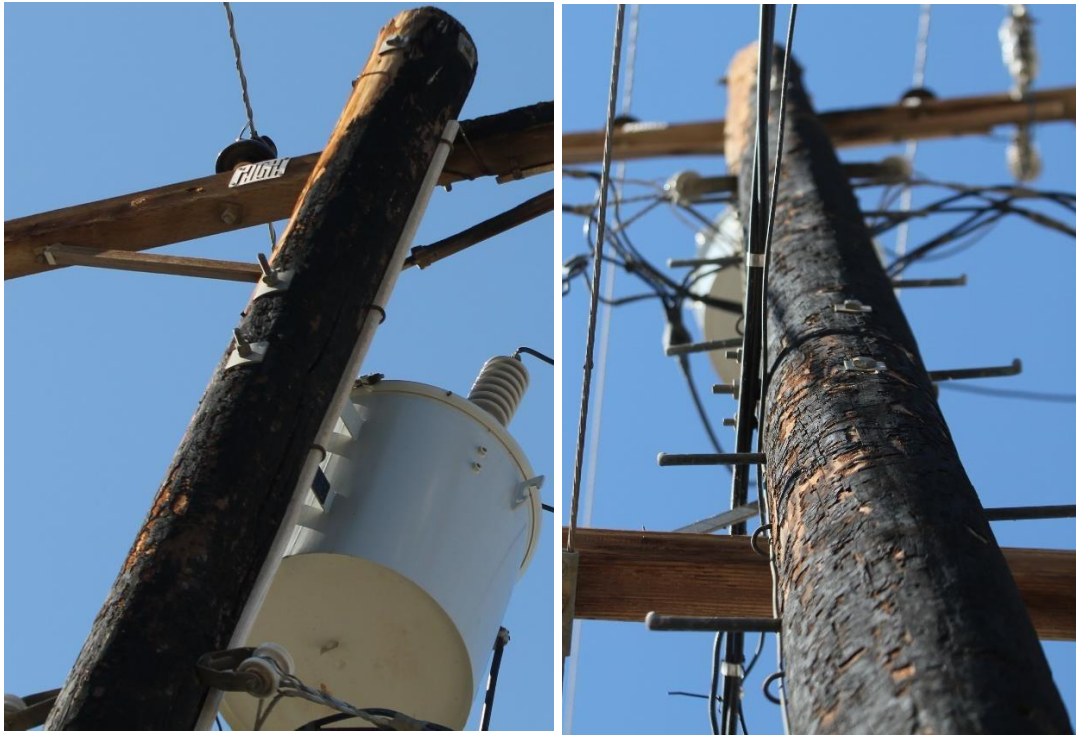
10. Burned poles

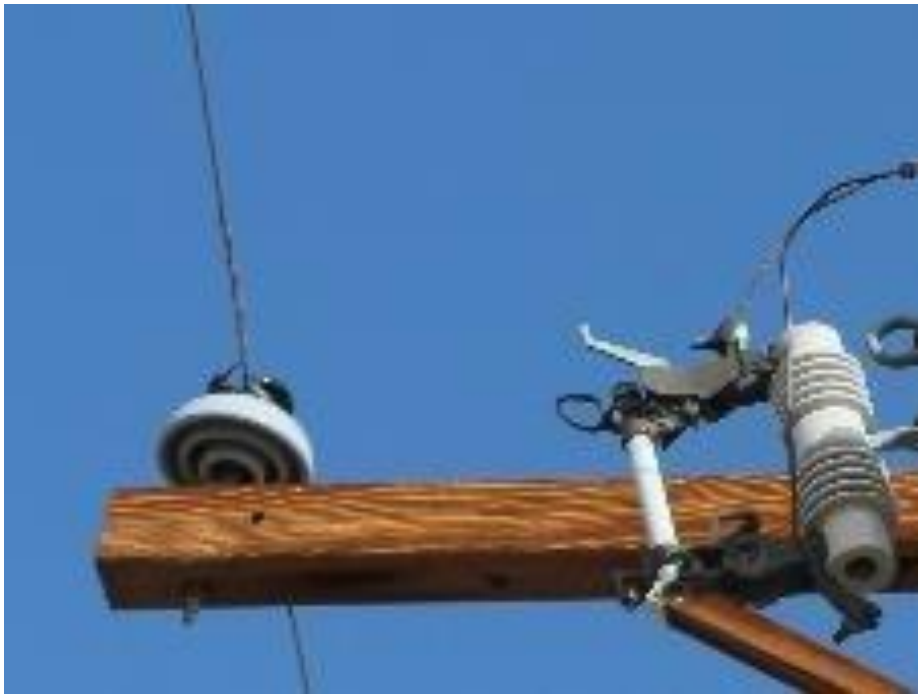
11. Missing nuts and bolts

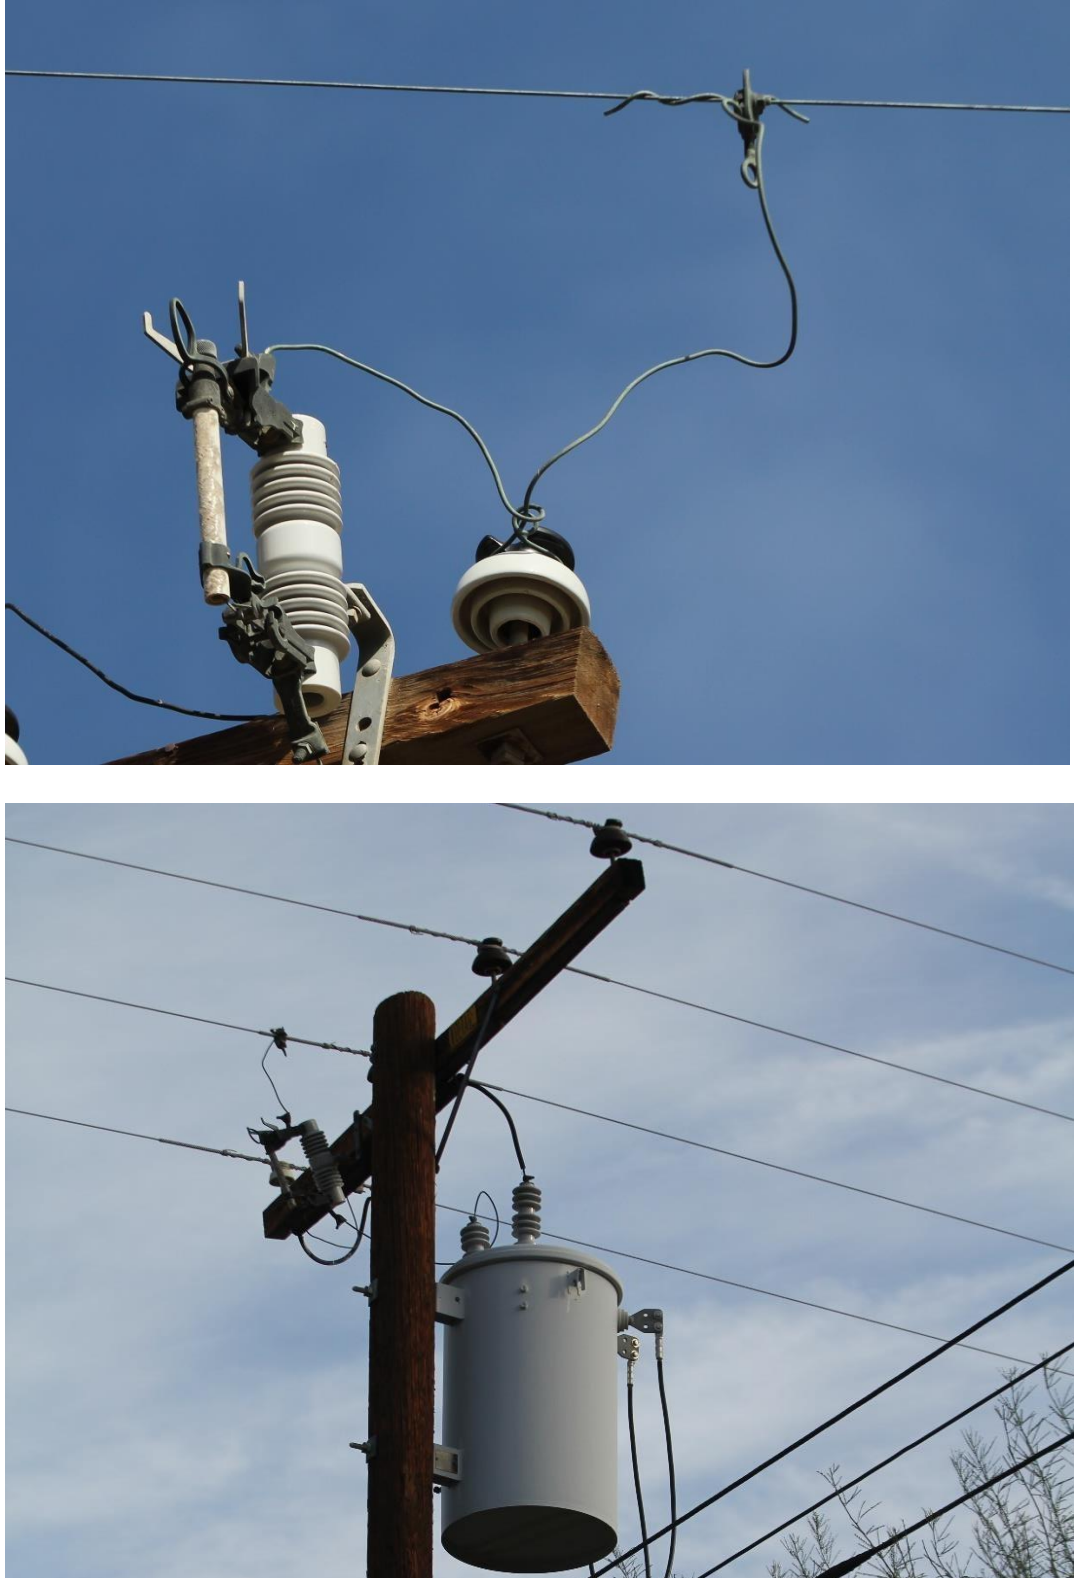
Observation / Issue	Sample Photo(s)
12. Standards inconsistencies, e.g. wire clamping, use of surge arrestors

- 8) Regarding surge arresters: They should have a copper braided ground in order to allow the expulsion to blow out the bottom side of the arrester. Currently, the arrester is attached with a #4 or #6 solid ground that won't allow the arrester to operate properly.

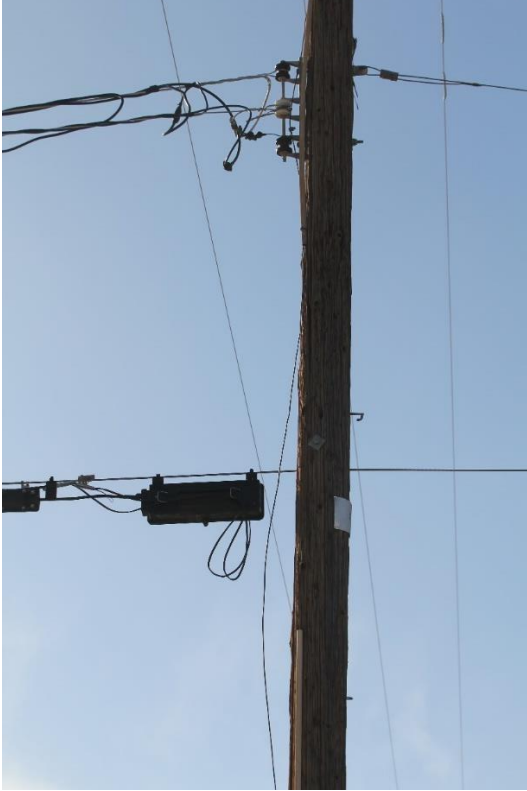
- (No pole number - by Palo Verde St. across from 21649) needs ground molding fix, need pole steps

Note: frequently climbed poles require pole steps

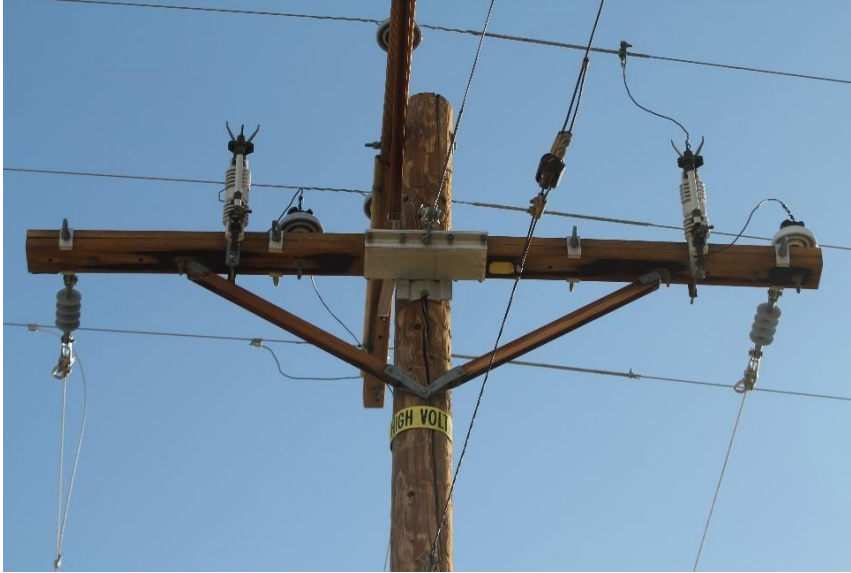
- 21131 possible tracking on cutout arm? Or just stains? Install load break cutouts, unless IID utilizes a loadbreak tool for this type of operation.

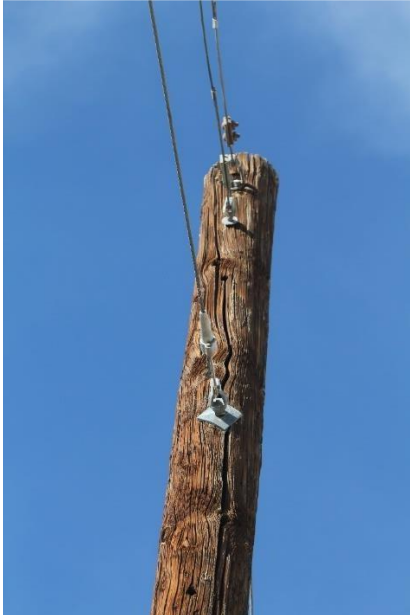
- (No pole number - across from 21130D) needs split bolt. Bolts in poles drilled in close proximity on one side have a tendency to split the pole, - recommend drilling a hole at 90° and inserting a bolt with curved washers on both side to prevent further splitting.

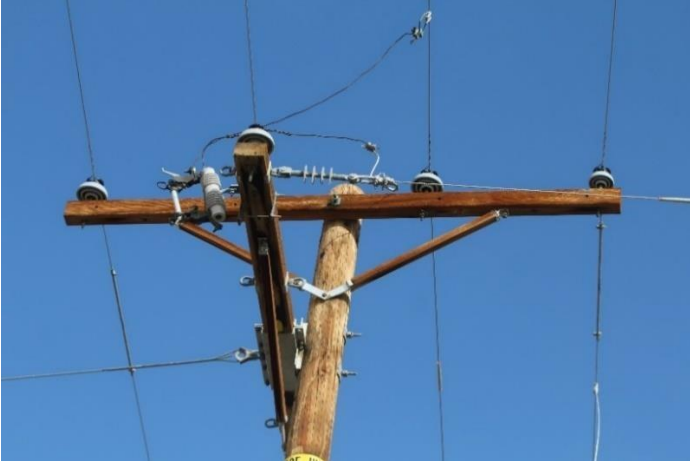
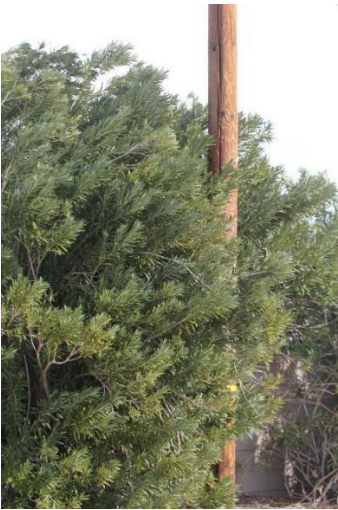
- 21129 need pole ground? missing nuts washers on top arm, also clear veg below cutout

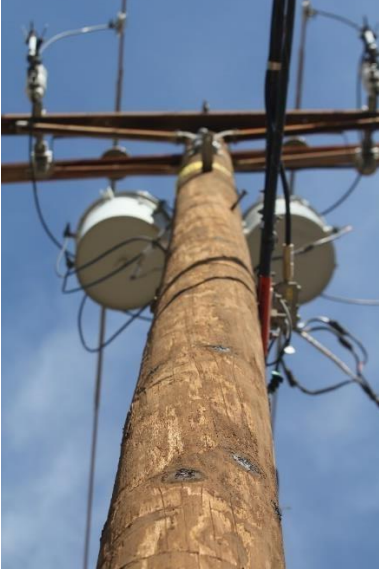
- 1202311 needs pole steps (common need on all poles in area with transformers and cutouts)

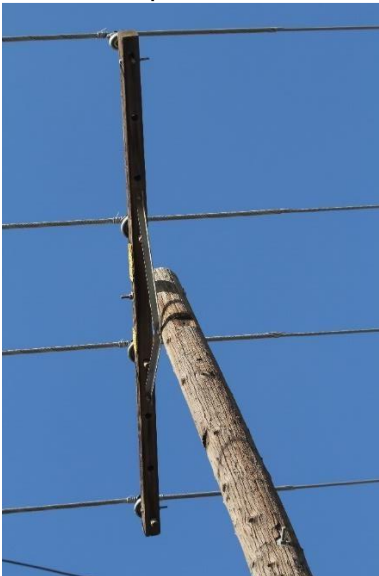
- 2260 replace cross arm

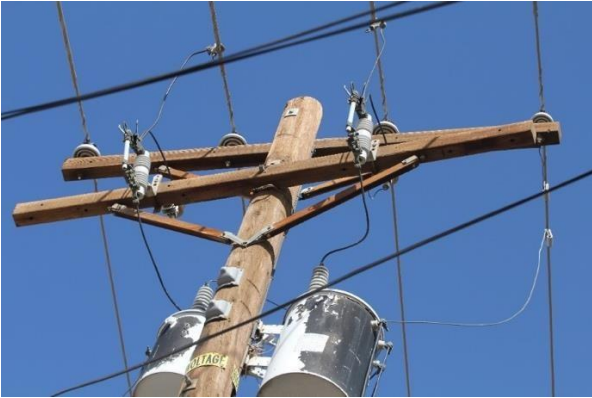
- 1217942 (and in general) - keep washers square to the arm, keep arms parallel -recommend hot line clamps for making jumpers from the primary bushings to the Common Neutral to enable clearing the transformers with a live-line tool/shotgun.

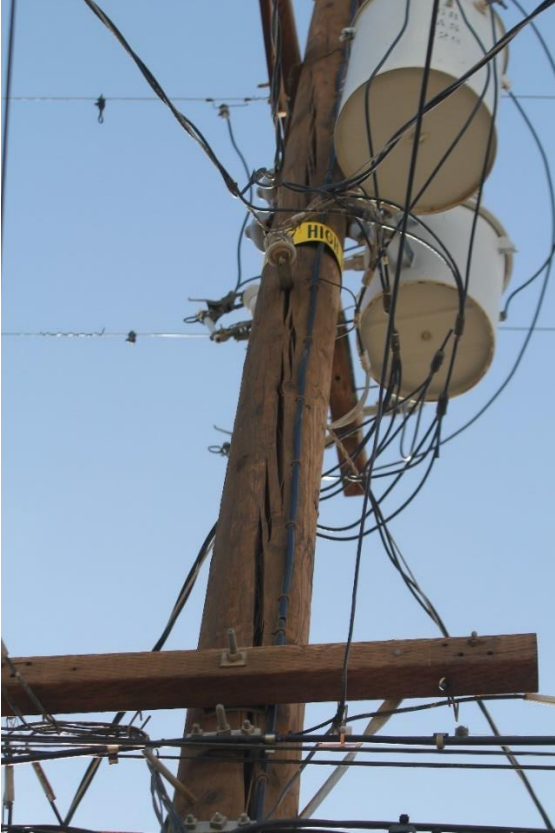
- 1219098 - need split bolt

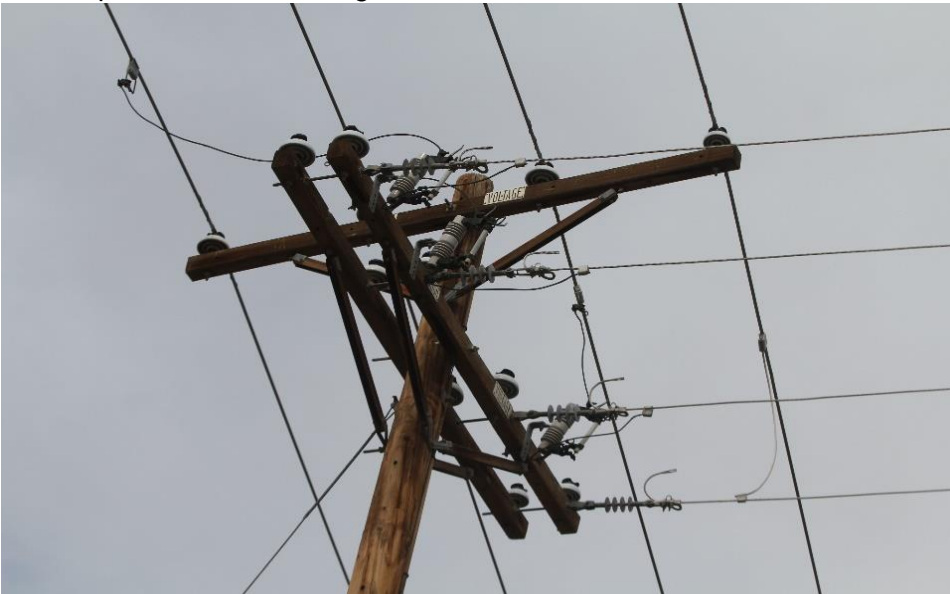
- 22416d need load break cutouts -recommend documenting corner configuration in GIS in the event that the pole has to be changed out.

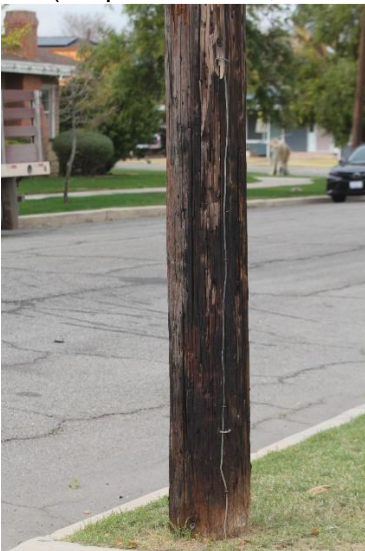
- (No pole number, across from 41284d) - needs ground cover low on the pole

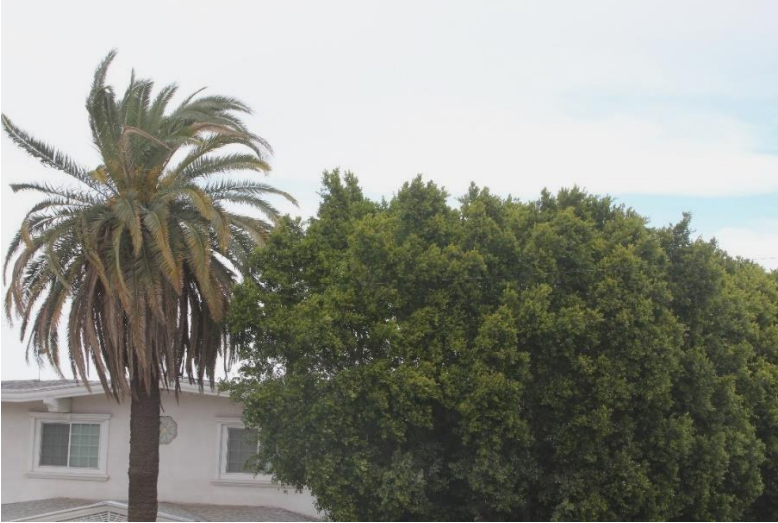
- Heffernan and 5th - wire in trees, may want to consider installing tree wire in these types of conditions.

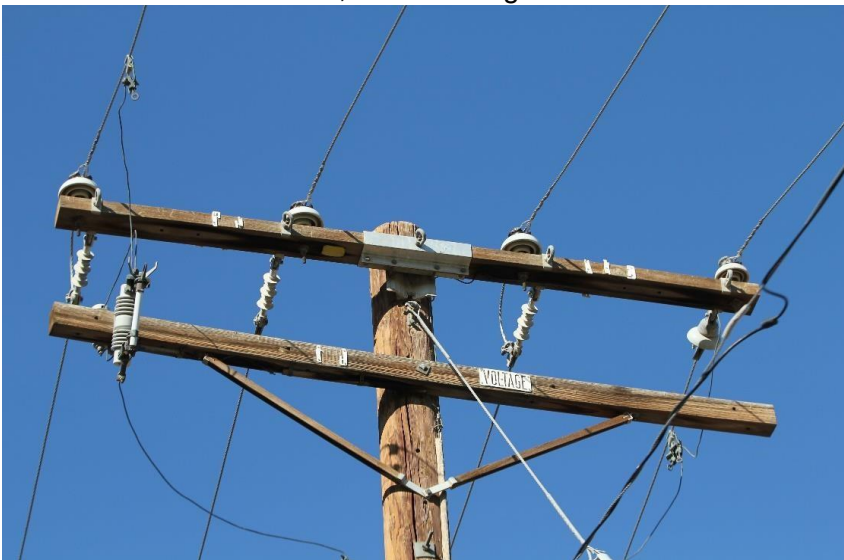
- 8393 need bolt covers; also tracking

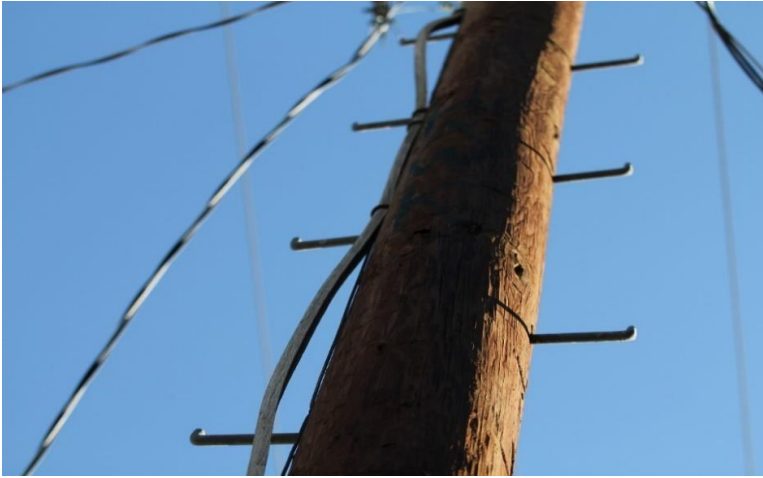
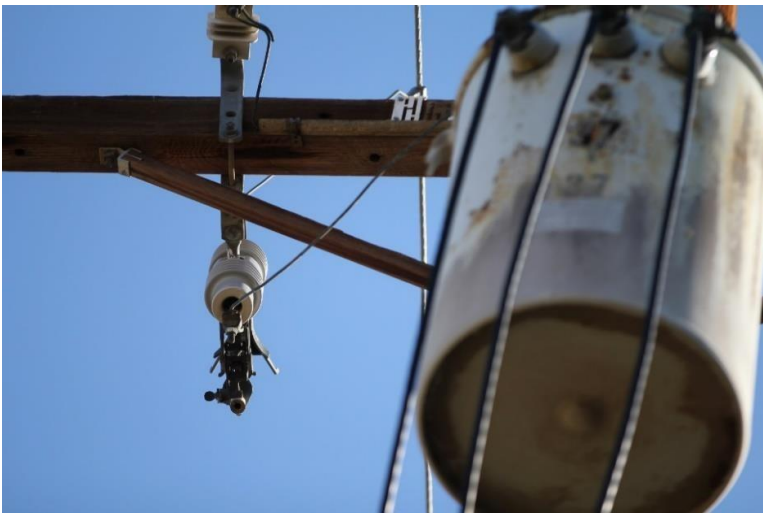
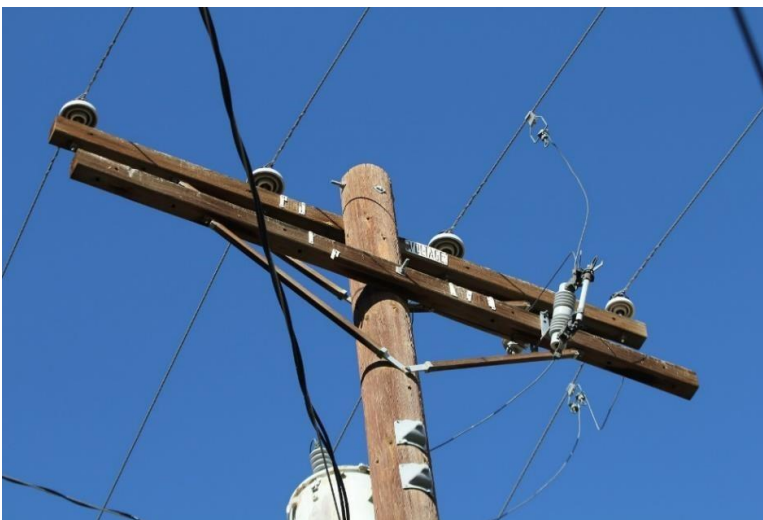
- 8394 tracking, high voltage signs, ground molding; other pics show need for surge arrester wire improvement (use braided wire); can use bracket instead of extra cross arm. Recommend using brackets that are fabricated to hold cutouts and arresters.

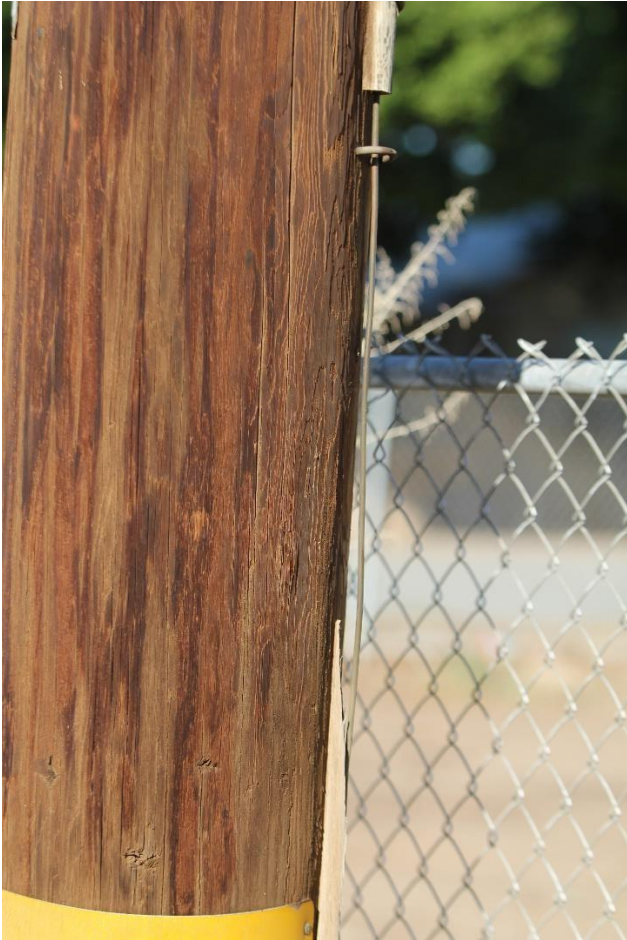
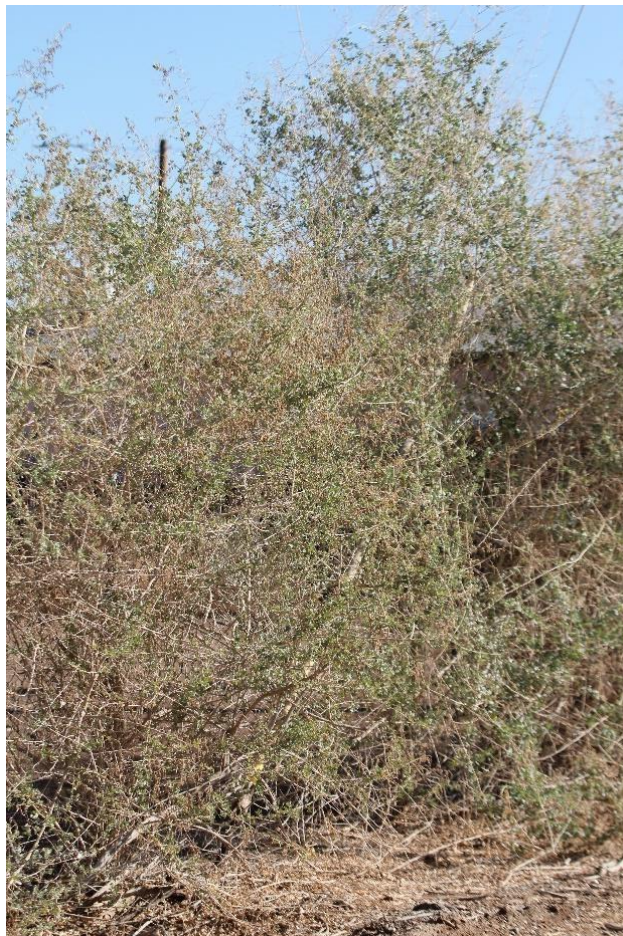
- 84673d ground molding damaged; 2nd pic clear brush from guy wire

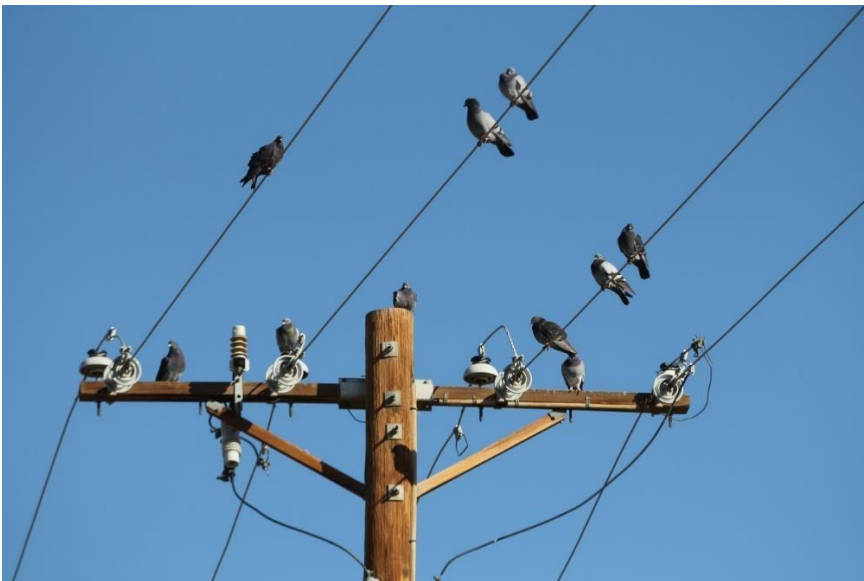
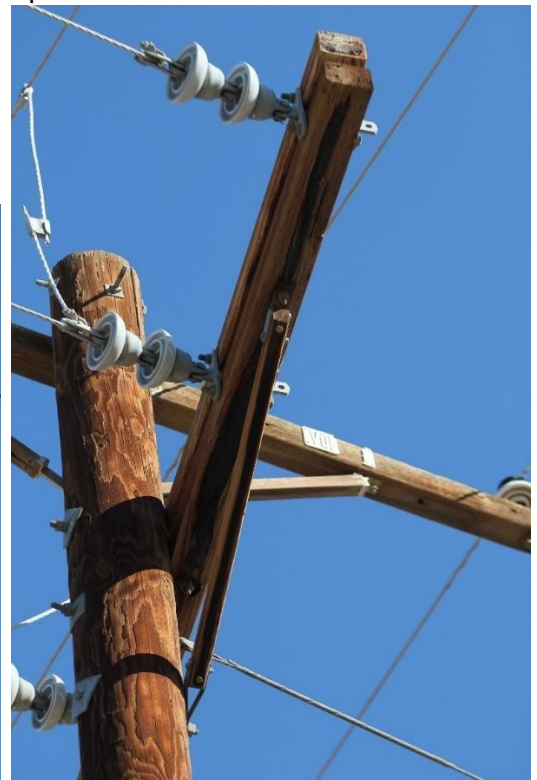
- 8815 bird contamination contributes to tracking; 2nd pic: tracking, no pole steps; multiple bolts in a linear direction at top of pole could lead to splitting in the future, install split bolt.

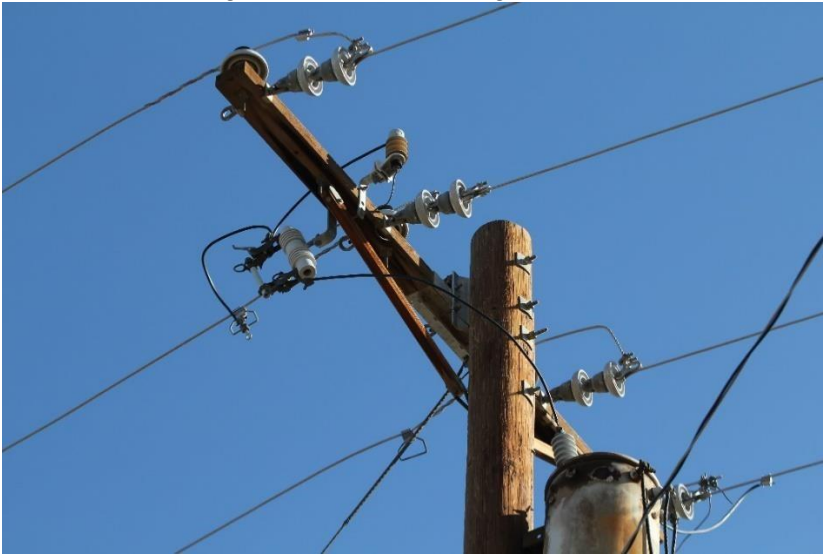
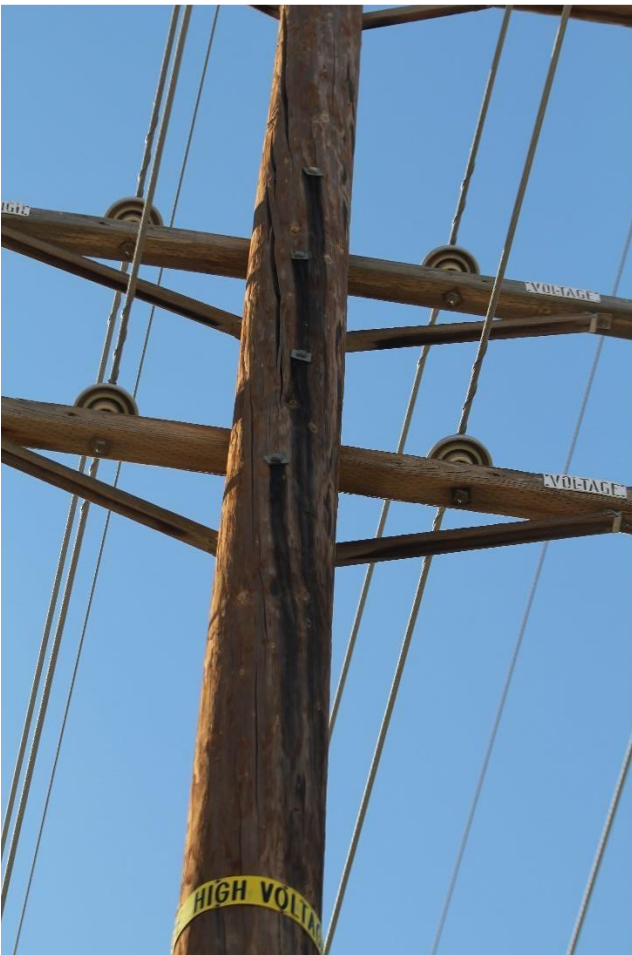
- 80967 Missing bolt covers, tracking

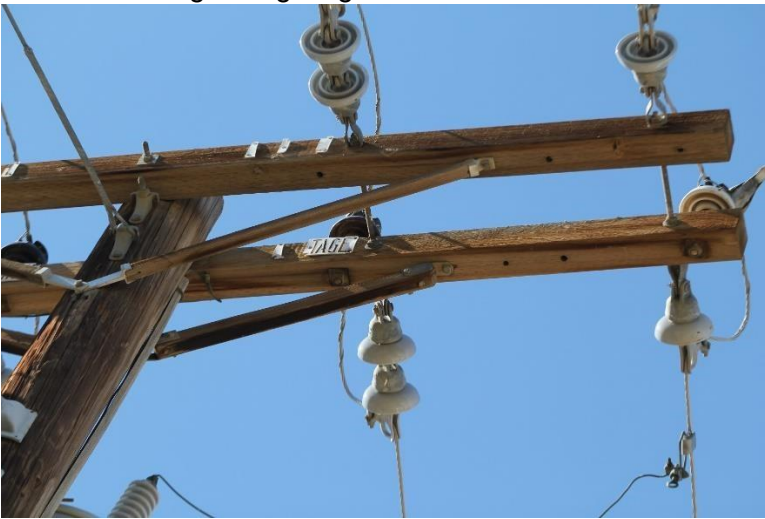
- 11503 tracking voltage signs

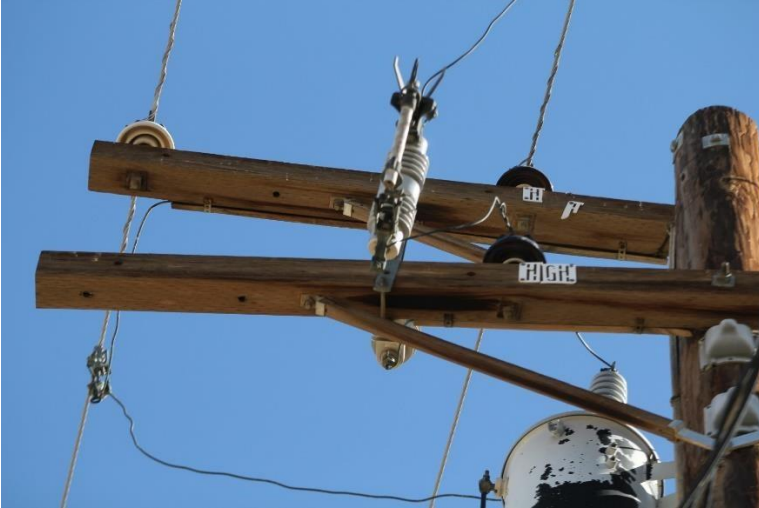
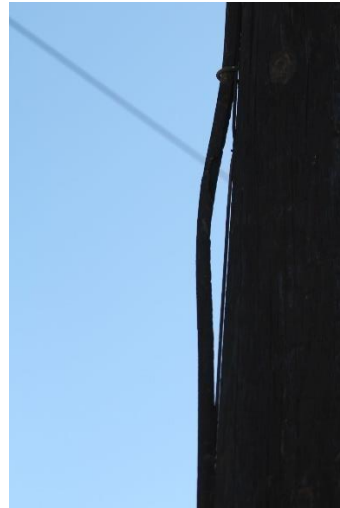
- 10477 tracking, damaged signs, molding issue

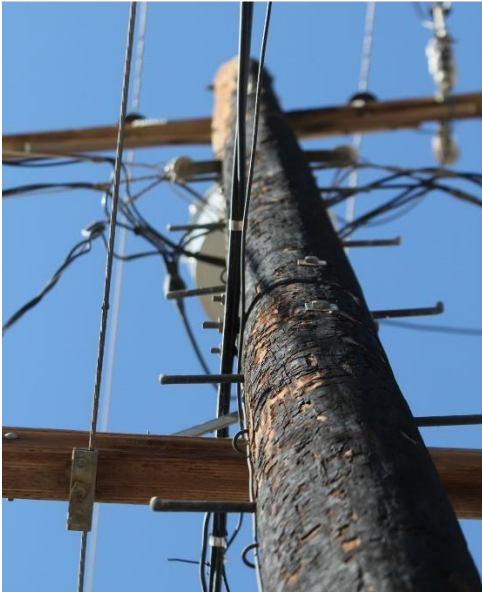
- 11595 burned pole, tracking, no hard caps on transformer, damaged signs, ground molding

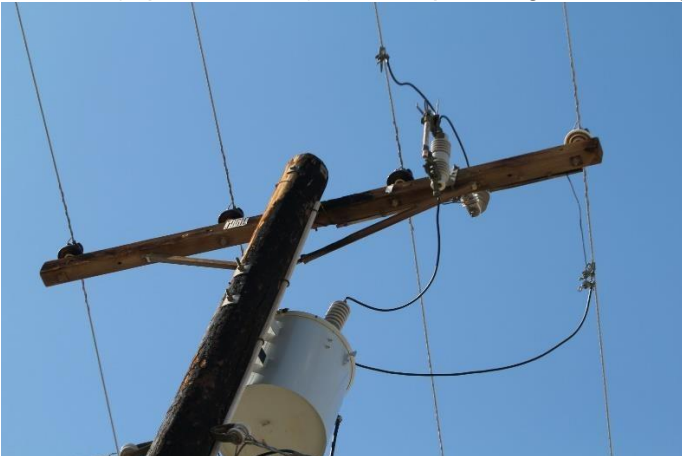
- 1?359- (# plate melted), burned pole, signs, molding

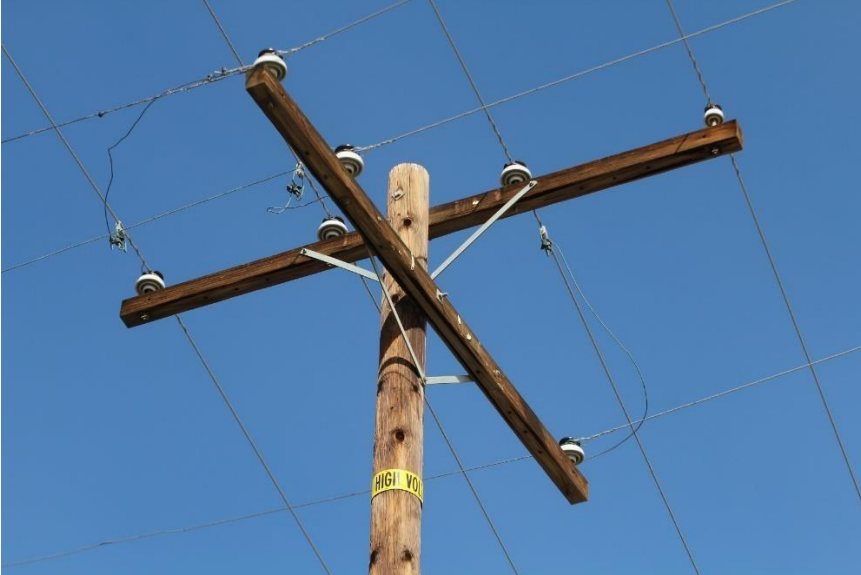
- 912061 tracking, missing nut/bolt, no ground, no CN signage.
