IID 2021 IID Service Territory Field Survey

Introduction and Summary

Rough field notes and pictures – numbers represent pole numbers when they were visible

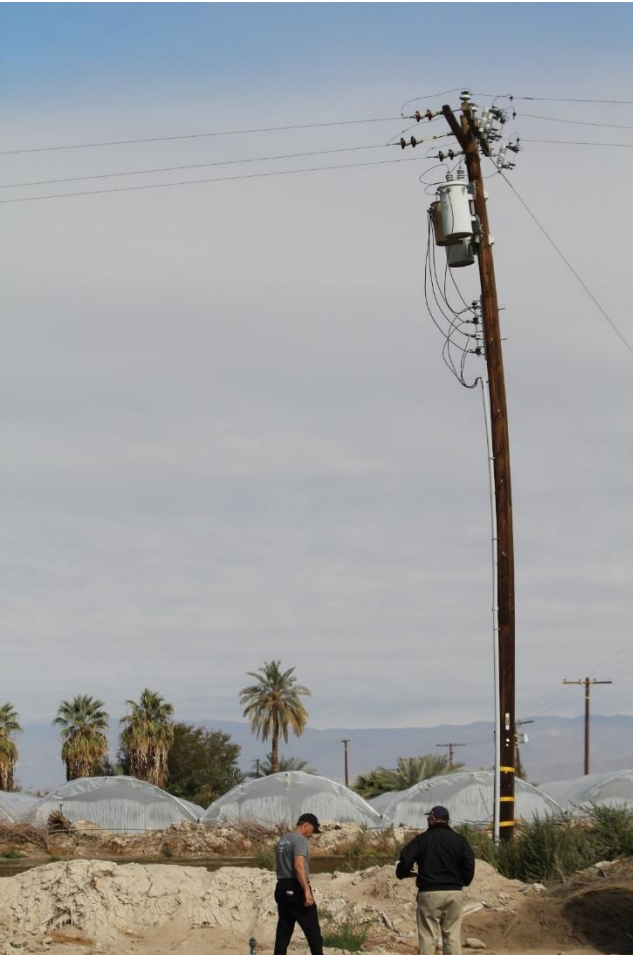
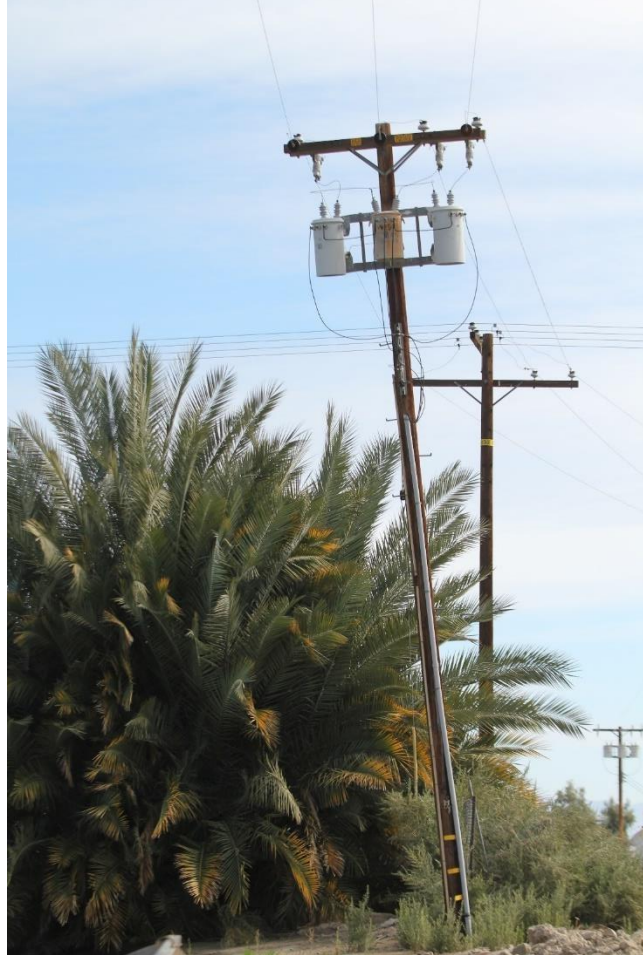
- 98792 leaning pole in line with conductors but also leaning sideways, uneven strain and sagging,

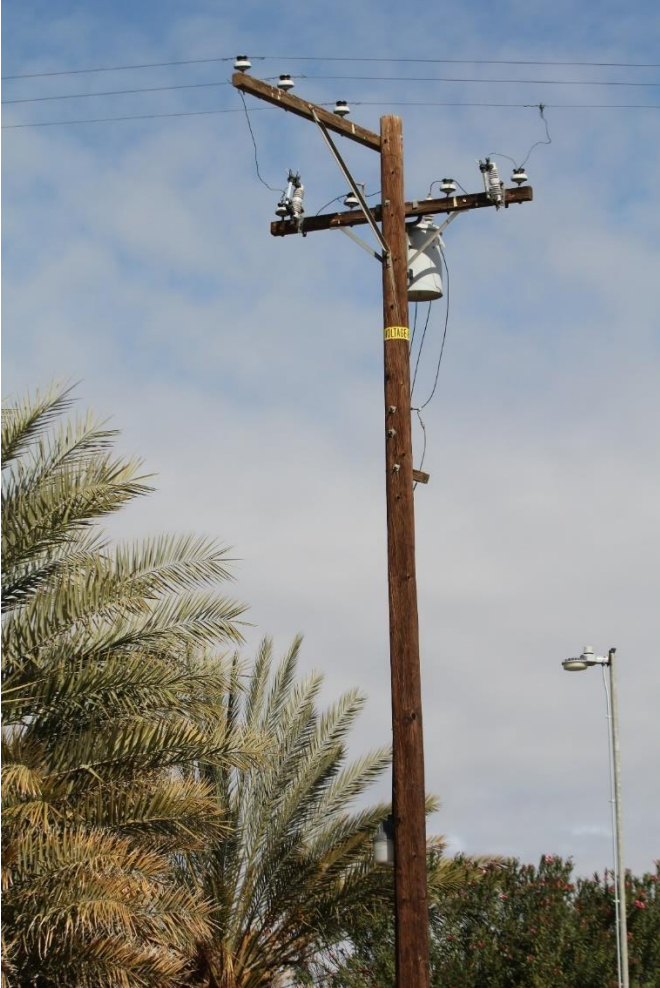
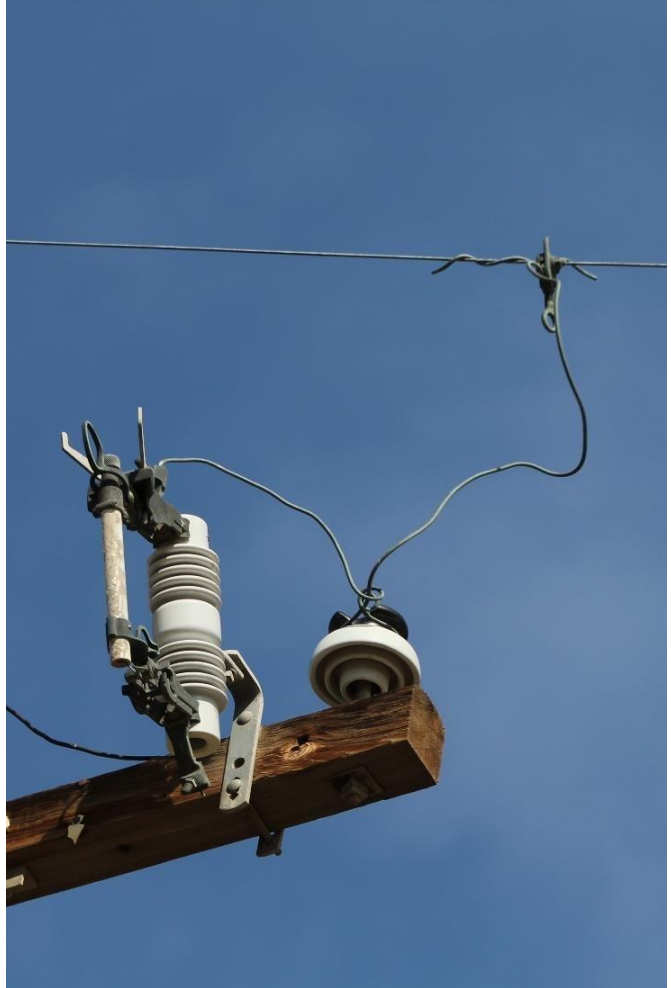
- 912062d pole top rotating, probable cause is the wood has dried out over the years and pole top has moved; also 2nd pic: Should always add stirrups or line guards to hot side of disconnect; in this case they used an extra wire to protect the conductor— again, very little tracking in this region

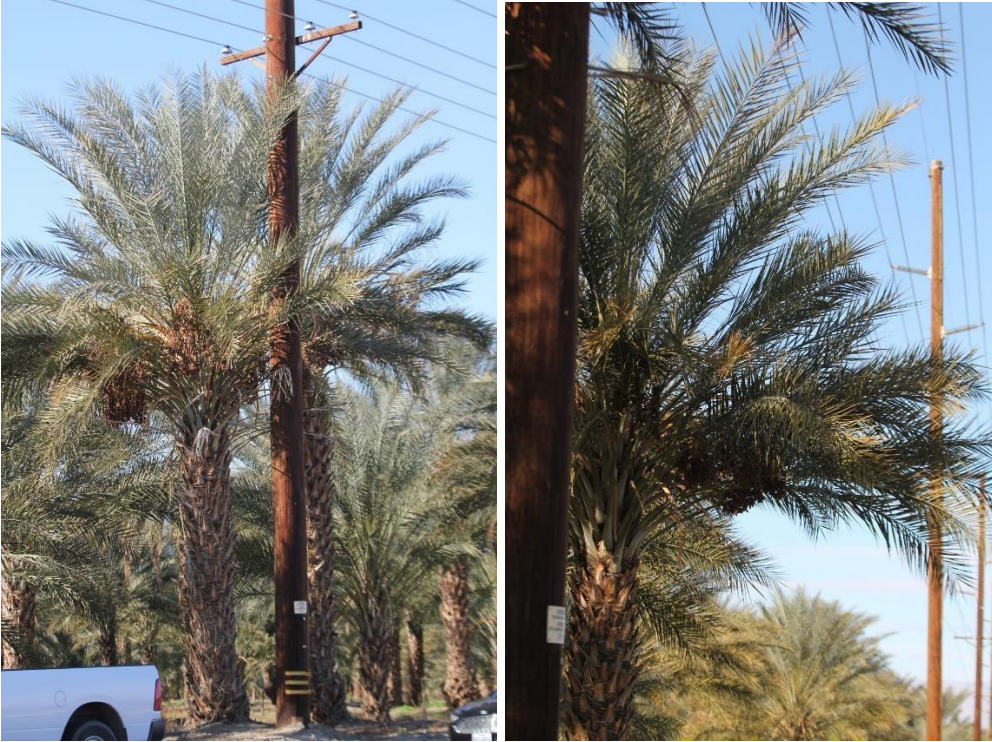
- T17899 veg intrusion – trees planted under lines

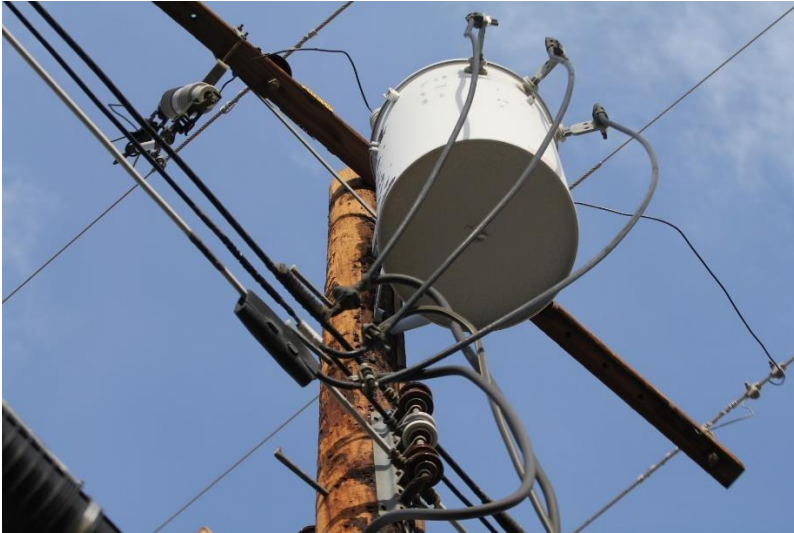
- 906954 tracking from primary neutral, no hard caps, had a wire down previously; no arrestors in area

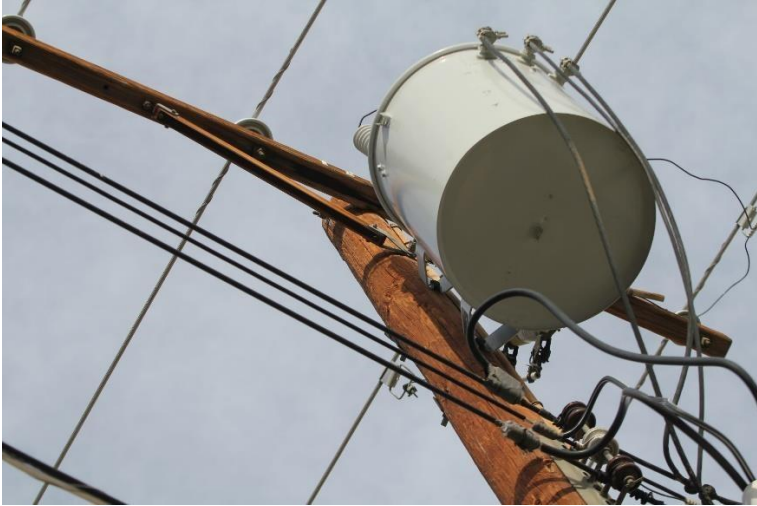
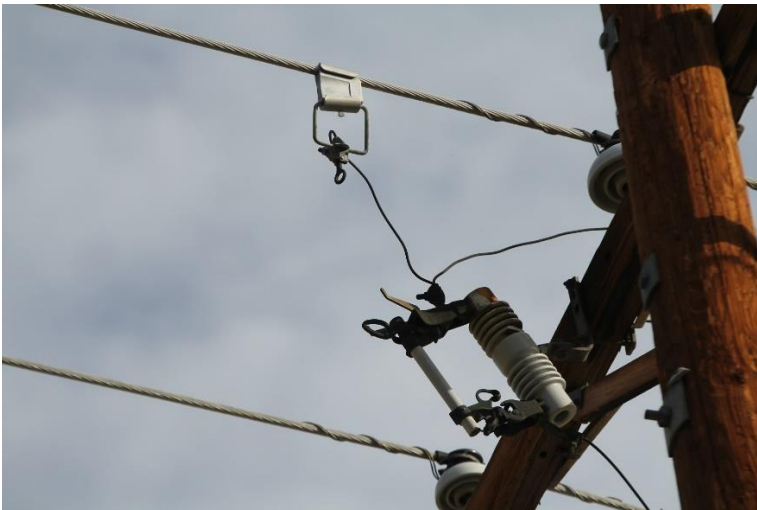
- 1064243 tracking, sign damaged, molding on cross arm damaged, needs pole steps, has arrestor.

Additional note: La Quinta-subdivision has a primary feed, each easement has 75-100 Kva transformer feeding main line supply secondary and all services are fed underground with risers. Also see pic after this shot regarding clamp and wiring.

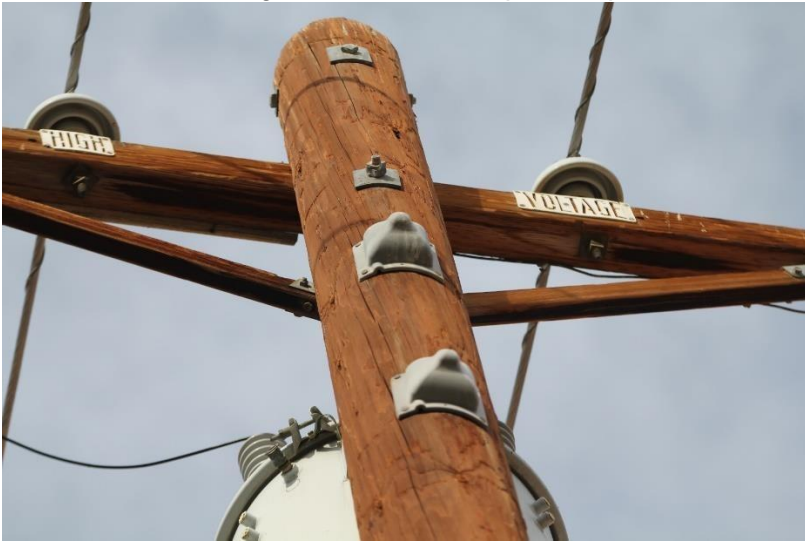
- 1064244 tracking, has arrestor, no pole steps

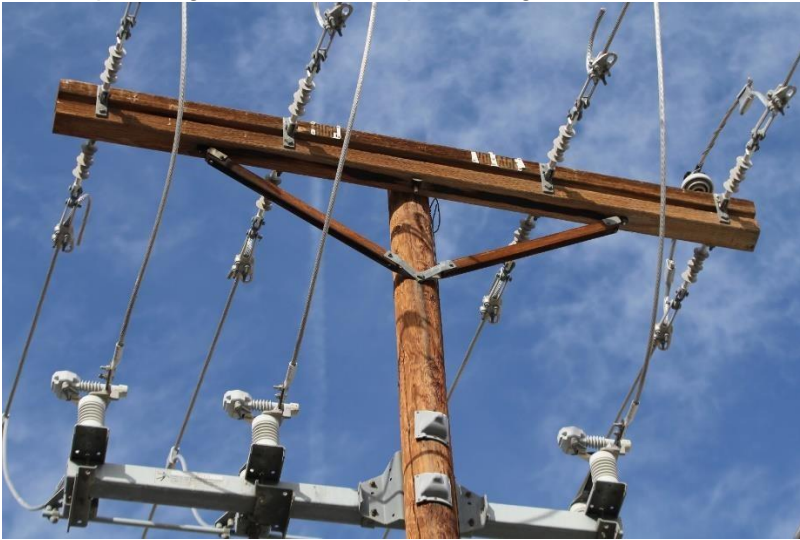
- 1062300 tracking, loose connector

This is a Gang Operated Air Brake Switch – the switch handle is located at the ground level. Recommend installing a grounded tread plate bonded to the handle. This will place the operator in an equipotential zone when operating the switch and protecting the worker from a flash energizing the handle.

- 9) Regarding Gang-Operated-Air-Brake switches, with the operating handle located at ground level (doesn't appear to have the switch handle grounded): Best practice would be to have the handle grounded to a tread plate that the operator stands on to operate the switch. This would place the worker in an equipotential zone and protect them from a high voltage flashover that would migrate down the handle to ground.

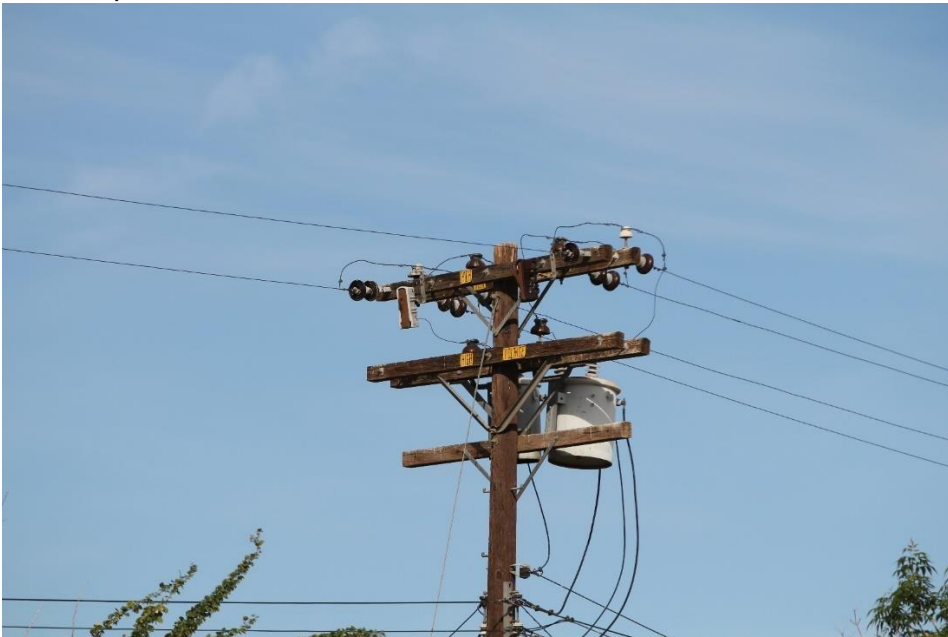
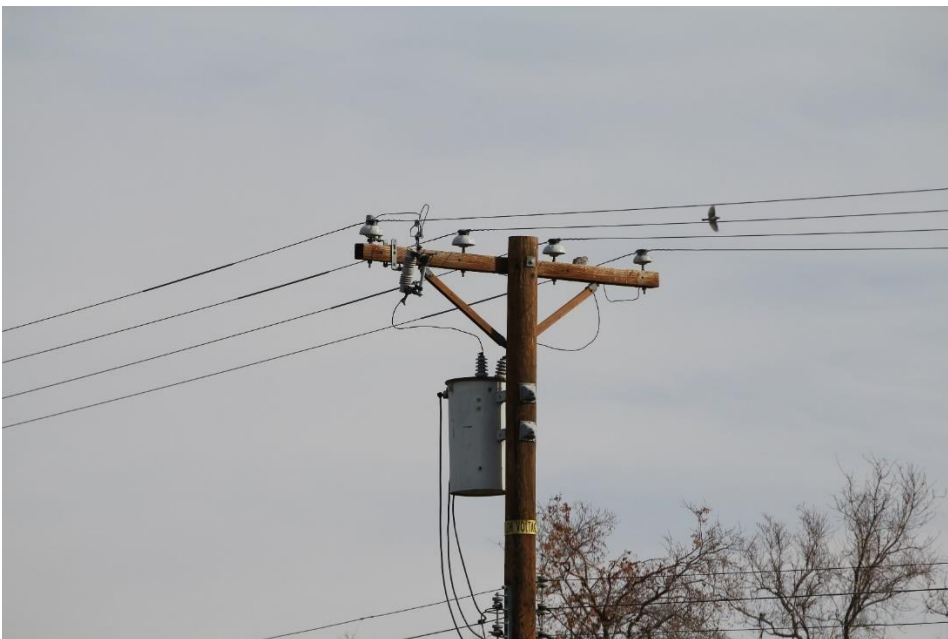
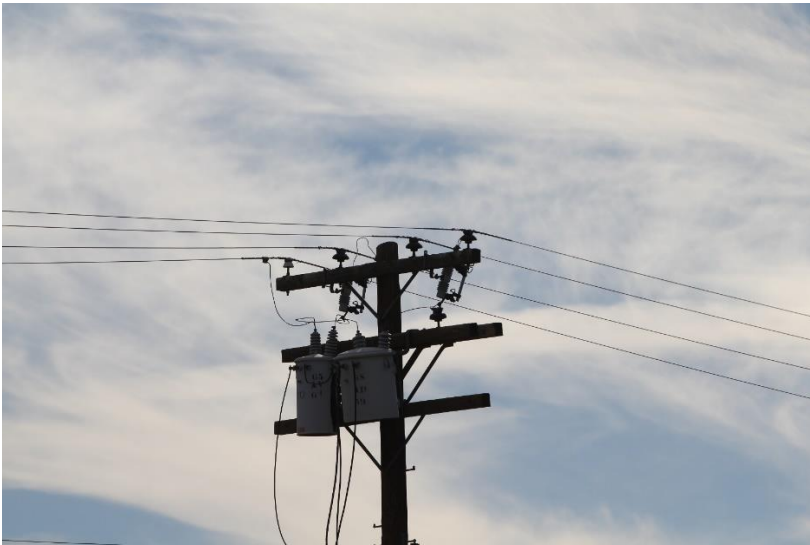
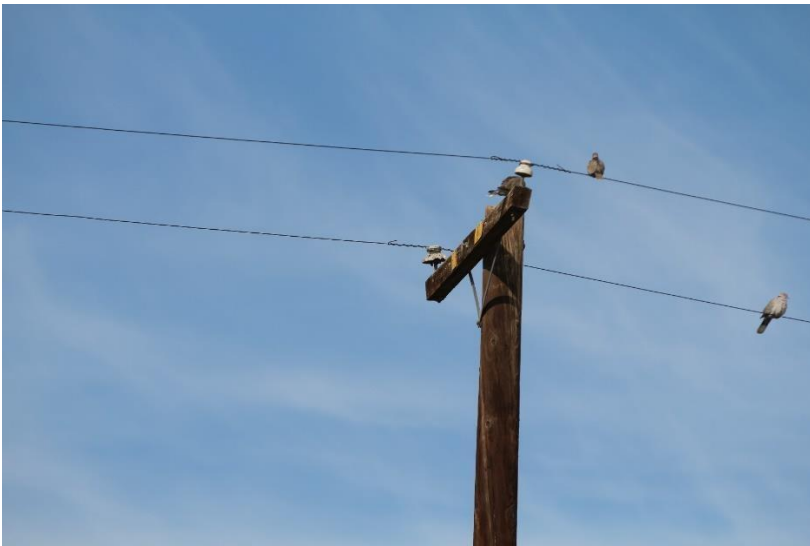
- Extensive bird contamination (likely tracking), broken glass insulators (recommend replace all insulators in the area)
- Transformer bank in pic 1 – should upgrade transformer bank, hardware, insulators and cutouts - wrong type of cutouts (these are old box type C/O's from when this was a 2400/4160 system); old construction not upgraded to higher voltage
- Fix High voltage signs
- No arrestors, inconsistency
- Last pic, broken insulator far side

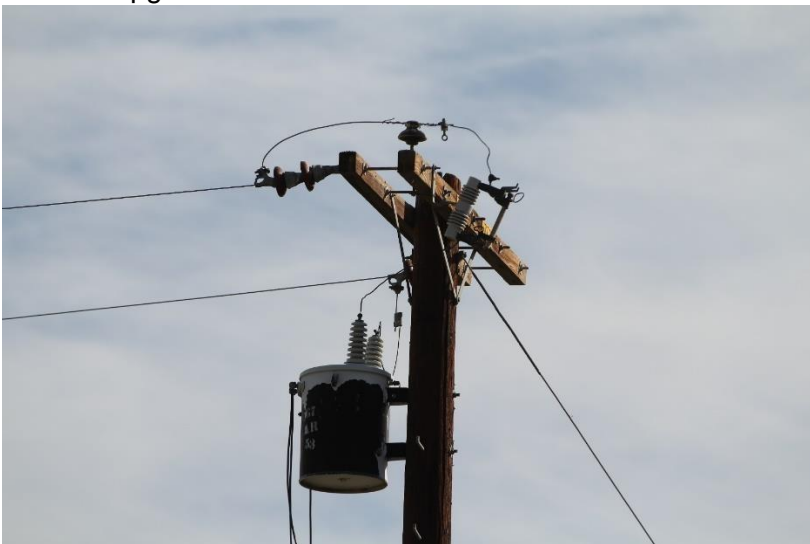
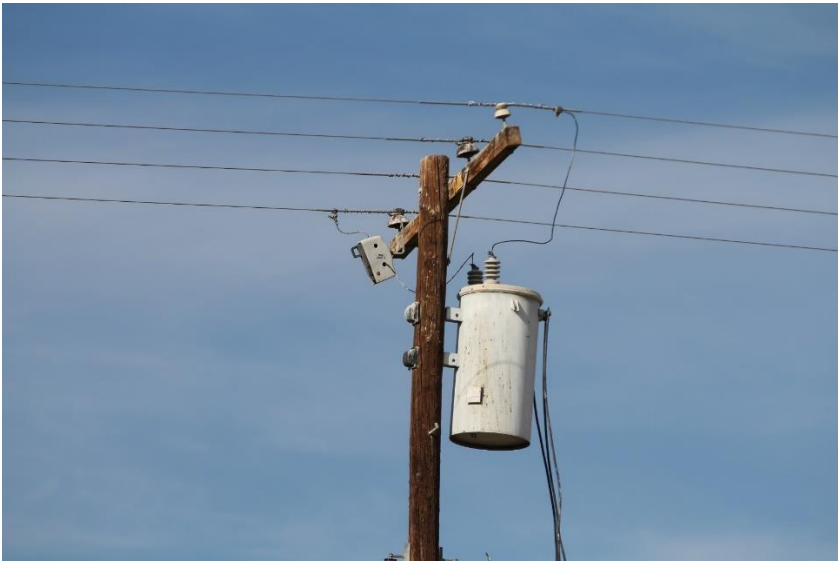
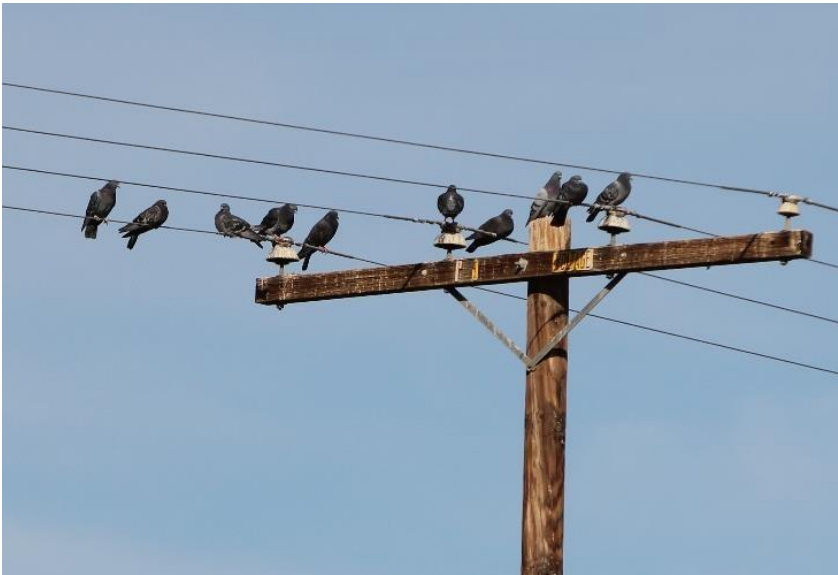
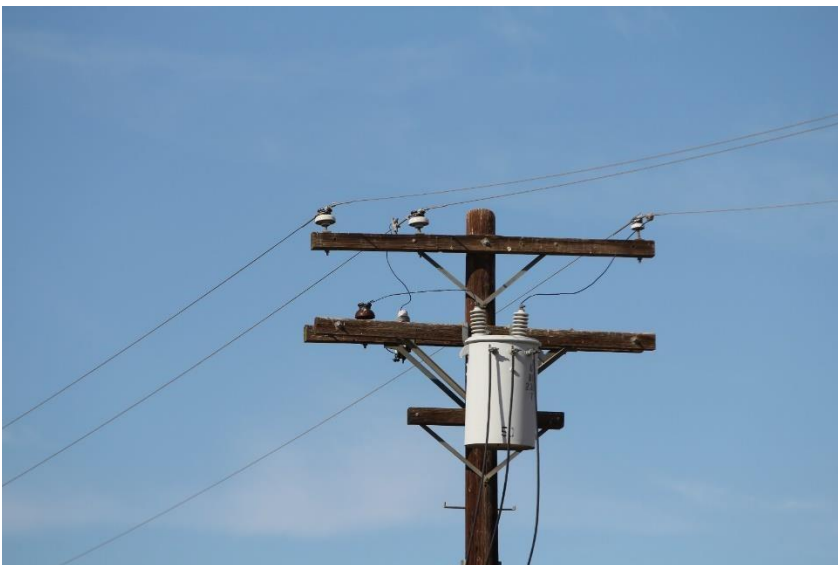
- Bird contamination, upgrade insulators, signs, cutouts not rated for voltage, no hard caps... recommend total upgrade

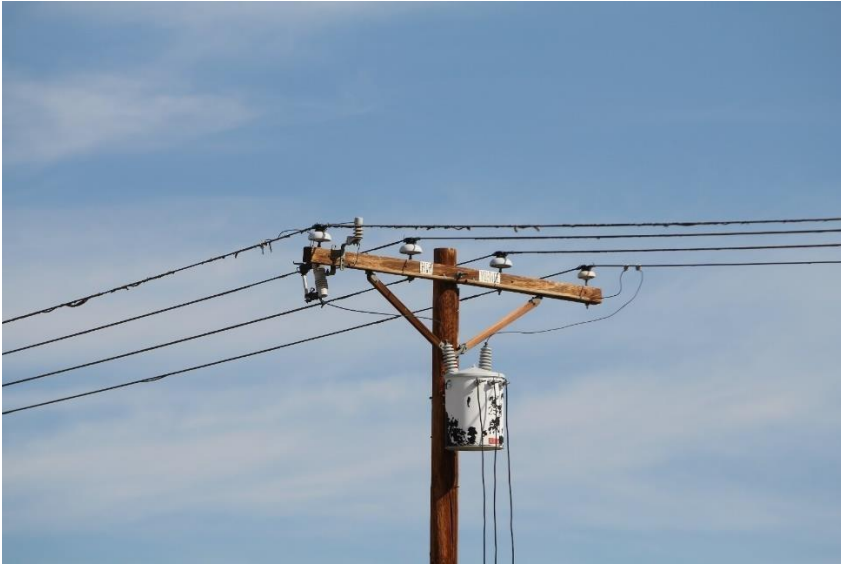
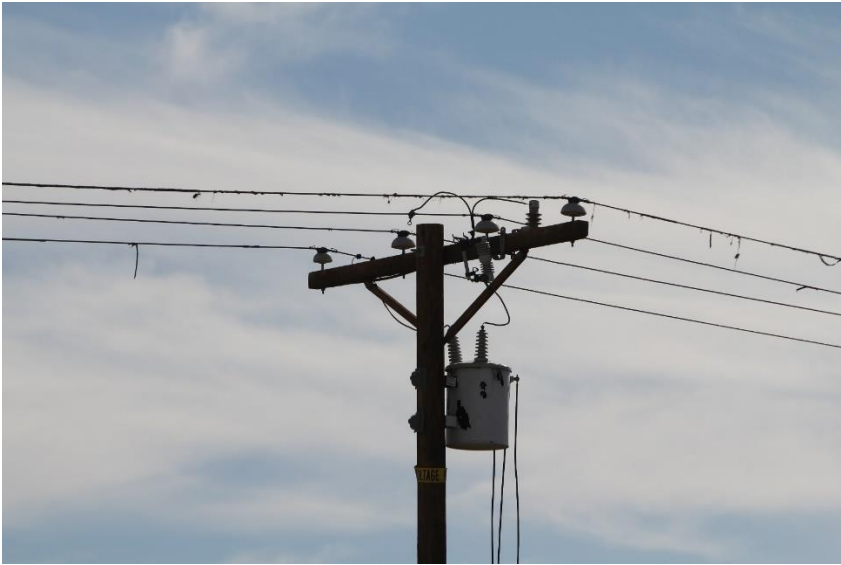
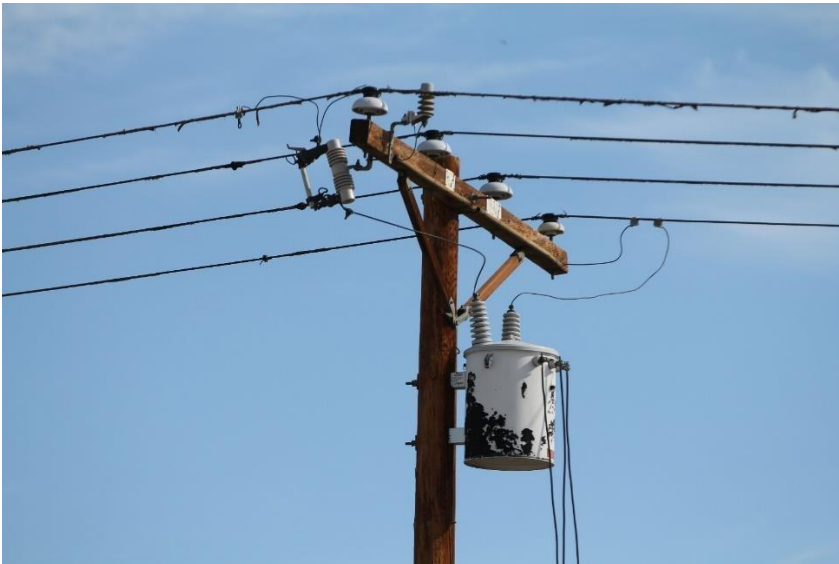
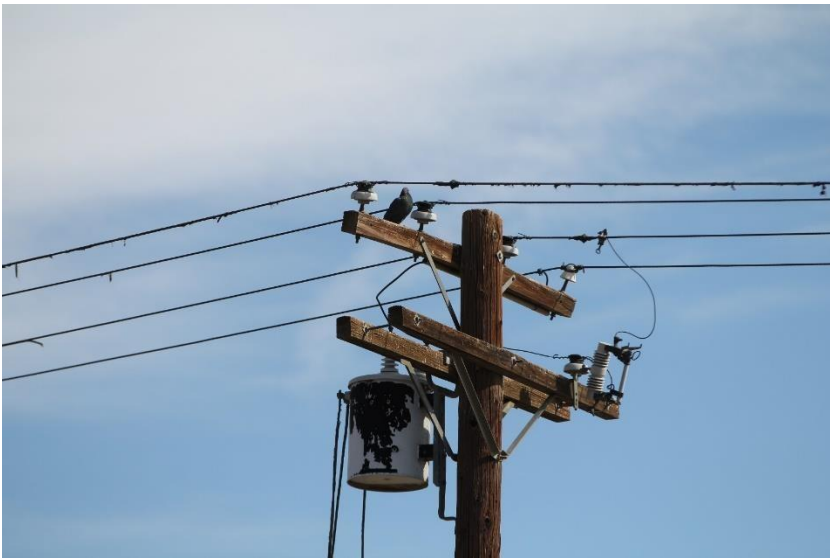
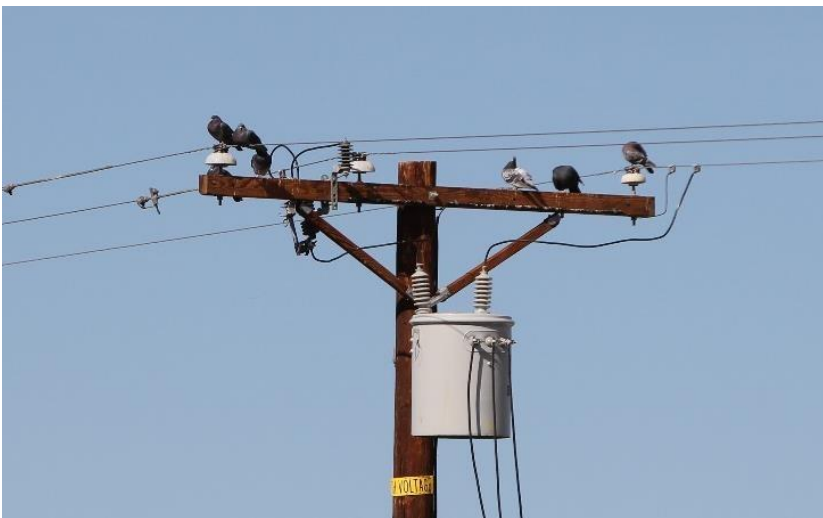
- Excessive bird contamination, some old infrastructure, insulation shot, missing bolt covers; maybe upgrade copper wire to aluminum (can sell copper)

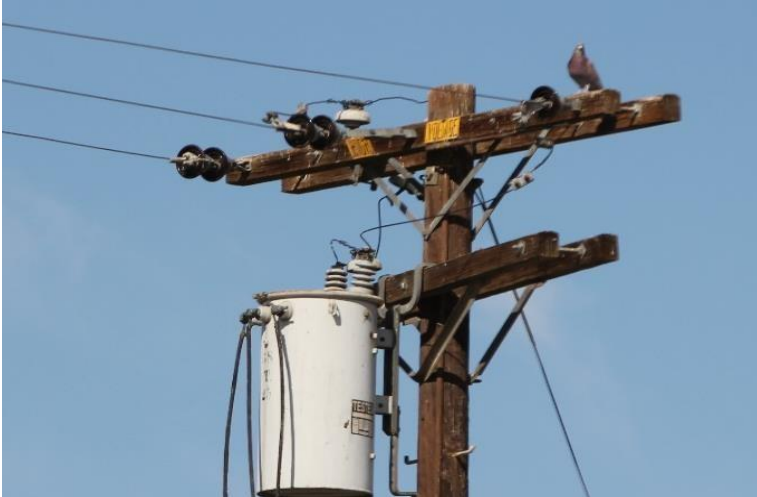
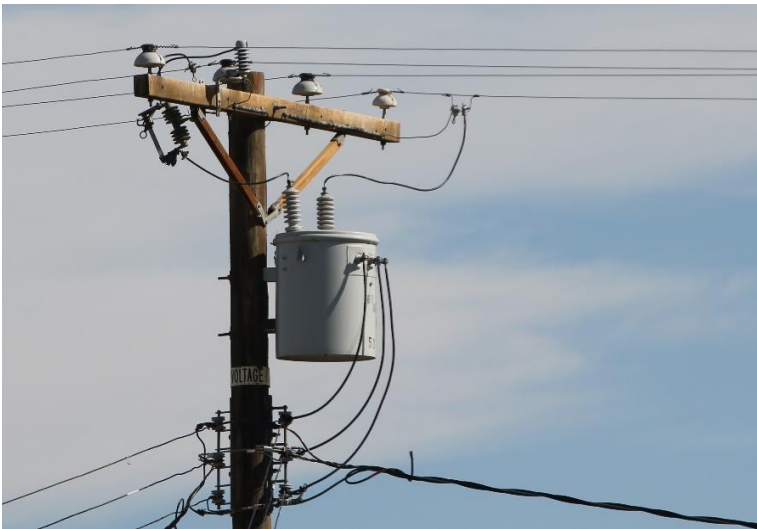
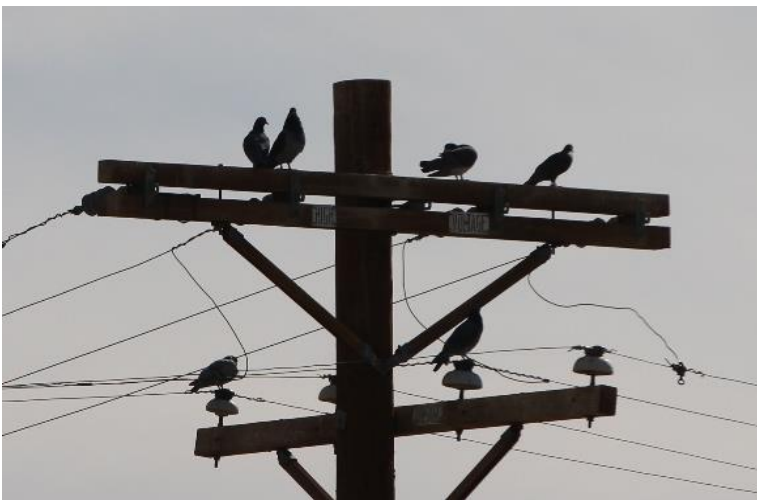
- Birds, missing bolt covers, sign issues, old insulators, very little tracking, but likely bird related outages...
