Final Independent Evaluator Annual Report
on Compliance

Bureau Veritas North America, Inc.
Horizon West Transmission, LLC

June 29, 2021

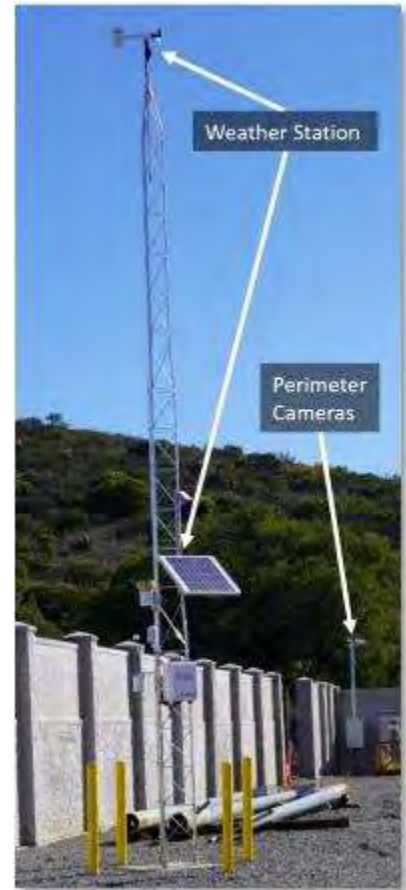
Figure 2. North Wall, Weather Station

1. **Weather station and eight perimeter high-definition (HD) cameras:** The weather station is integrated with SDG&E's network of weather stations across their service territory. Two HD zoomable cameras were installed at each corner of the Facility's perimeter wall for a total of eight cameras. The cameras extend beyond the ten-foot wall height, and at two locations, two additional 360-degree security awareness cameras were also installed.

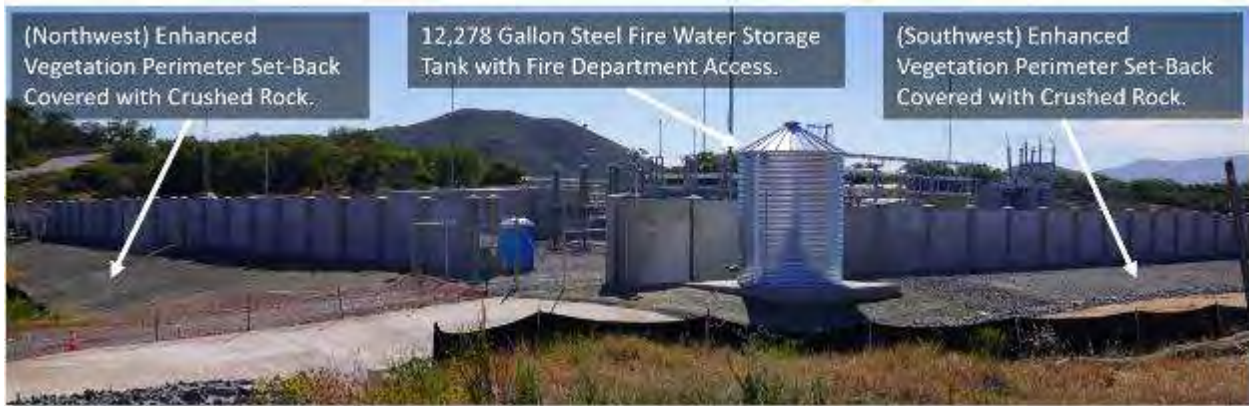
Figure 4. Fire Dept. Water Tank, NW Corner

- Vegetation-free fire breaks approximately 30 feet in width with a crushed rock surface along the Facility's perimeter.
- There is a 12,278-gallon steel fire water storage tank with fire department access and draft connection. The tank is secured to a concrete foundation near the southwest entrance of the Facility.

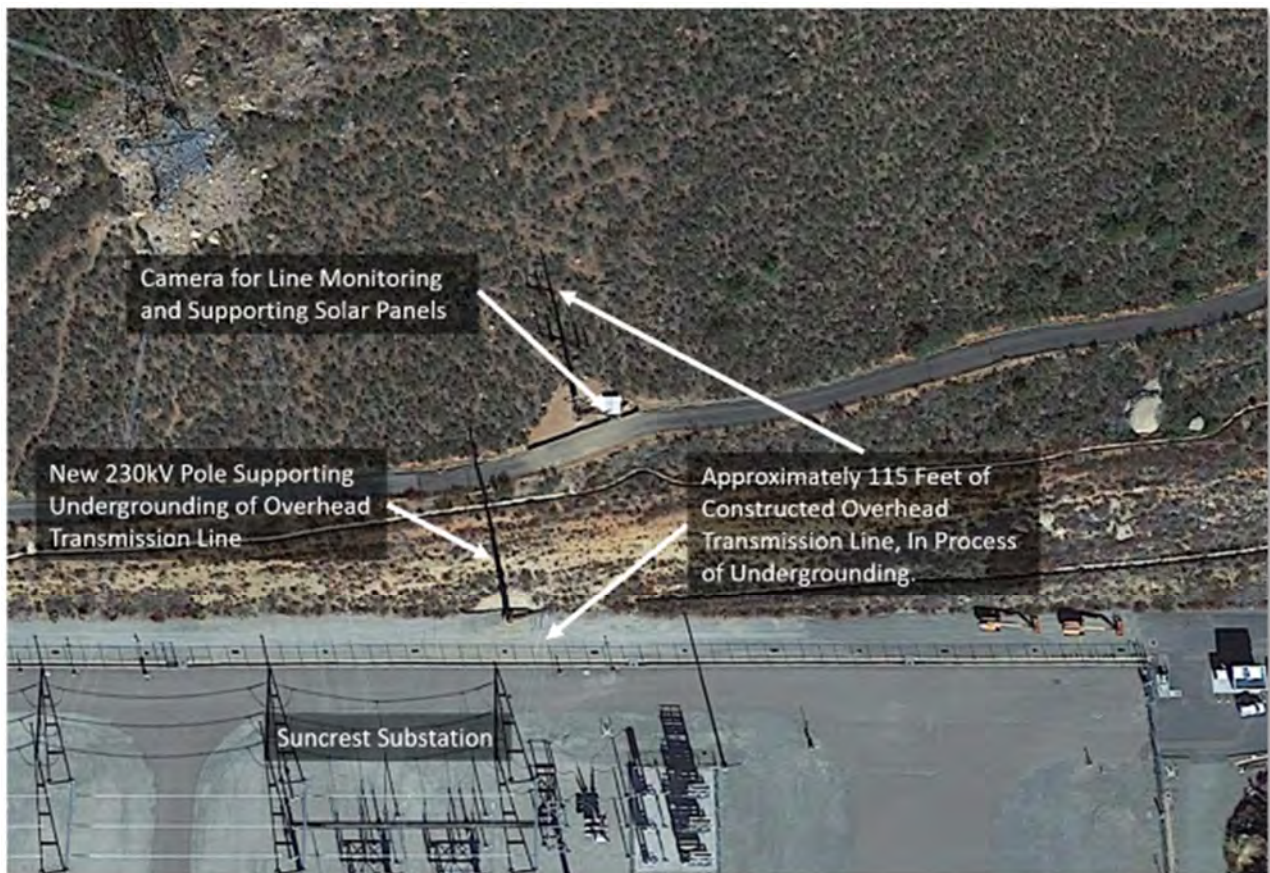
Figure 6. Overhead Transmission

At the point of interconnection to SDG&E's Suncrest Substation, the 115 foot-segment of HWT owned overhead transmission line is in the process of being underground. As noted in HWT's ARC for 2020, construction completion of the undergrounding span is scheduled for August 2021.

At the time of the field visit, the new 230 kV cable pole, immediately adjacent to the substation fence, was installed, and the trench and conduit work to the new cable pole. The original cable pole has been removed, and its foundation is intact, as well as the mast-mounted camera and ground-mounted solar panel and control box. A construction crew was onsite performing tasks to prepare for cable installation for the new underground section.

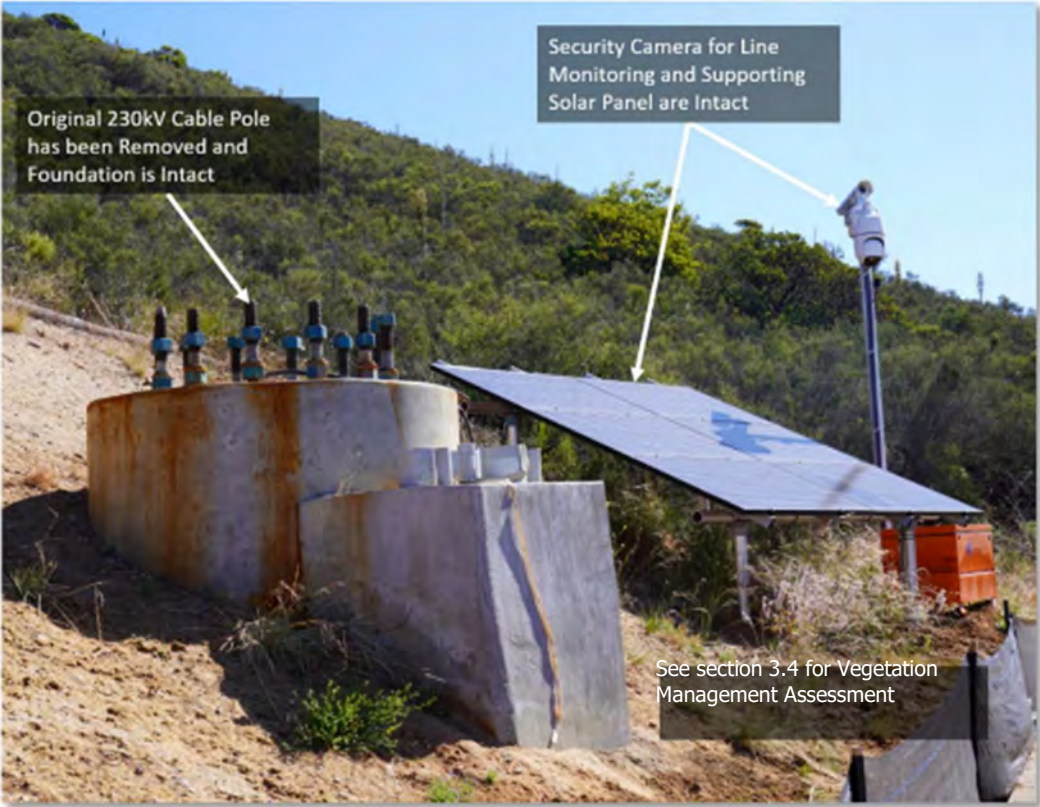
Figure 7. Foundation for Single Steel Pole, Security Camera

Exterior to the Facility, it was observed that a small ground photovoltaic array that supports an exterior camera has approximately 3 feet of dry vegetation directly below the array as demonstrated in Figure 7 and requires fuel mitigation.

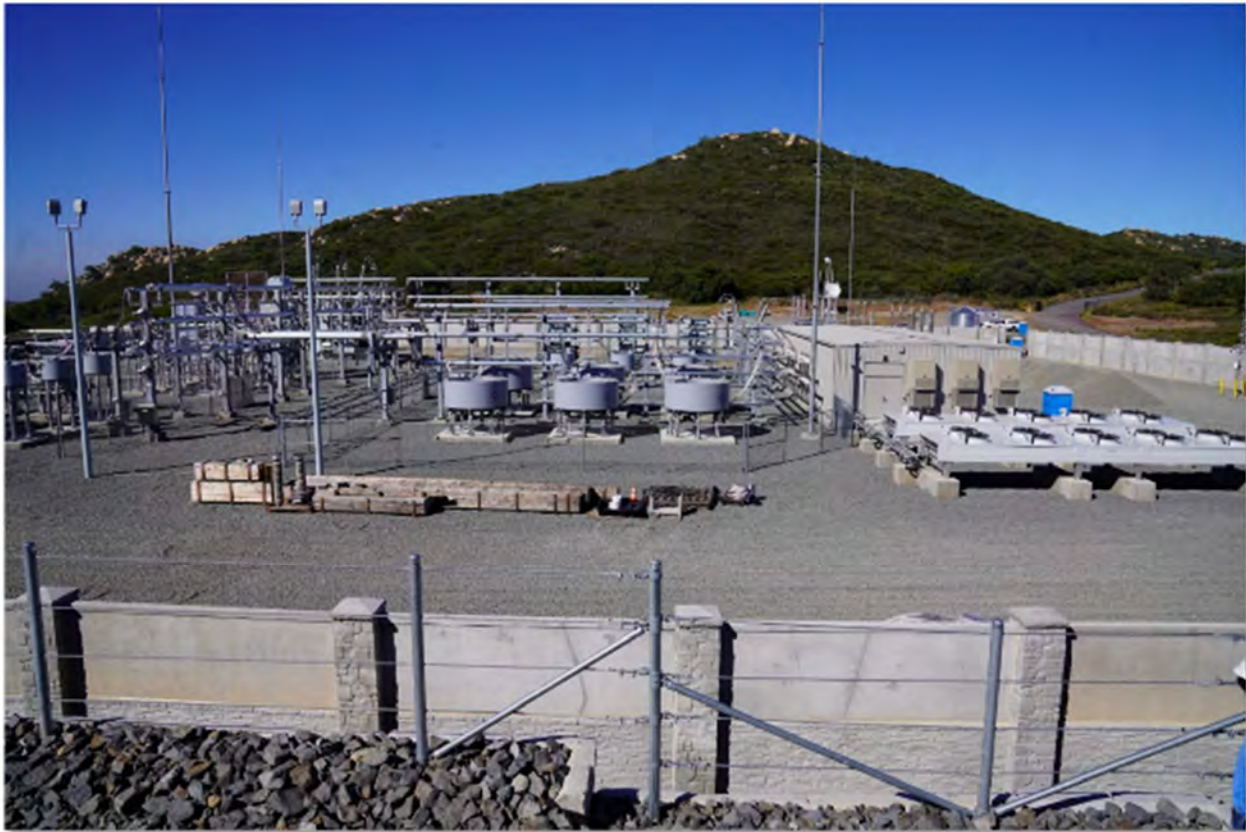
Figure 9. North Exterior Wall and Yard

Findings – IE confirmed that internal to the Facility, no ground vegetation was observed. The interior of the Facility is made up of crushed rock and decomposed granite. A 10-foot concrete perimeter wall surrounds the Facility, which acts as a fire break between the Facility and the wildland surrounding it. Outside the perimeter wall, it was observed that approximately 20 feet of clear ground are provided by crushed rock and dirt. No vegetation or combustible materials was observed inside or directly outside the perimeter fence.

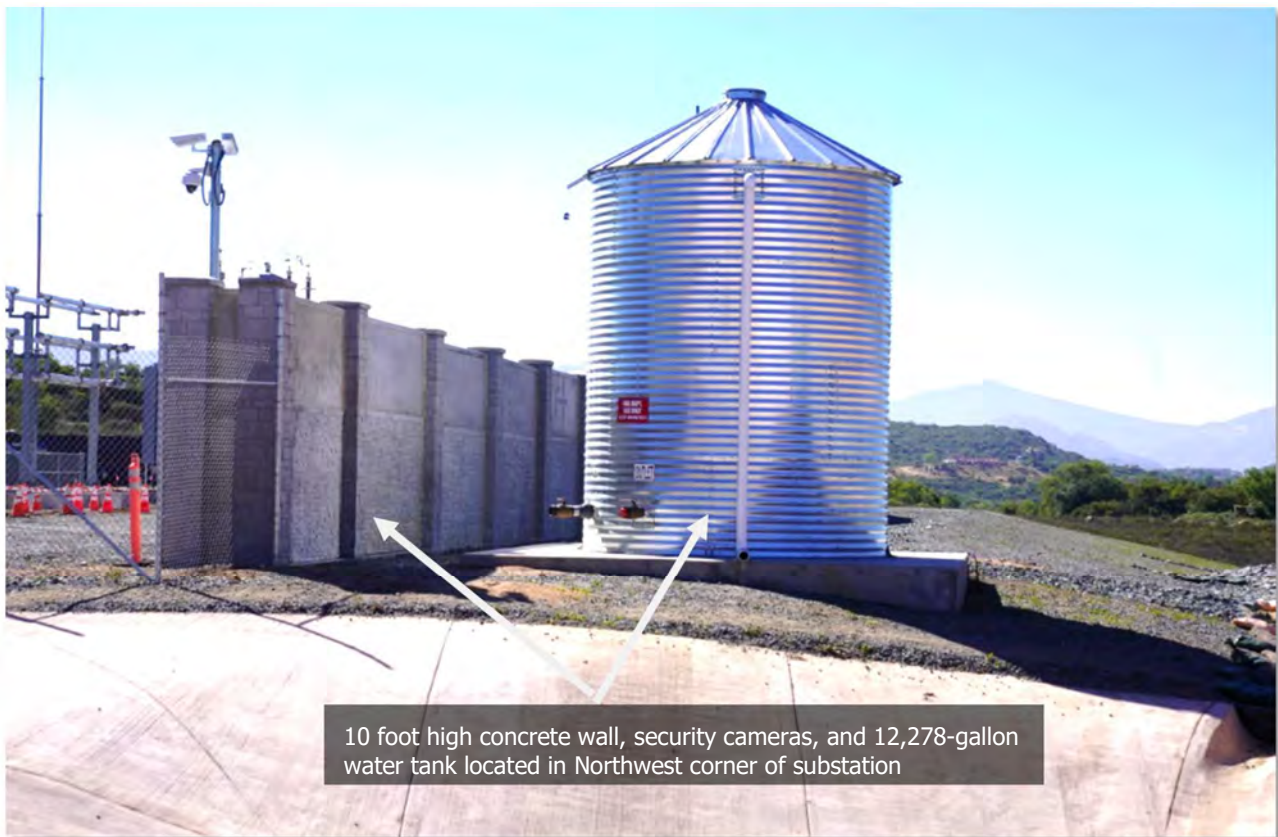
Figure 10. Fire Dept. Water Tank, NW Corner, Exterior, 12,278 gal

HWT provided a Fire Protection Plan accepted and approved by San Diego County Fire Authority (SDCFA). An item that was not identified as installing a 12,278-gallon water storage tank with a concrete foundation is installed at the substation's northwest corner. The local Fire Authority Having Jurisdiction has reviewed the installation of the tank - see Photo 3 of this assessment.

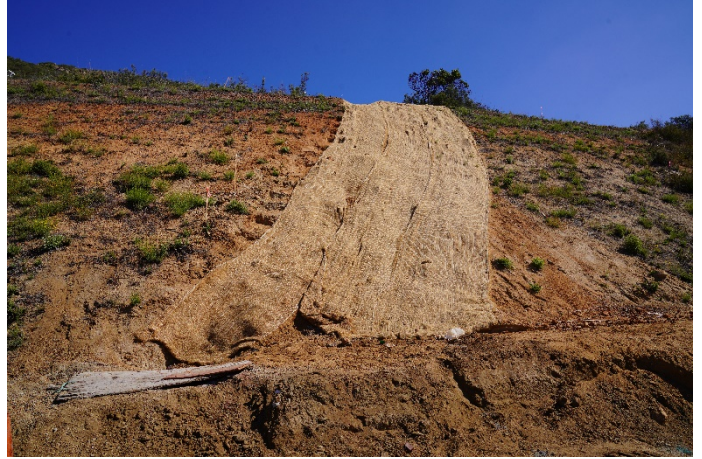
338 material covering washout on hill, View North

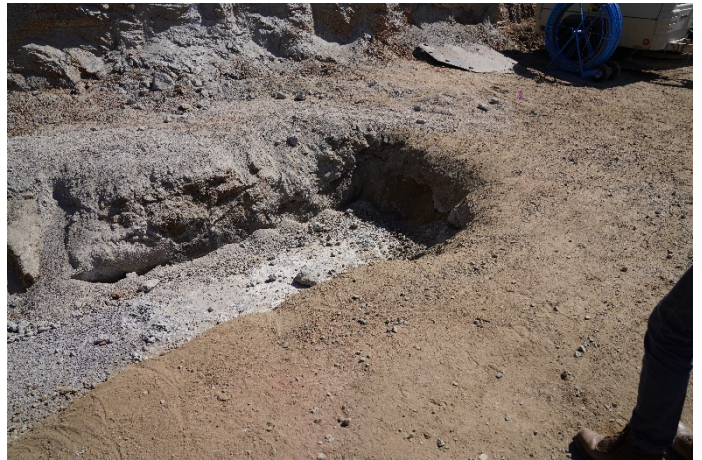
343 Hole in ground, top of concrete encased duct bank

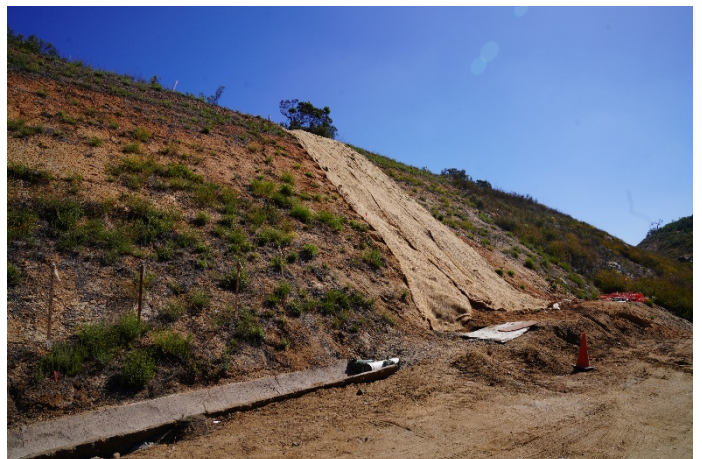
345 material covering washout on hill, View Northeast
