NOTICE OF VIOLATION

Energy Safety Inspection Report

Report Name: SCE_ ATJ_20211115-01

Date(s): November 15, 2021

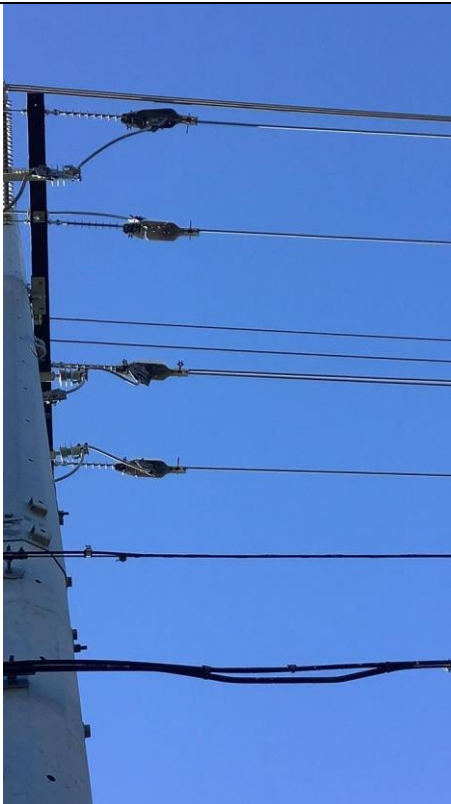
Per SCE's Distribution Design Standards (DDS) and Distribution Overhead Construction Standards (DOH), when installing covered conductor, vibration dampers must also be installed.¹ Energy Safety staff found that vibration dampers were not installed at multiple structures where covered conductor was completed. The structures missing vibration dampers where covered conductor was installed are identified in Table 2 above. On November 19, 2021, SCE submitted a memo to Energy Safety titled, "Interim Deviation from Standards on Vibration Damper for Covered Conductor"² (hereafter, "Memo"). This Memo was dated August 18, 2021, and indicates that due to supply chain issues, SCE will suspend the installation of vibration dampers until December 31, 2021. In accordance with SCE's Q2 QDR submission, the covered conductor installations inspected by Energy Safety were completed prior to the issuance of the Memo. Also, SCE informed Energy Safety of this supply chain issue only after inspections commenced. Consequently, Energy Safety finds that SCE is still in violation of its protocols requiring the installation of vibration dampers as part of covered conductor installations.

Item1IA1img1: At dead end, no vibration dampeners installed

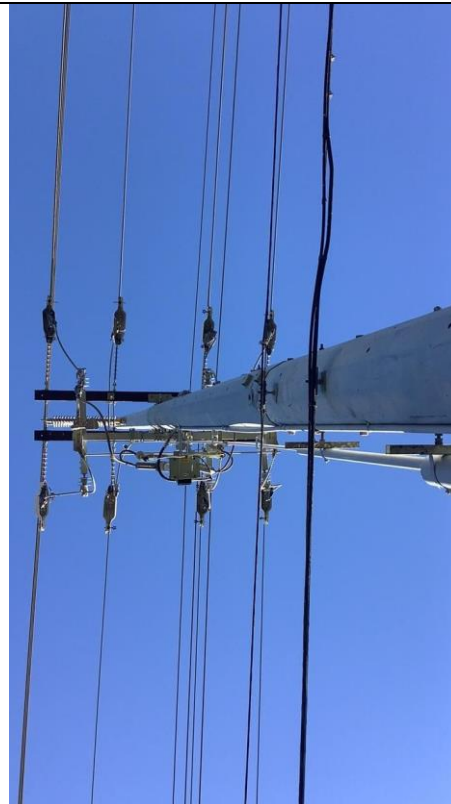
Item1IA1img2: Showing where covered conductor ends and bare conductor begins

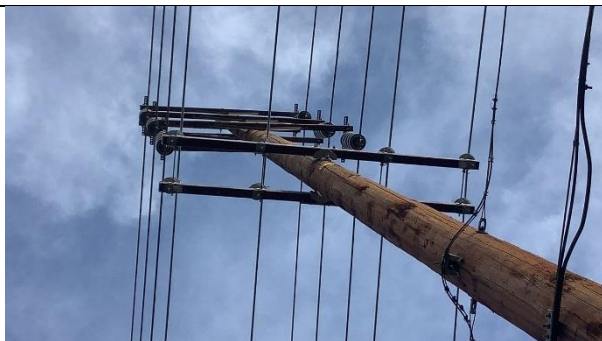
Item4IA1img1: Vibration dampers not installed

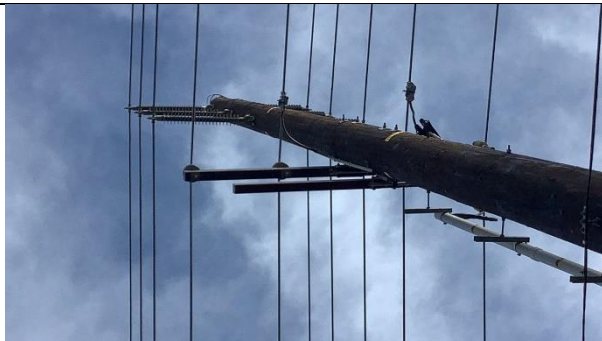
Item5IA1Img1: Vibration dampers not installed
