NOTICE OF VIOLATION

Energy Safety Inspection Report

Report Name: ATJ_SCE_20211207-01

Utility: Southern California Edison

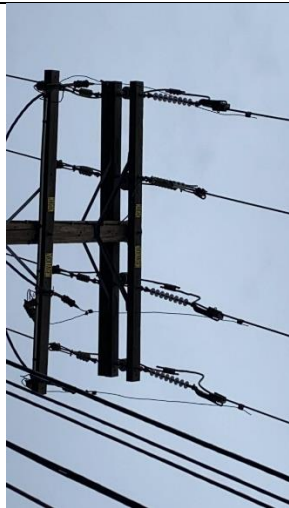
Structure ID: 4467330E

1. Violation 1: Per SCE’s 2021-Q1 quarterly data report (QDR), covered conductor was installed on pole 4467330E. This structure was reported in covered conductor initiative (2021 WMP initiative number 7.3.3.3.1) with a status of “complete.” However, upon inspection, SCE did not install covered conductor at this pole. Covered conductor work starts at next pole. Energy Safety considers this data accuracy violation to be in the Minor risk category.
2. Violation 2: At poles numbered 1289686E, 1789149E, and 4475177E the pole ID did not match the ID provided by SCE in its QDR spatial data. Energy Safety considers this data accuracy violation to be in the Minor risk category.
3. Violation 3: Per SCE’s Distribution Design Standards (DDS), section DDS-10, page 10-82, “for the 336 (30/7) ACSR covered conductor, vibration dampers shall be installed on every

Item3IA1img1: Bare conductor when data indicates that there should be covered conductor

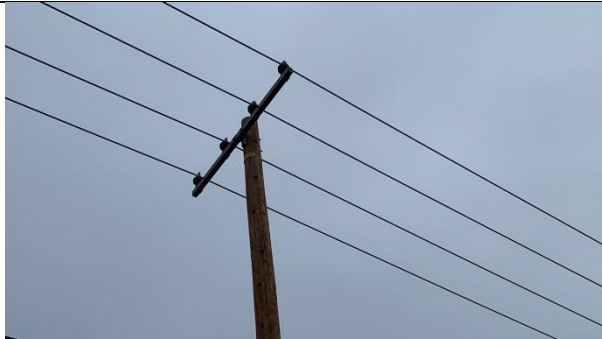
Structure ID: 4556899E

Per SCE's Distribution Design Standards (DDS) and Distribution Overhead Construction (DOH), when installing covered conductor, vibration dampers must also be installed.¹ Energy Safety staff found that no vibration dampers were installed at multiple structures where covered conductor was installed. The structures missing vibration dampers where covered conductor was installed are identified in Table 2 above. On November 19, 2021, SCE submitted a memo to Energy Safety titled, "Interim Deviation from Standards on Vibration Damper for Covered Conductor"² (hereafter, "Memo"). This Memo was dated August 18, 2021, and indicates that due to supply chain issues, SCE will suspend the installation of vibration dampers until December 31, 2021. In accordance with SCE's Q2 QDR submission, the covered conductor installations inspected by Energy Safety were completed prior to the issuance of the Memo. Also, SCE informed Energy Safety of this supply chain issue only after inspections commenced. Consequently, Energy Safety finds that SCE is still in violation of its protocols requiring the installation of vibration dampers as part of covered conductor installations.

Item4IA1img1: No vibration dampers

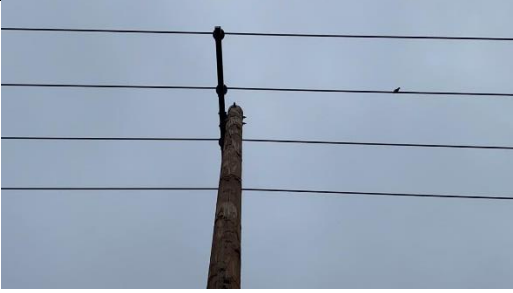
Structure ID: 4554799E

<p>Item5IA1mg1: No vibration dampers</p>

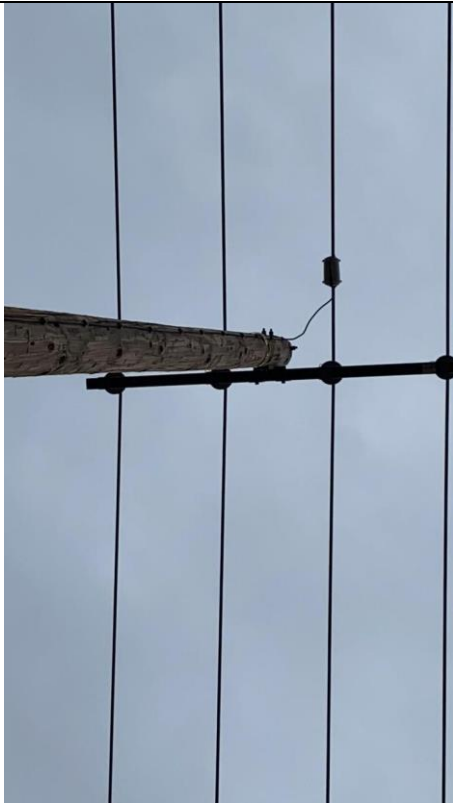
Structure ID: 4554798E

Item6IA1Img1: No vibration dampers

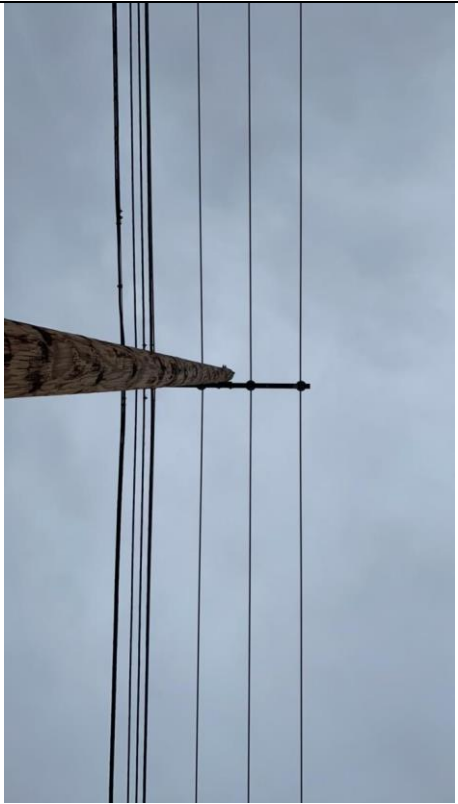
Structure ID: 4554796E

Item7IA1Img1: No vibration dampers

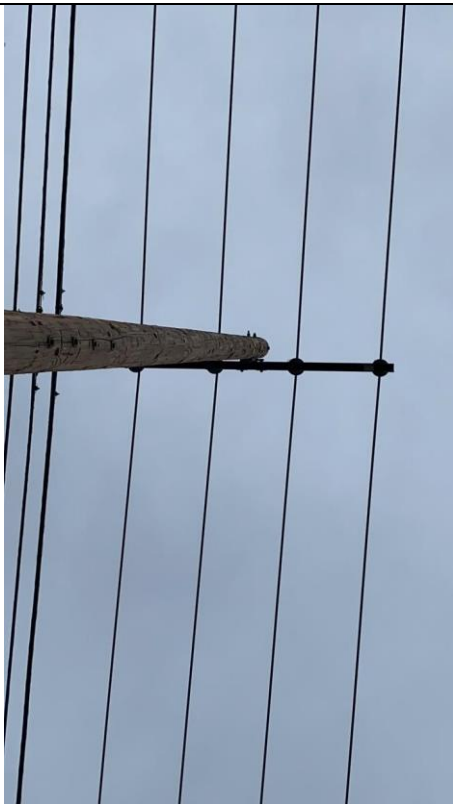
Structure ID: 4554794E

Item8IA1img1: No vibration dampers

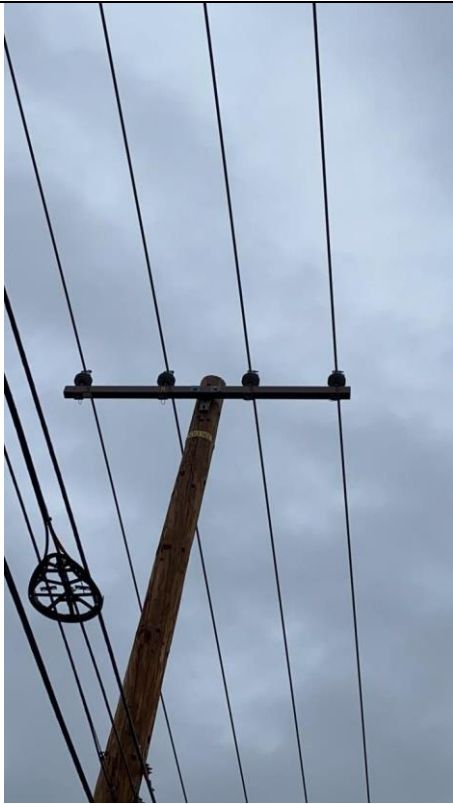
Structure ID: 4545339E

Item9IA1Img1: No vibration dampers

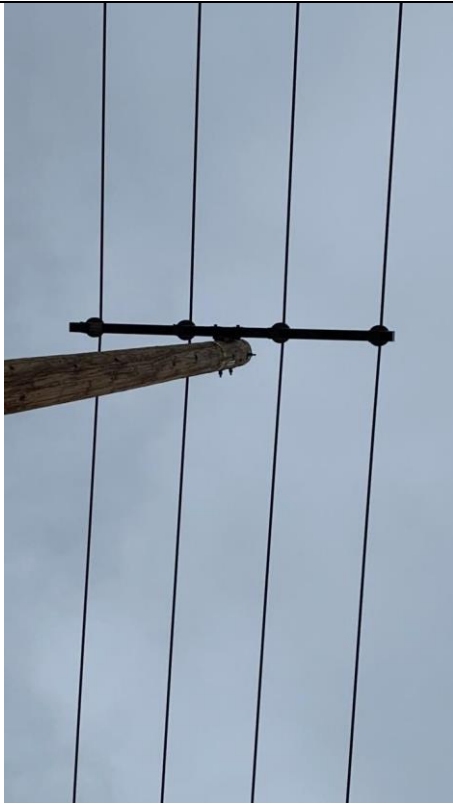
Structure ID: 4554790E

Item10IA1mg1: No vibration dampers

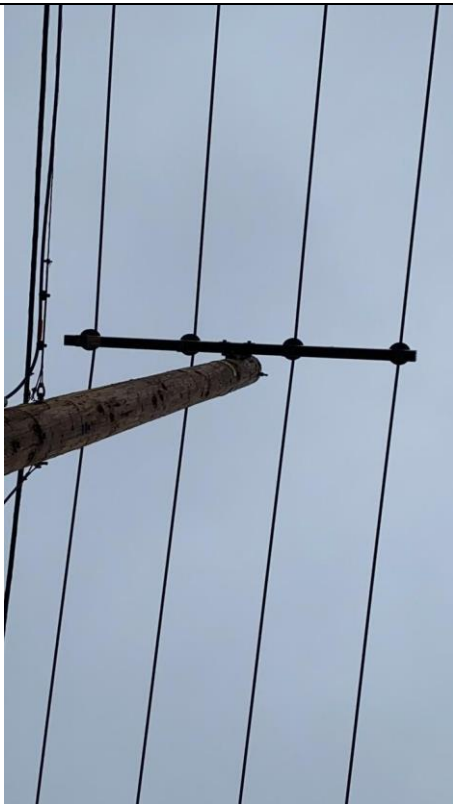
Structure ID: 4554788E

Item11IA1mg1: No vibration dampers

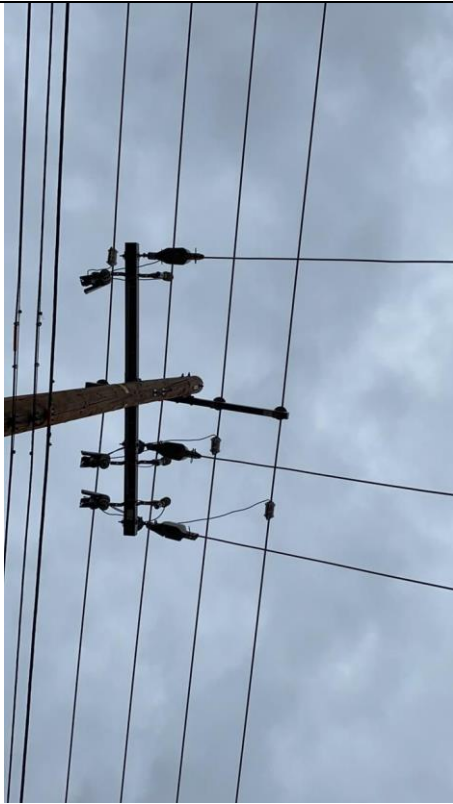
Structure ID: 4554787E

Item12IA1Img1: No vibration dampers

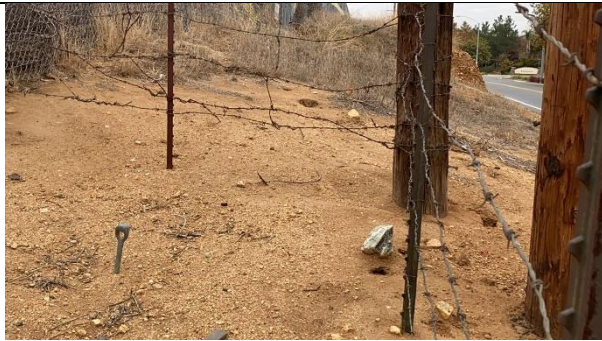
4. Violation 4: Per SCE's protocols for Distribution Overhead Construction (DOH), PO 300 page 9 of 9, when an anchor location is abandoned, the rod and plate shall be removed if in a hazardous or potentially dangerous location. Otherwise, cut the rods off at least 12 inches below the ground line and abandon the remaining anchor. Screw anchor rods may be either unscrewed or cut off. Under no conditions should the rod be bent over or left exposed. Energy Safety identified pole numbered 4554787E in violation of this protocol with an abandoned guy anchor left above the ground line. Energy Safety considers this violation to be in the Minor risk category.

Per SCE's protocols for Distribution Overhead Construction (DOH), PO 300 page 9 of 9, "When an anchor location is abandoned, the rod and plate shall be removed if in a hazardous or potentially dangerous location."⁵ Otherwise, cut the rods off at least 12 inches below the ground line and abandon the remaining anchor. Screw anchor rods may be either unscrewed or cut off. Under no conditions should the rod be bent over or left exposed. Structures where this protocol was not followed are noted in Table 2 above.

Item12IA3Img1: Abandoned guy anchor

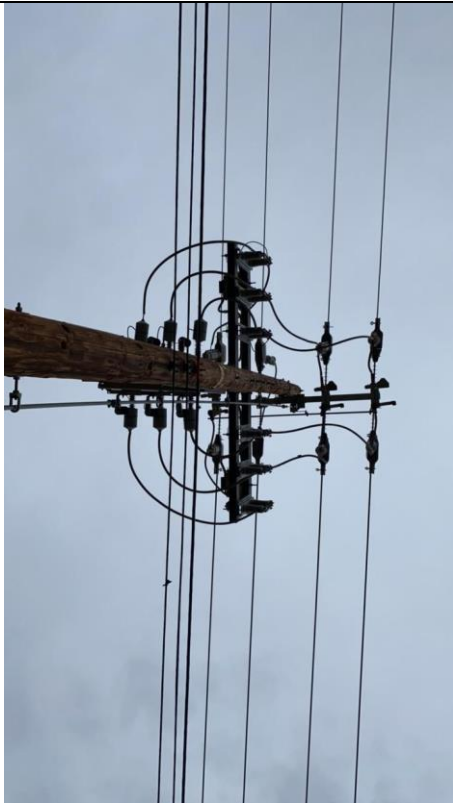
Structure ID: 4554785E

Item13IA1mg1: No vibration dampers

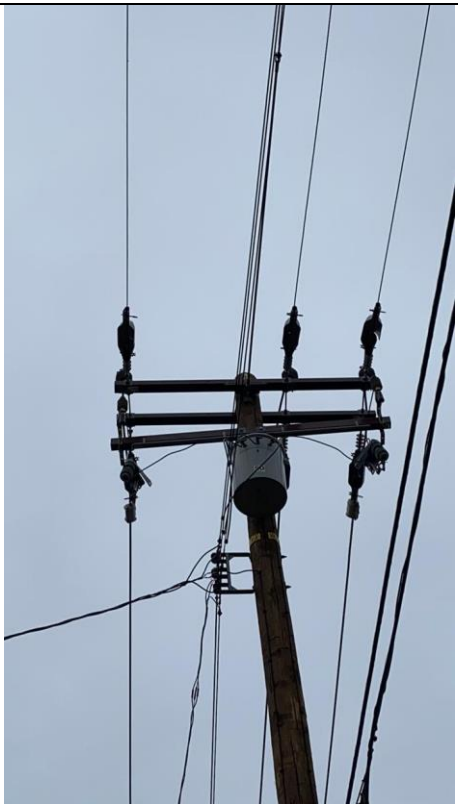
Structure ID: 1026956E

Item14IA1mg1: No vibration dampers

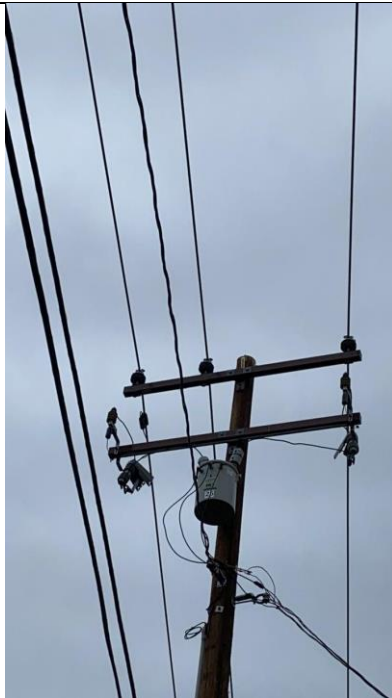
Structure ID: 1407366E

Item15IA1Img1: No vibration dampers

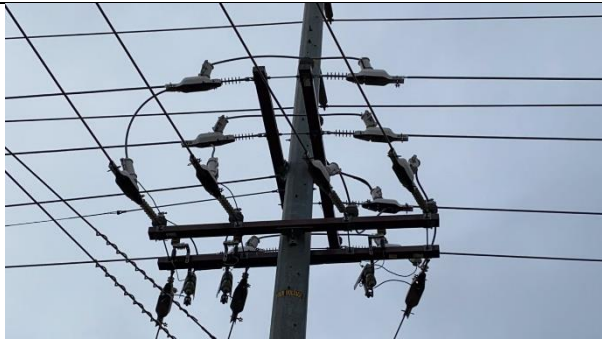
Item16IA2img1: No vibration dampers

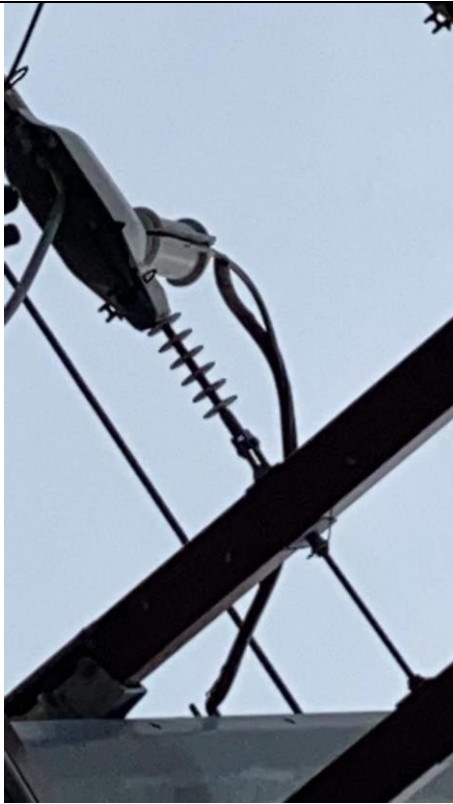
6. Violation 6: Per SCE’s Distribution Overhead Construction Standards (DOH, Section CC 150.4, covered conductor construction should use covered conductor jumpers at dead-end construction. Pole numbered 1789149E had covering that was detaching and frayed from its jumper wire. Energy Safety considers this a violation for failure of adhering to protocol to be in the Minor risk category.

Energy Safety found a structure where the covering on a jumper cable was frayed. Per SCE's DOH, "When making connections, jumpers shall be covered conductor of equal or greater ampacity."⁴This may compromise the insulation's ability to prevent foreign objects from contacting the energized conductor. The structure where the frayed covering was observed is noted in Table 2 above.

Item16IA3Img1: Covering falling off covered jumper cable

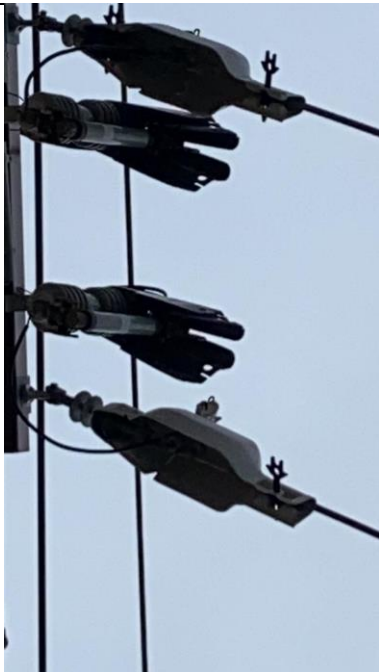
5. Violation 5: Per SCE DOH, “Dead-ends shall be covered with a Dead End Clamp in covered conductor systems. Covering dead-ends will ensure that stripped portions of the covered conductor at the dead-end will be protected from contact that could lead to phase-to-phase or phase-to-ground faults.”¹ Pole numbered 1789149E had a dead-end clamp that was loosely attached to a conductor. Energy Safety considers this a violation for failure of adhering to protocol to be in the Minor risk category.

Energy Safety discovered a dead-end clamp that was loosely attached to the covered conductor. Per SCE DOH, "Dead-ends shall be covered with a dead-end clamp in covered conductor systems. Covering dead-ends will ensure that stripped portions of the covered conductor at the dead-end will be protected from contact that could lead to phase-to-phase or phase-to-ground faults."³ The structure where this violation was observed is noted in Table 2 above.

Item16IA4Img1: Loose dead-end clamp

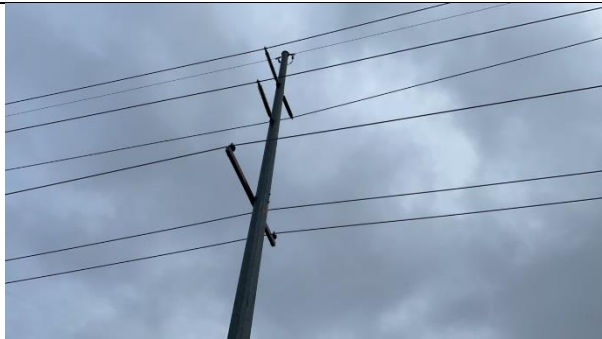
Structure ID: 4475177E

Item17IA1mg1: No vibration dampers
