NOTICE OF VIOLATION

Energy Safety Inspection Report

Report Name: ATJ_SCE_20211130-01

Date(s): November 30, 2021

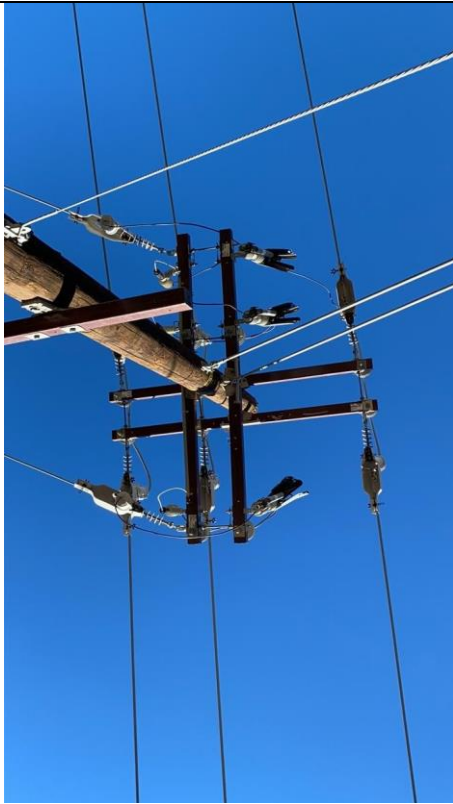
Per SCE's DDS and DOH, when installing covered conductor, vibration dampers must also be installed.⁴ Energy Safety staff found that vibration dampers were not installed at multiple structures

Item1IA1img1: Vibration dampers not installed

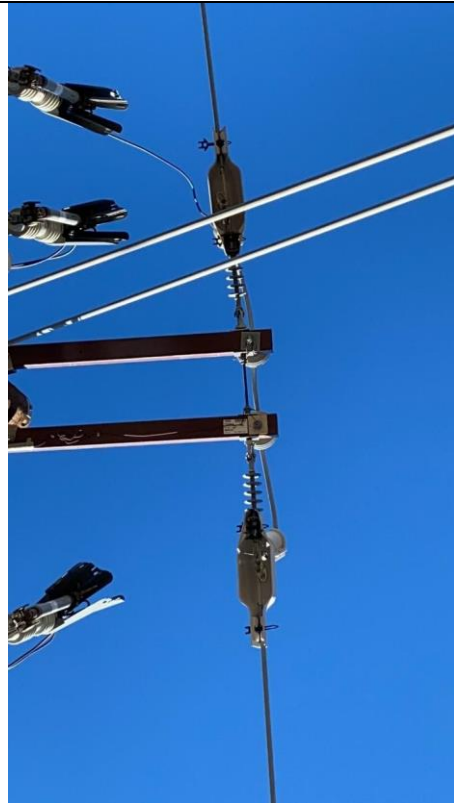
Item1IA1img2: Close up, no vibration dampers installed

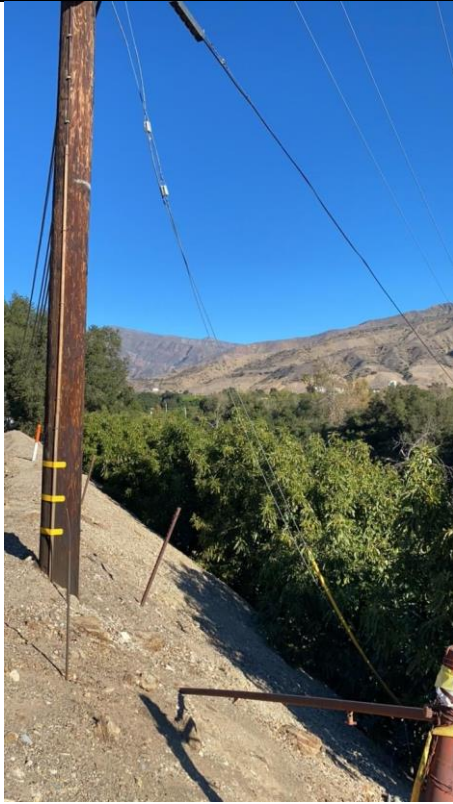
In addition to the violations discovered during WMP inspections of SCE's covered conductor installations, Energy Safety discovered one structure that had a loose guy wire. Energy Safety considers loose guy wires as a condition that increases an electrical corporation's ignition risk because the primary purpose of a guy wire is to provide stability to a structure (e.g., a pole) where imbalanced loads are present. If a guy wire is loose and not maintained taut, it cannot serve its intended purpose of balancing load and adding stability, thus increasing the risk of structure failure and potential ignition under adverse weather conditions. The structure where a loose guy wire was observed is identified in Table 3.

Item2GW1Img1: Overview of pole with loose down
guy wire

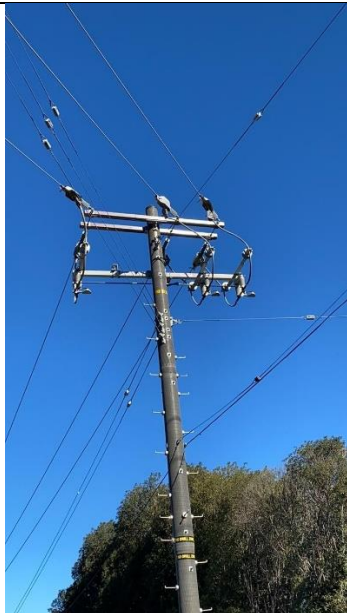
conjunction with covered conductor installation.¹ Poles numbered 929077E, 929076E, 4094278E, 4157910E, 4944416E, and 1025312E had covered conductor installed but failed to install fiberglass guy strain insulators, in accordance with SCE protocol. Energy Safety considers this violation for failure of adhering to protocol to be in the Minor risk category.

Item6IA1Img1: Overall of 6 guy spans with porcelain insulators

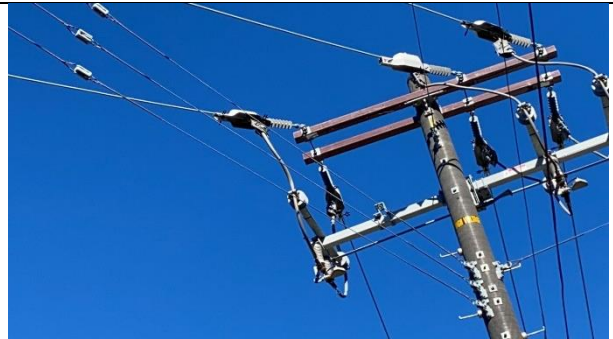
Item6IA1Img2: Close up of 3 guy spans with porcelain insulators

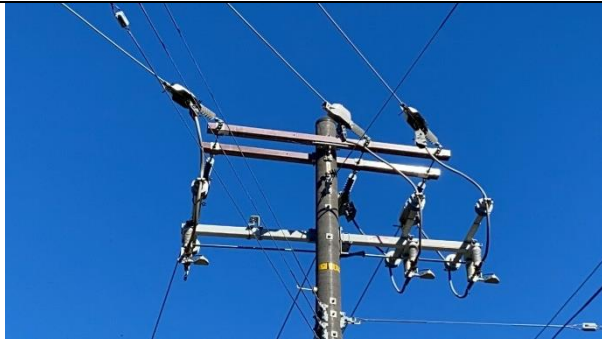
Item6IA2Img1: Vibration dampers not installed

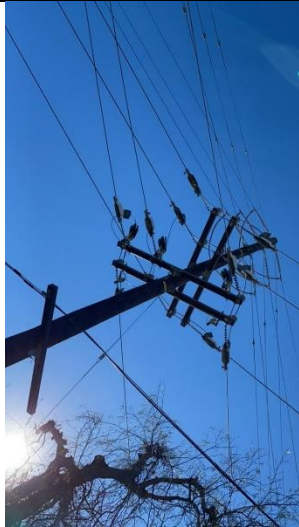
Item7IA1Img1: Vibration dampers not installed

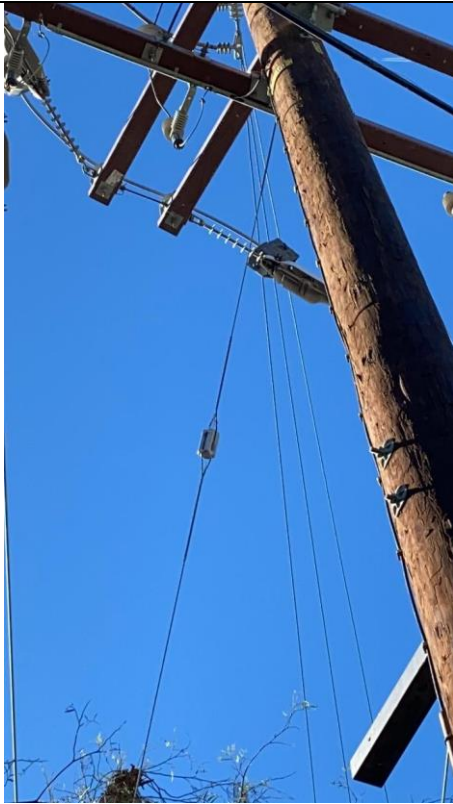
Item7IA2Img1 : Fiberglass down guy wire insulator not installed

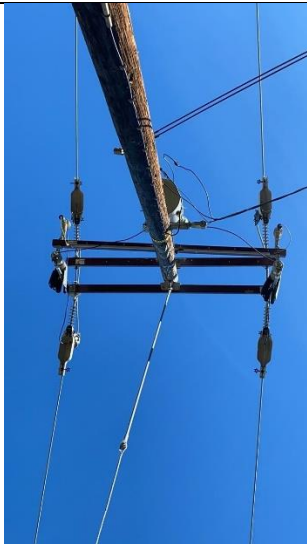
Item8IA1Img1: Vibration dampers not installed

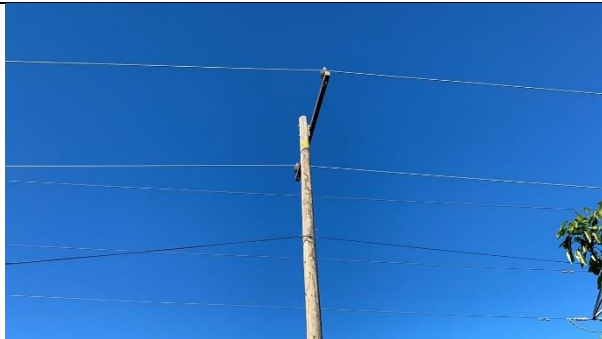
Item9IA1img1: Vibration dampers not installed

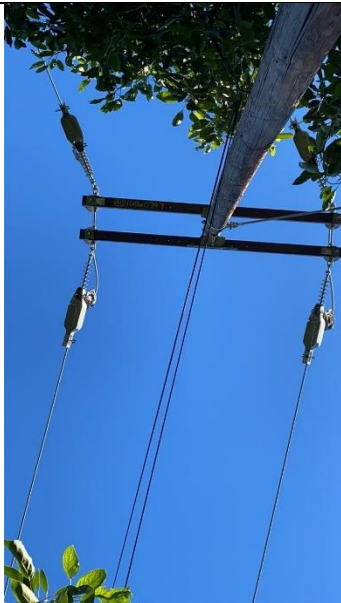
Item10IA1Img1: Vibration dampers not installed

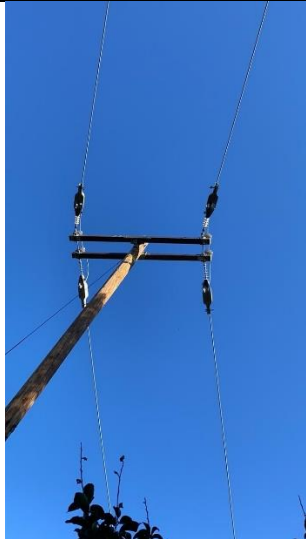
Item11IA1img1: Vibration dampers not installed

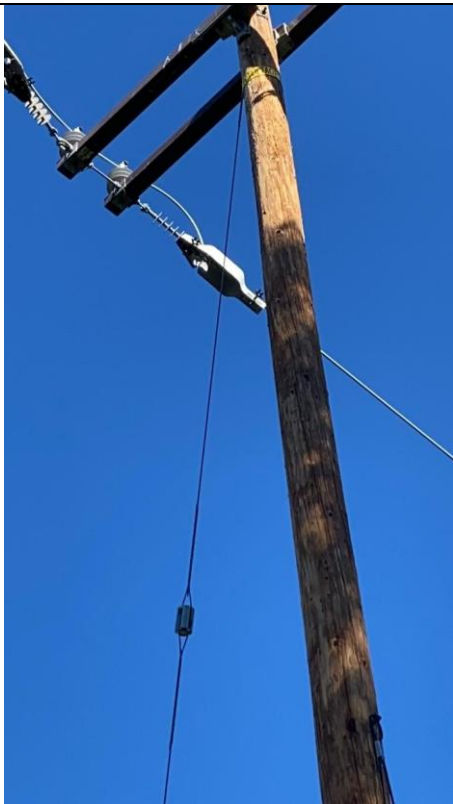
Item11IA2Img1: Fiberglass down guy wire insulator not installed

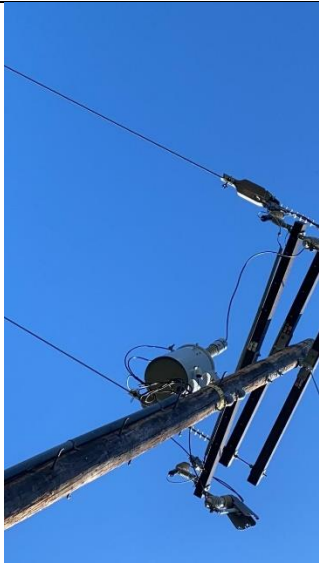
Item12IA1Img1: Vibration dampers not installed

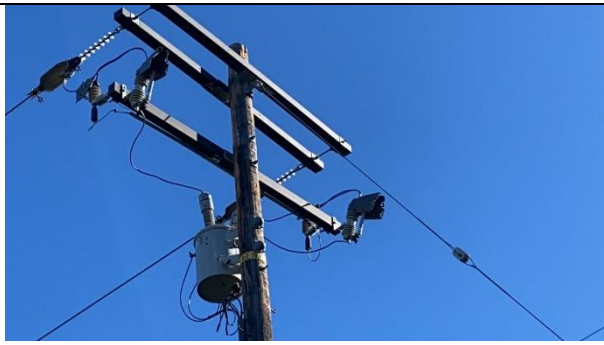
Item12IA2Img1: No fiberglass down guy wire insulator installed

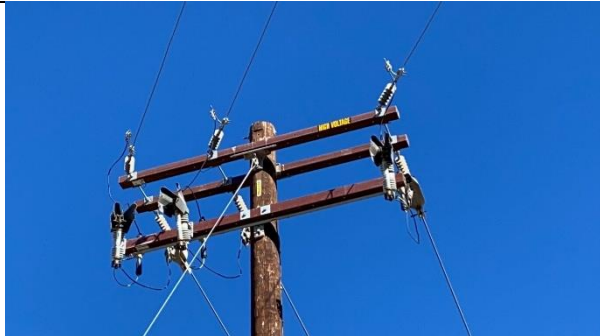
In its 2021-Q2 quarterly data report (QDR) submission on August 1, 2021, SCE provided initiative data indicating that covered conductor installation projects (2021 WMP initiative number 7.3.3.3.1) in Santa Paula and Fillmore were completed. This QDR submission represented the reporting period of April through June (i.e., Q2) 2021. Based on this information received from SCE, Energy Safety planned an inspection of select structures in these areas to assess the accuracy of SCE data, the completeness of SCE's work, and whether SCE followed its protocols for covered conductor installation. Upon arriving to the inspection location in Fillmore, Energy Safety observed that the covered conductor work was reported as terminating at the pole numbered 1832050E but instead terminated one span further at the pole numbered 4944416E. This data accuracy violation is noted in Table 2 above.

Item13IA1Img1: Bare wire to covered conductor

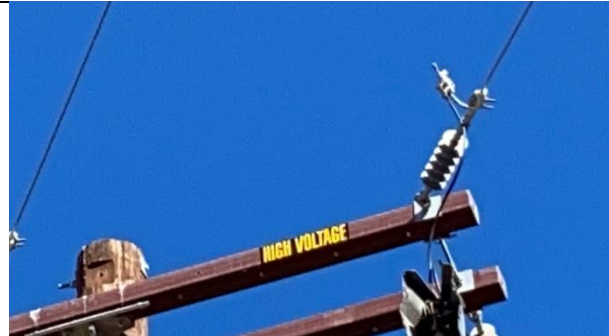
Item13IA1Img2: Bare wire to covered conductor close up

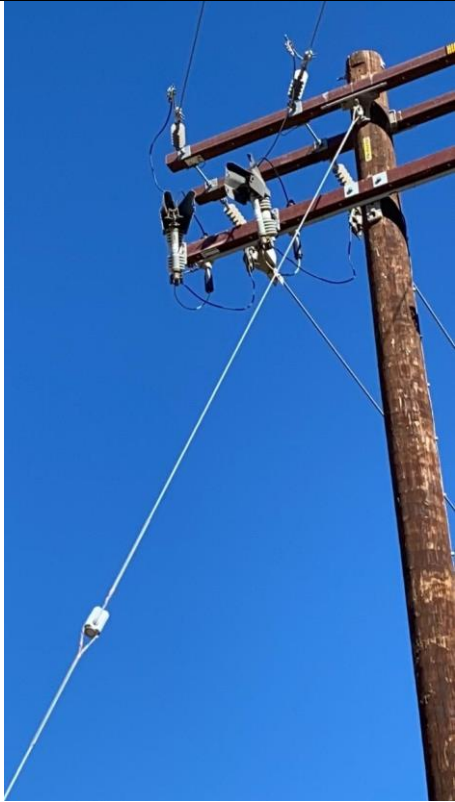
Item13IA2Img1: : Fiberglass down guy wire insulator not installed

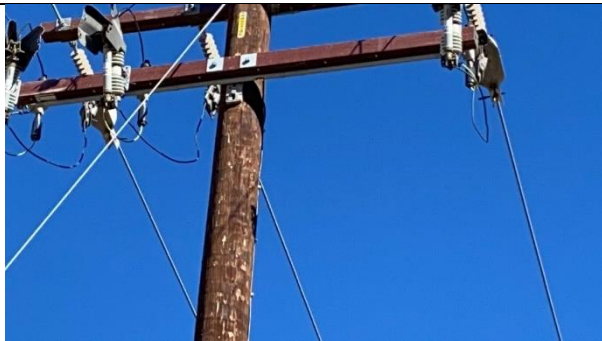
Item13IA3Img1: Vibration dampers not installed

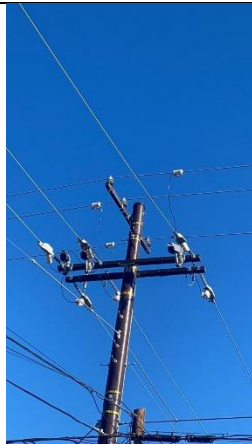
Item14IA1Img1: Vibration dampers not installed

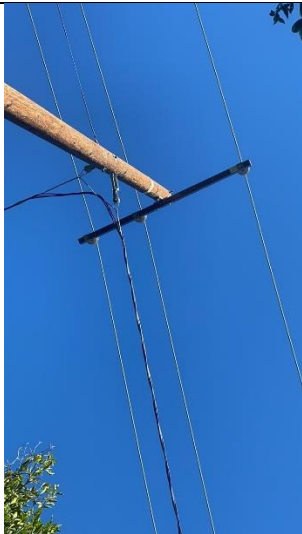
Item15IA1Img1: Vibration dampers not installed

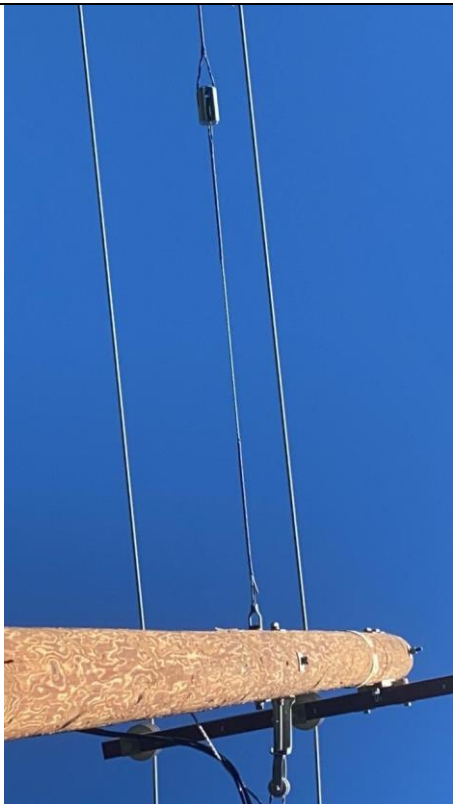
Item15IA2Img1: : Fiberglass span guy wire insulator not installed

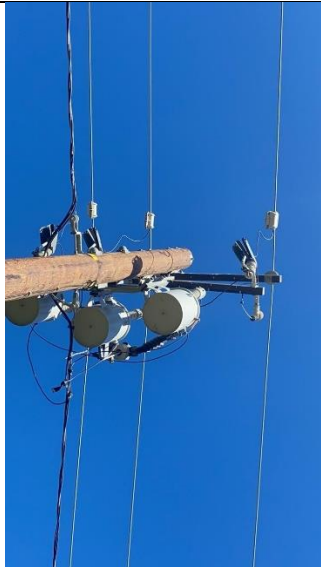
Item16IA1Img1: No vibration dampers installed
