NOV_SCE_ATJ_ 20211209-01

NOTICE OF VIOLATION

Energy Safety Inspection Report

Report Name: ATJ_SCE_20211209-01

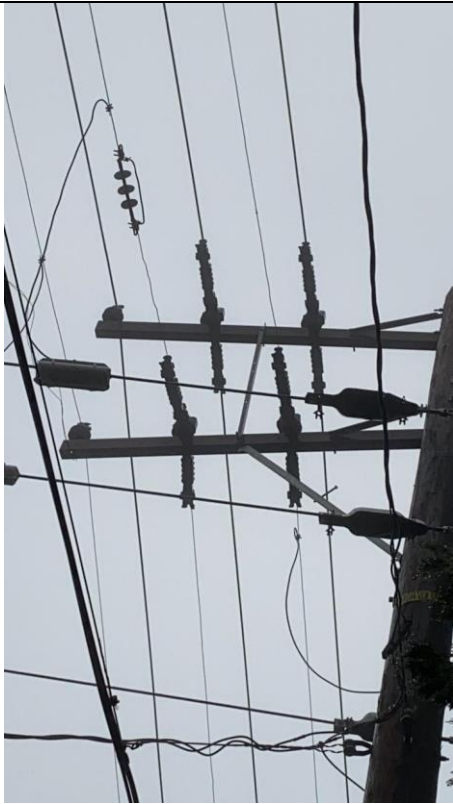
1. Violation 1: Per SCE’s 2021-Q1 quarterly data report (QDR), covered conductor was installed on poles numbered 687838E, 1403136E, 4558869E, 1763105E, and 1414393E. All these structures reported a covered conductor initiative (2021 WMP initiative number 7.3.3.3.1) with a status of “Complete.” However, upon inspection, SCE has not even begun covered conductor installation at any of these locations. Energy Safety considers this data accuracy violation to be in the Moderate risk category.

2. Violation 2: Per SCE’s 2021-Q1 QDR, covered conductor was installed on poles numbered 687838E, 1403136E, 4558869E, 1763105E, and 1414393E. Upon inspection, Energy Safety staff found no covered conductor installed at the above-mentioned structures. Given SCE’s focus on covered conductor as one of its flagship wildfire mitigation programs and the scope of this mitigation program, Energy Safety is greatly concerned about how much

Item1IA1Img1: Top level crossing phase showing bare wire and no covered conductor installed

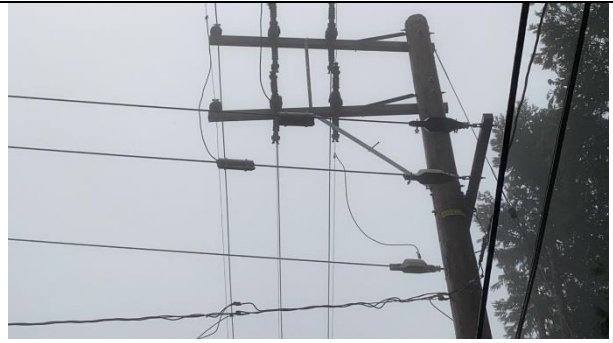
Item1IA1Img2: See mid-level of pole where covered conductor work was completed

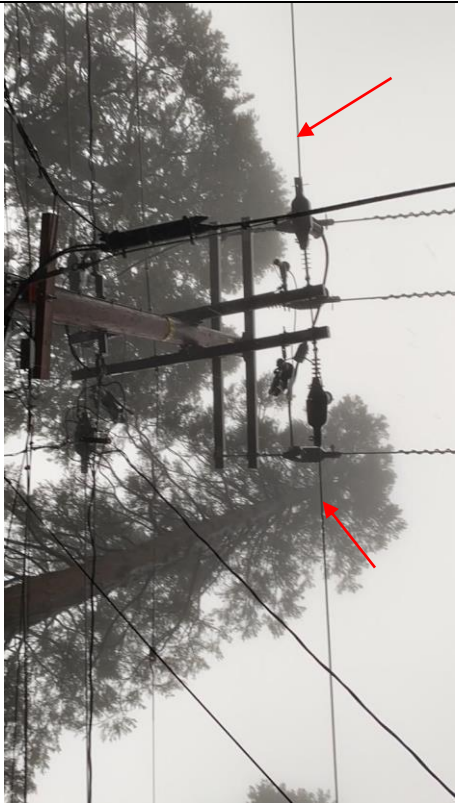
4. Violation 4: Per SCE’s Distribution Design Standards (DDS), section DDS-10, page 10-82, “for the 336 (30/7) ACSR covered conductor, vibration dampers shall be installed on every span in both light loading and heavy loading areas.” SCE’s Distribution Overhead Construction Standards (DOH), section CC 190, page 1 of 11, indicates vibration dampers are required when installing covered conductor. Pole numbers 4931111E, F16868Y, 549418E, and 4421488E had covered conductor installed but failed to install vibration dampers. Energy Safety considers this violation for failure of adhering to protocol to be in the Minor risk category.

Per SCE's Distribution Design Standards (DDS) and Distribution Overhead Construction Standards (DOH), when installing covered conductor, vibration dampers must also be installed.¹ Energy Safety staff found that no vibration dampers were installed at multiple structures where covered conductor was installed. The structures missing vibration dampers where covered conductor was installed are identified in Table 2 above. On November 19, 2021, SCE submitted a memo to Energy Safety titled, "Interim Deviation from Standards on Vibration Damper for Covered Conductor"² (hereafter, "Memo"). This Memo was dated August 18, 2021, and indicates that due to supply chain issues, SCE will suspend the installation of vibration dampers until December 31, 2021. In accordance with SCE's Q2 QDR submission, the covered conductor installations inspected by Energy Safety were completed prior to the issuance of the Memo. Also, SCE informed Energy Safety of this supply chain issue only after inspections commenced. Consequently, Energy Safety finds that SCE is still in violation of its protocols requiring the installation of vibration dampers as part of covered conductor installations.

Item3IA1mg1: No vibration dampers on span (see red arrow)

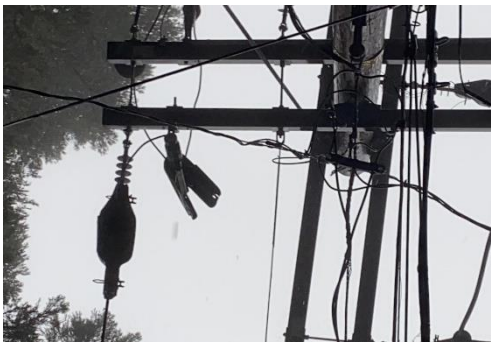
6. Violation 6: Per SCE’s Distribution Overhead Construction Standards (DOH), Section CC 150.4, “All overhead equipment shall utilize appropriate wildlife covers.”² Pole numbered 4931111E had a wildlife fuse cover improperly installed. Energy Safety considers this violation for failure of adhering to protocol to be in the Minor risk category.

Regarding wildlife fuse covers, per TE connectivity BCAC-G-CUTOOUT (referred to by SCE as SAP10184097) product installation instructions, to install SCE SAP 10184097, "position the keyway slot on the bottom of the cover between the 1st and 2nd insulator skirts."⁶ Energy Safety found one instance where wildlife fuse cover SAP 10184097, was not installed between the first and second insulator skirts. This structure is noted in Table 2.

Item3IA2Img1: Fuse cover does not sit between first and second insulator skirt

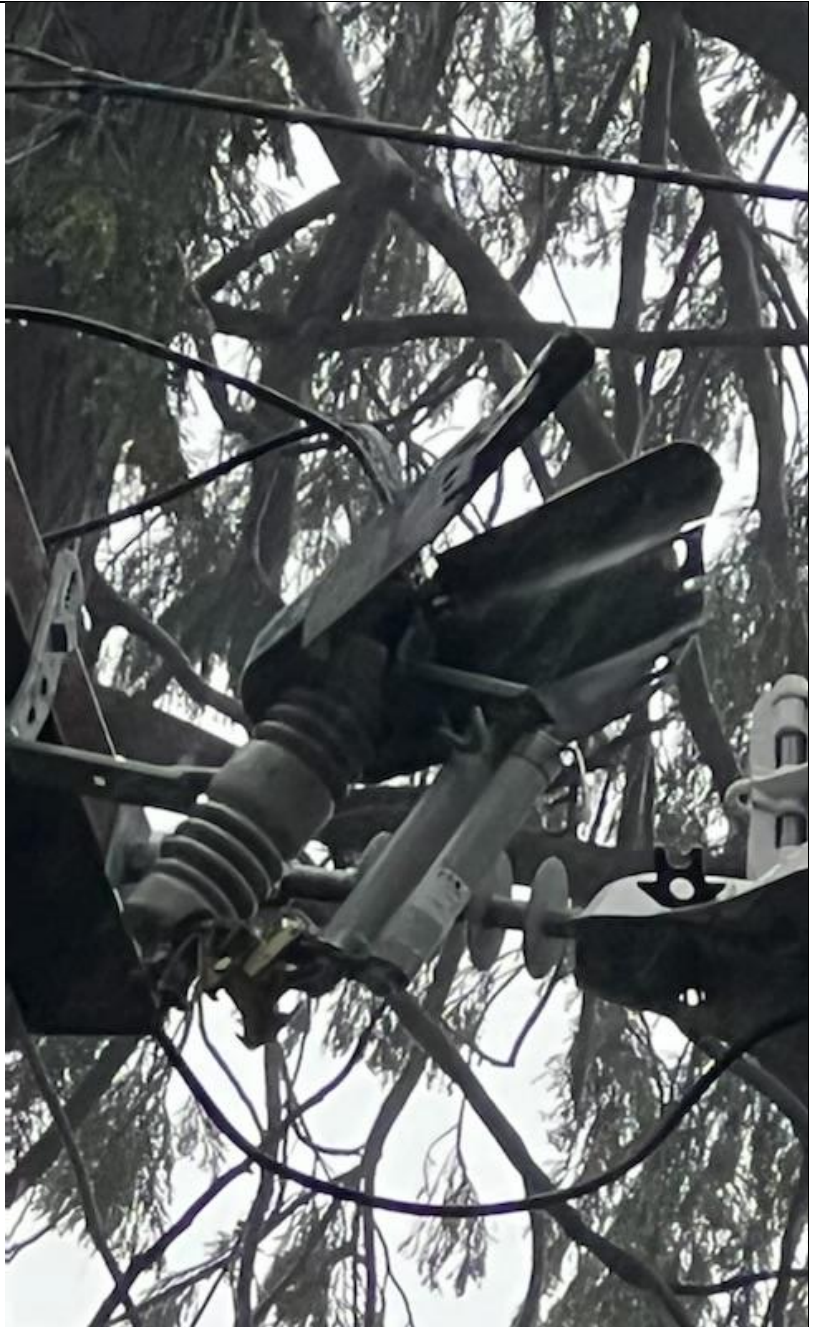
Item3IA2Img2: Close up of fuse cover from previous image

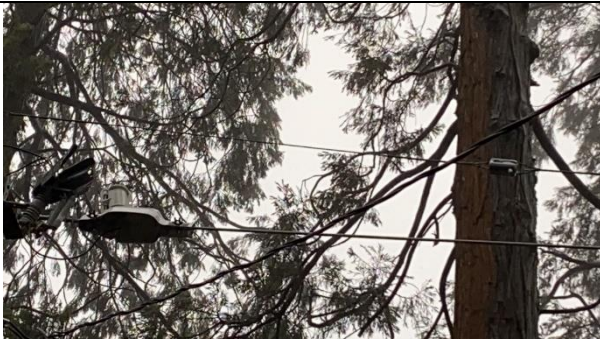
3. Violation 3: Per SCE’s Distribution Overhead Construction Standards (DOH), section PO 300, page 3 of 9, and Distribution Design Standards (DDS), section DDS-10, page 10-26, installation of a fiberglass guy strain insulator is required for distribution guying applications and repairs in high fire risk areas (HFRA) and shall be installed in conjunction with covered conductor installation.¹ Poles numbered 4931111E, F16868Y, and 549418E had covered conductor installed but failed to install fiberglass guy strain insulators, in accordance with SCE protocol. Energy Safety considers this a violation for failure of adhering to protocol to be in the Minor risk category.

During the inspection, Energy Safety found several instances where fiberglass guy wire strain insulators were not installed where covered conductor work was completed, per SCE's protocols. Structures where this protocol was not followed are noted in Table 2 above.

Item3IA3Img1: Porcelain type guy span insulator

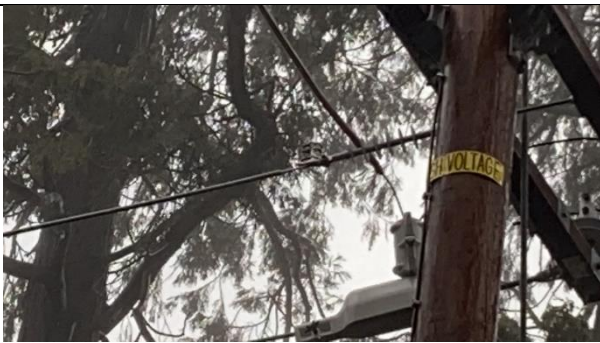
5. Violation 5: Per SCE’s Distribution Overhead Construction Standards (DOH), “If conductor is exposed, install bolted wedge connector cover.” Pole numbered 4931111E did not have bolted wedge connector cover installed on the center phase. Energy Safety considers this a violation for failure of adhering to protocol and in the Minor risk category.

In accordance with SCE's protocols for covered conductor installation, DOH CC 180, "If conductor is exposed, install bolted wedge connector cover." During the inspection, Energy Safety found one instance where a bolted wedge connector cover was not installed on exposed conductor where covered conductor work was completed, per SCE's protocols. Structures where this protocol was not followed are noted in Table 2 above.

Item3IA4Img1: Bare dead-end conductor with no cover

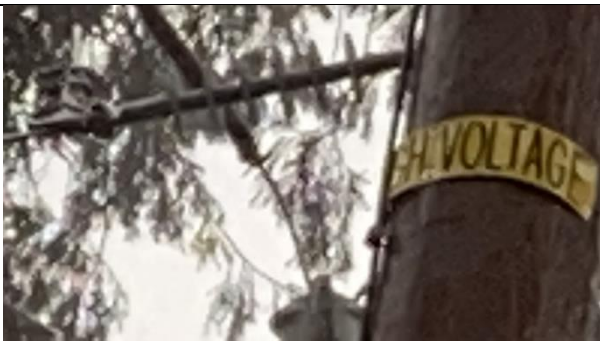
7. Violation 7: Per SCE’s Distribution Overhead Construction Standards (DOH), section CC 150, jumpers that are connected to covered conductor must be covered. Energy Safety found that pole numbered 4931111E had a jumper connected to covered conductor that was bare before entering a bolted wedge connector cover. Energy Safety considers this violation for failure of adhering to protocol to be in the Minor risk category.

Per SCE's Distribution Overhead Construction Standards (DOH), section CC 150, jumpers that are connected to covered conductor shall be covered. Energy Safety found one instance where a jumper connected to covered conductor was bare before entering a bolted wedge connector cover. These structures are noted in Table 2.

Item3IA5Img1: Bare jumper going into bolted wedge connector cover

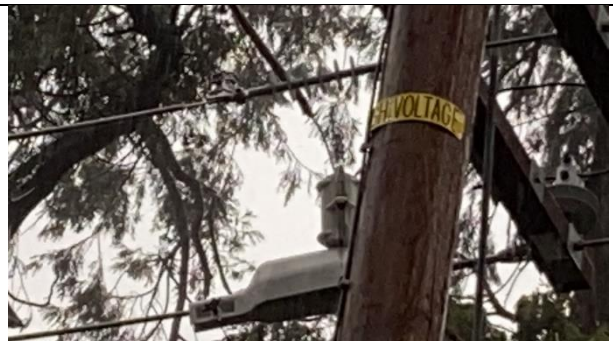
Item3IA5Img2: Overall photo bare jumper going into bolted wedge connector cover

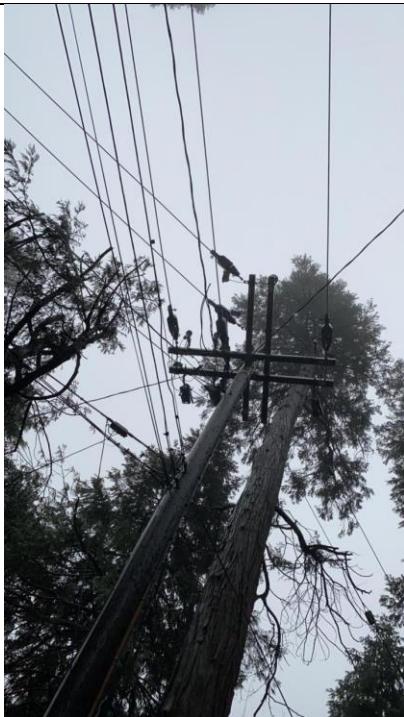
Item4IA1Img1: No vibration dampers

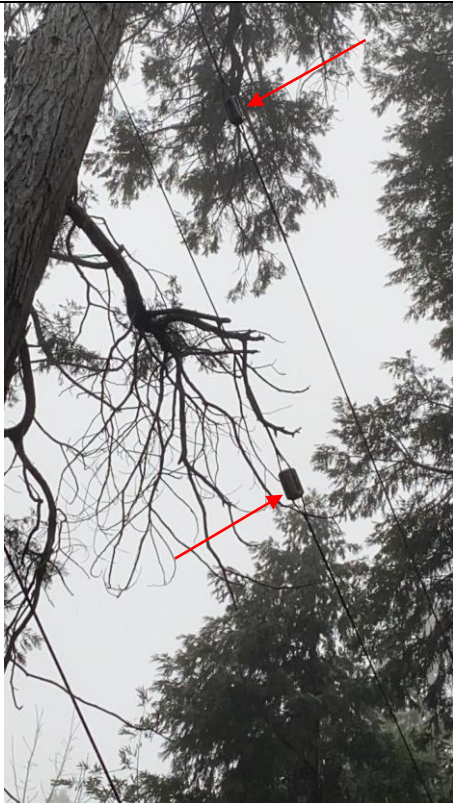
Item4IA2Img1: Porcelain insulator on down guy wire

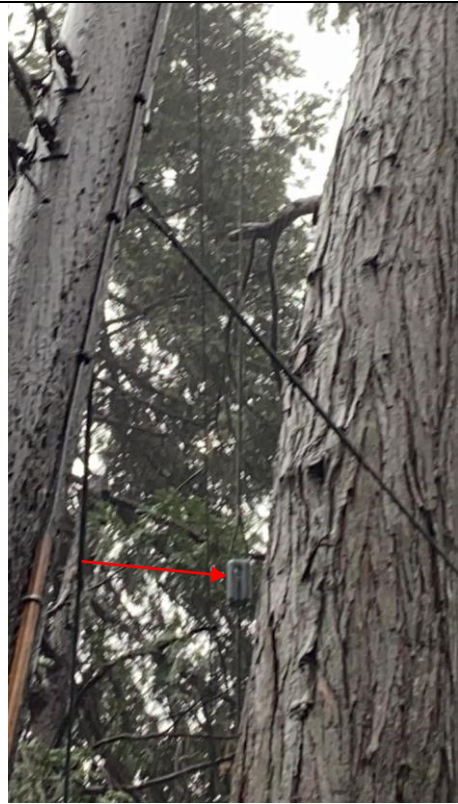
Item4IA2Img2: Third porcelain type down guy insulator

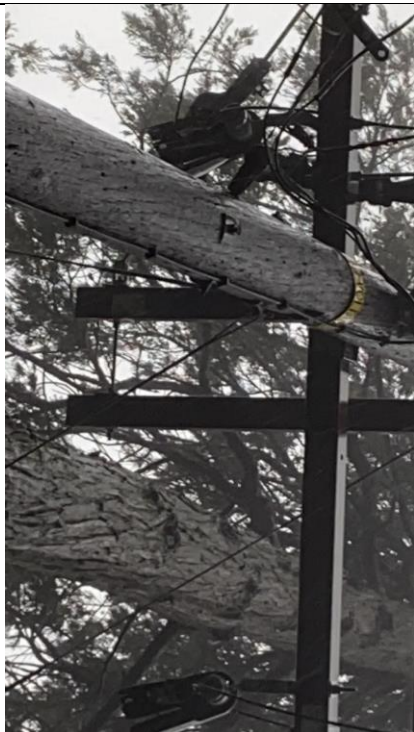
9. Violation 9: Per SCE’s 2021-Q1 quarterly data report (QDR), covered conductor was not installed at pole numbered F16868Y. Structures adjacent were reported under the covered conductor initiative (2021 WMP initiative number 7.3.3.3.1) with a status of “complete.” However, upon inspection, it was found that covered conductor was installed at this pole. Energy Safety considers this data accuracy violation to be in the Minor risk category.

| Item4IA3Img1: View of pole crossarm with covered conductor | |

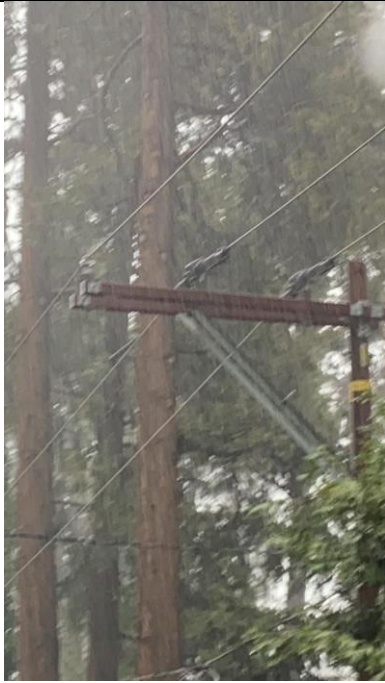
Item5IA1Img1: No vibration dampers

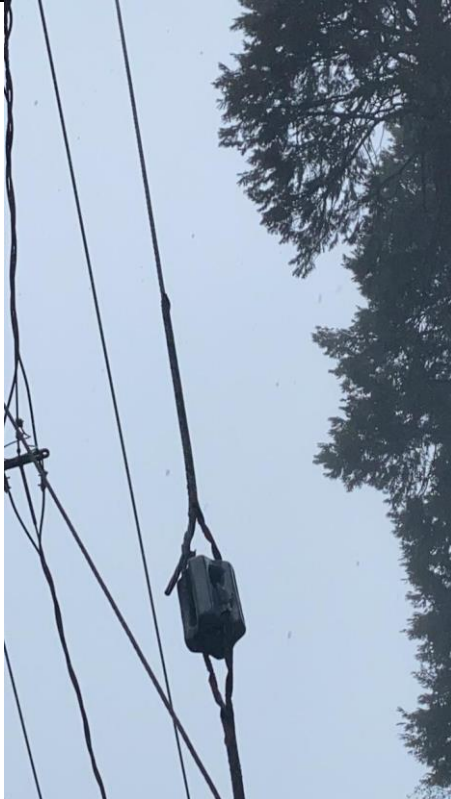
Item5IA2Img1: Porcelain down guy insulator

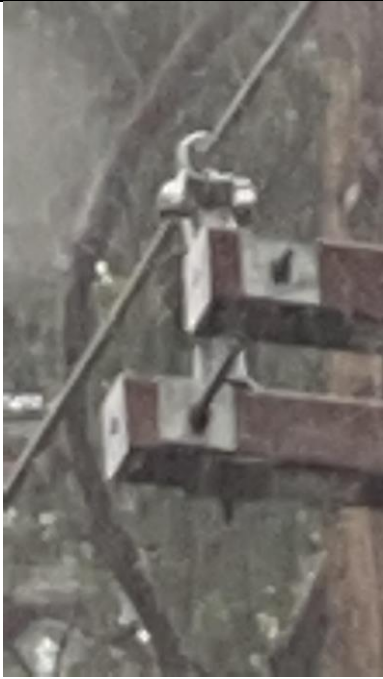
8. Violation 8: Per SCE’s Distribution Overhead Construction Standards (DOH), section GR 200.5, “Vice-top insulators with nylon inserts shall only be used in covered conductor systems.”³ Poles numbered 549418E and 4421488E did not have vice-top insulators with

Per SCE's Distribution Overhead Construction Standards (DOH), section GR 200.5, "Vice-top insulators with nylon inserts shall only be used in covered conductor systems." Energy Safety found multiple instances where a covered conductor was not supported by the aforementioned type of insulator. Structures where this protocol was not followed are noted in Table 2 above.

Item5IA3Img1: Close up view of insulator. Should be vice top polymer pin type insulators.

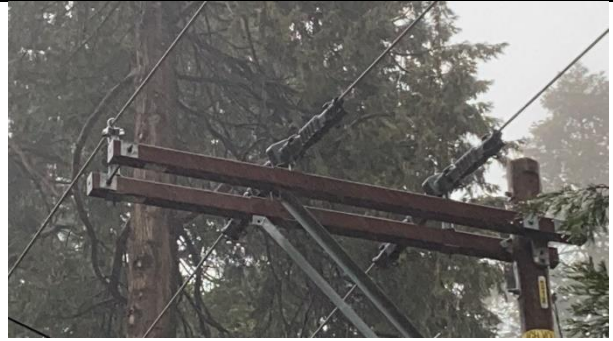
Item5IA3Img2: Overall view of insulators with wildlife covers

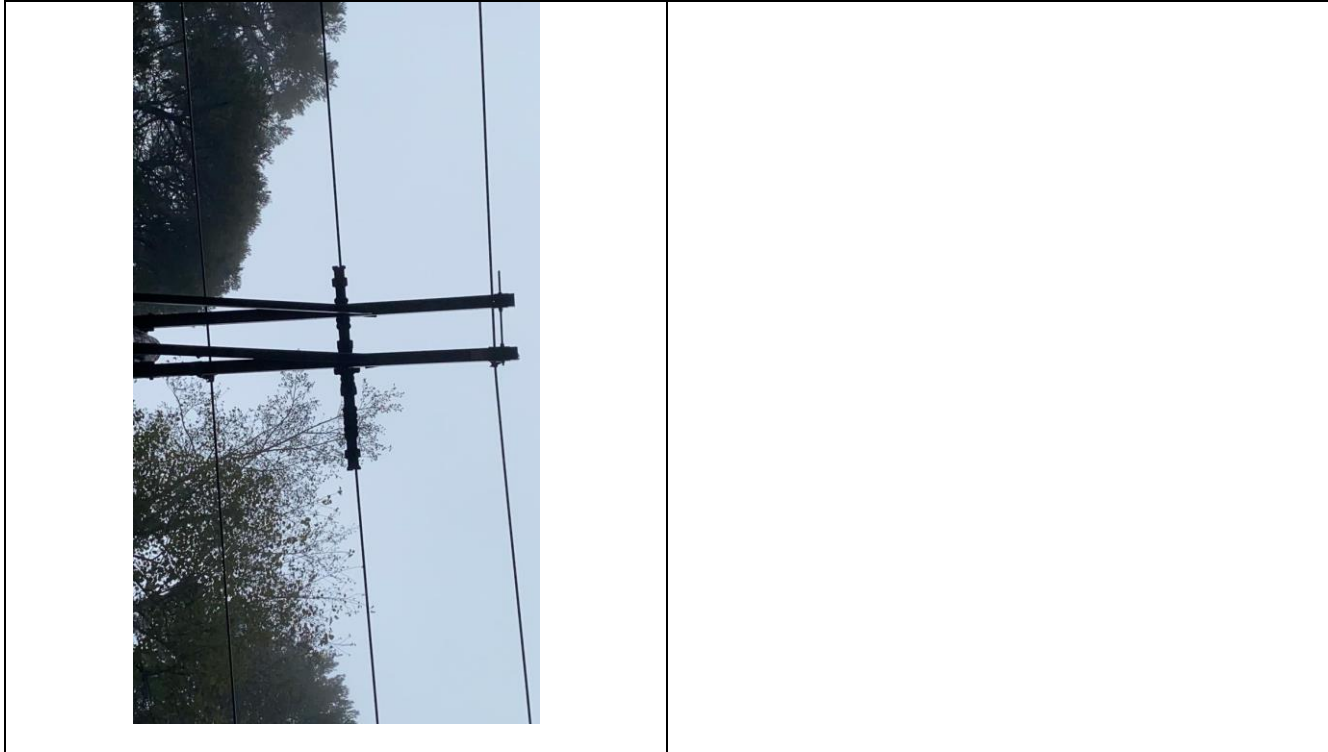
| Item6IA1Img1: No vibration dampers | |

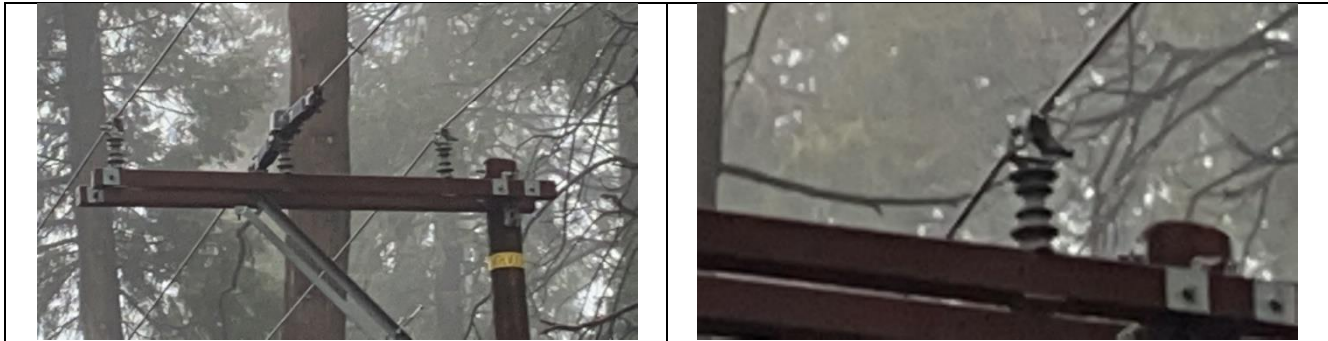
| Item6IA2Img1: Overall view of insulators with cover. Insulators should be vice top polymer pin type insulators with nylon inserts | Item6IA2Img2: Close up of insulator from previous image |

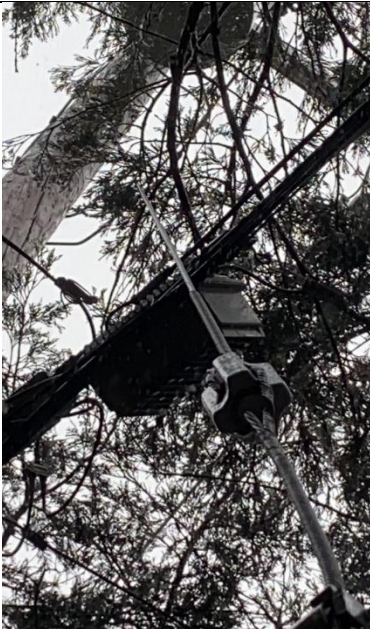
In addition to the violations discovered during WMP inspections of SCE's covered conductor installations, Energy Safety discovered vegetation contacting guy wire above the insulator. Guy wires are metallic and can become energized in some circumstances. Insulators break the current path and prevent electricity from reaching the ground where a down guy wire is anchored. However, the portion above the insulator may remain energized until the circuit is deenergized and may cause an ignition if energized while in contact with vegetation. Accordingly, Energy Safety considers vegetation in contact with down guy wires above the insulator a condition that increases an electrical corporation's ignition risk. A structure where vegetation was in contact with the guy wire above the insulator is noted in Table 3.

Item7GW21mg1: Vegetation touching guy wire above insulator

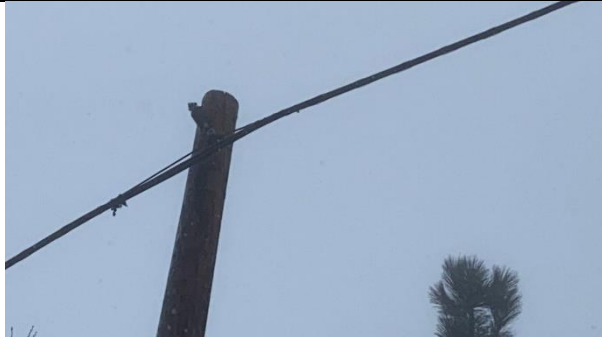
Item9IA1Img1: Close up no covered conductor

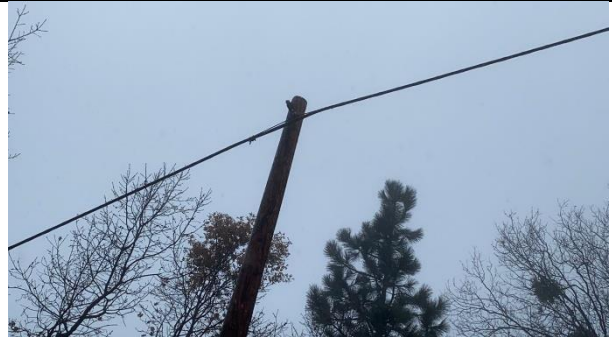
Item9IA1Img2: Zoomed out view of top of pole with no covered conductor

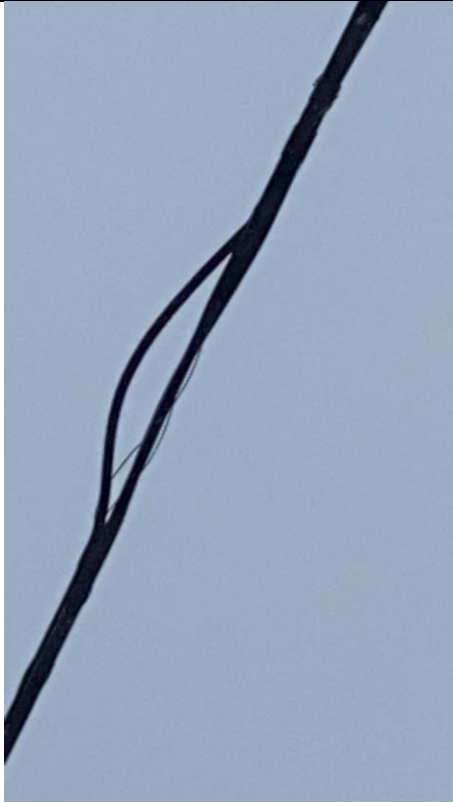
Energy Safety discovered multiple conductors that had broken and frayed strands. Energy Safety considers the presence of broken or frayed conductor strands a condition that increases the electrical corporation's ignition risk because the broken strands can weaken the conductor. The weakening of

conductors can result in heightened risk of conductor failure or of arcing that could result in an ignition. Structures where broken conductor strands were observed are identified in Table 3.

Item9CD4Img1: Broken support strand

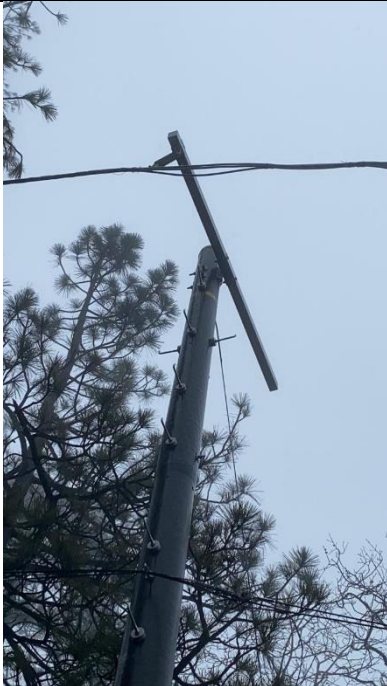
Item10IA1Img1: No covered conductor installed

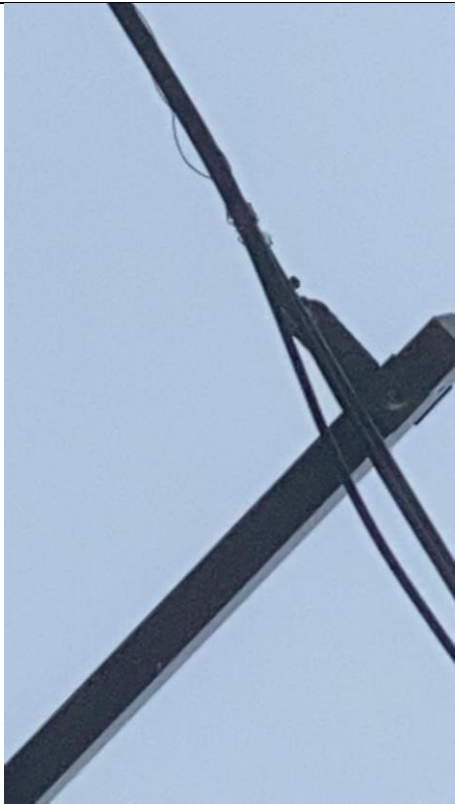
Item10CD4Img1: Fraying conductor

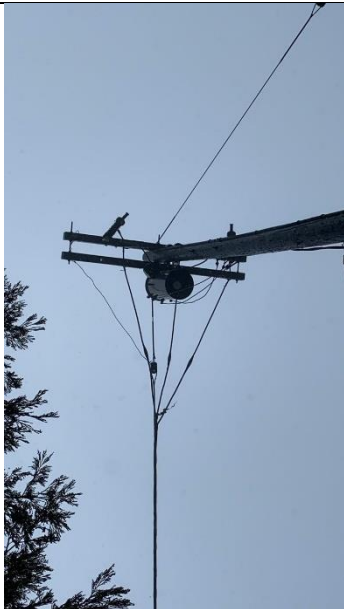
Item11IA1img1: No covered conductor installed
