NOTICE OF DEFECT

Energy Safety Inspection Report

Report Name: SCE_ ATJ_20211115-01

Date(s): November 15, 2021

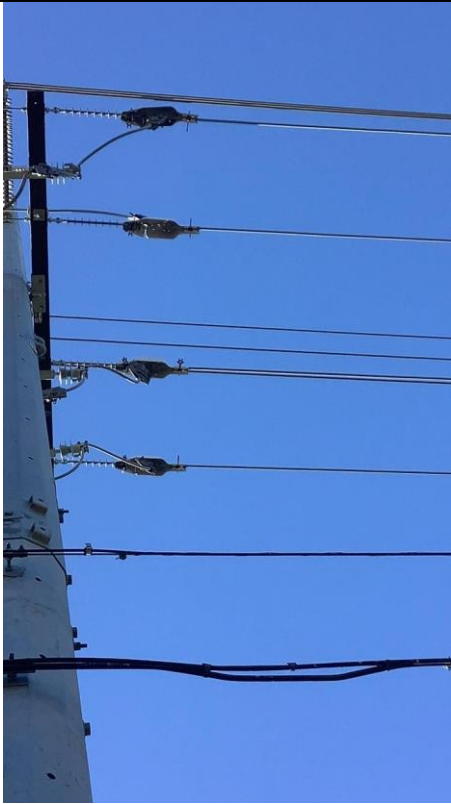
Per SCE's Distribution Design Standards (DDS) and Distribution Overhead Construction Standards (DOH), when installing covered conductor, vibration dampers must also be installed.¹ Energy Safety staff found that vibration dampers were not installed at multiple structures where covered conductor was completed. The structures missing vibration dampers where covered conductor was installed are identified in Table 2 above. On November 19, 2021, SCE submitted a memo to Energy Safety titled, "Interim Deviation from Standards on Vibration Damper for Covered Conductor"² (hereafter, "Memo"). This Memo was dated August 18, 2021, and indicates that due to supply chain issues, SCE will suspend the installation of vibration dampers until December 31, 2021. In accordance with SCE's Q2 QDR submission, the covered conductor installations inspected by Energy Safety were completed prior to the issuance of the Memo. Also, SCE informed Energy Safety of this supply chain issue only after inspections commenced. Consequently, Energy Safety finds that SCE is still in violation of its protocols requiring the installation of vibration dampers as part of covered conductor installations.

Item1IA1img1: At dead end, no vibration dampeners installed

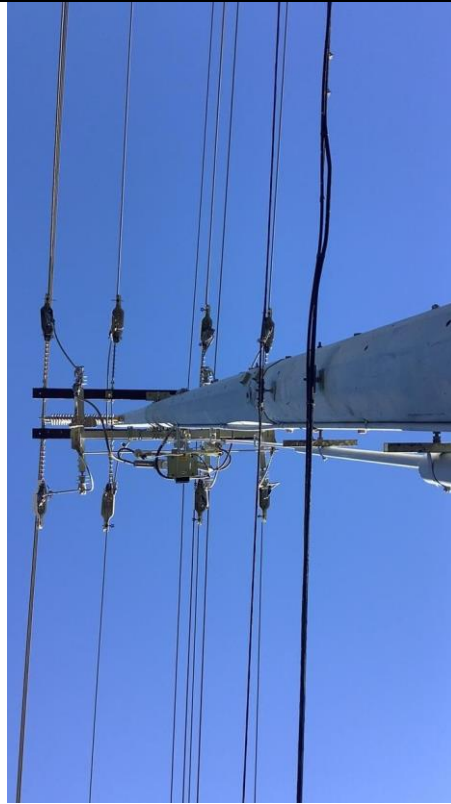
Item1IA1img2: Showing where covered conductor ends and bare conductor begins

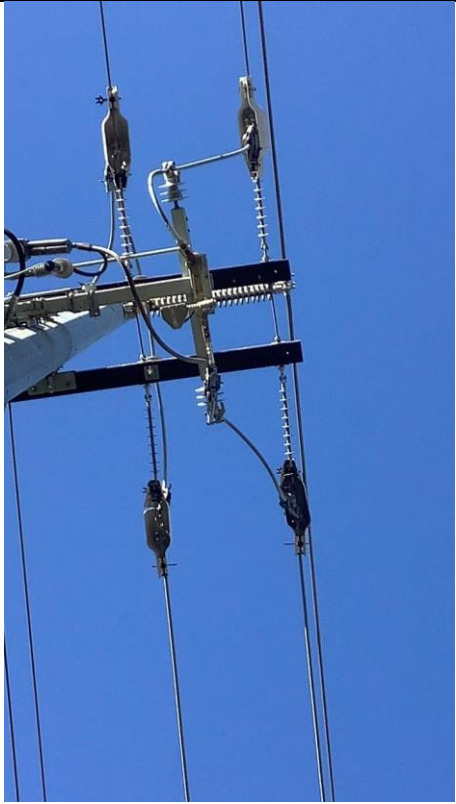
Item1IA1mg3: Close up of one phase showing no vibration dampers

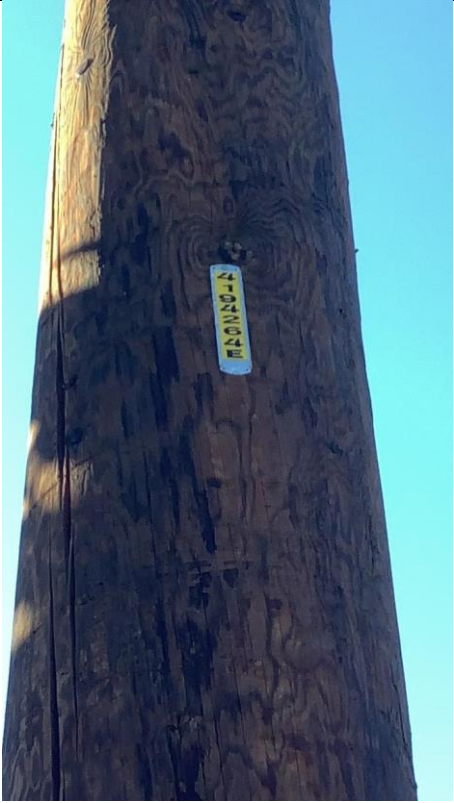
<p>Item2IA1Img1: Vibration dampers not installed</p>

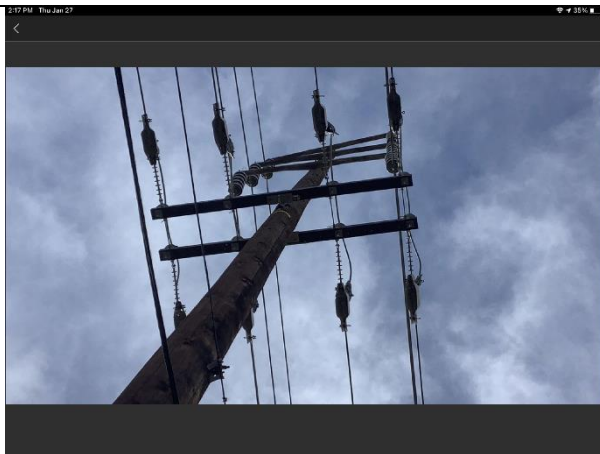
Item3IA1img1: Vibration dampers not installed

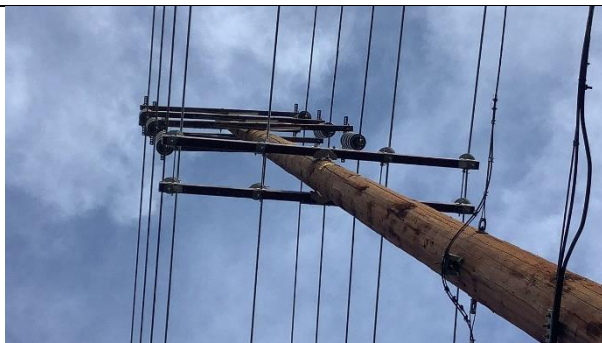
Item4IA1img1: Vibration dampers not installed

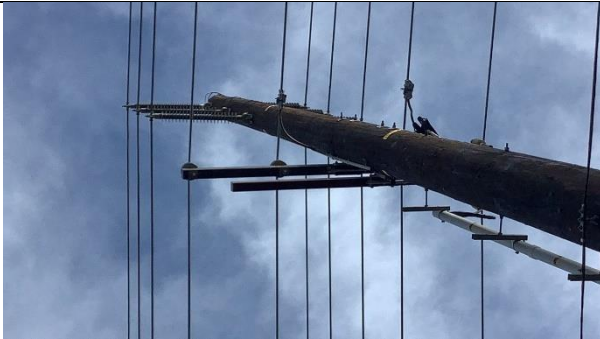
Item5IA1Img1: Vibration dampers not installed

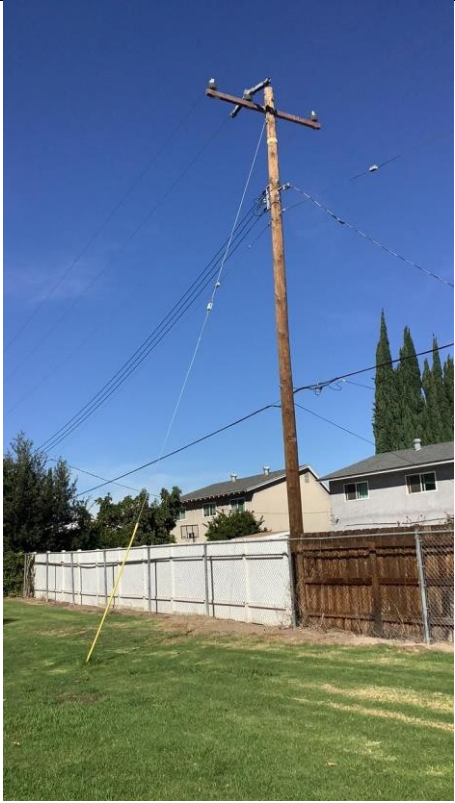
1. Defect 1: Poles numbered 1473787E and 1473789E had loose guy wires. The primary purpose of a guy wire is to provide stability to a structure (e.g., a pole) where imbalanced loads are present. To provide this stability a guy wire must be maintained taut. A loose guy wire increases the risk of structure failure and potential ignition under adverse weather conditions, as the guy wire can no longer serve its intended purpose of balancing an imbalanced load. Energy Safety considers this defect to be in the Minor risk category.

In addition to the violations discovered during WMP inspections of SCE's covered conductor installations, Energy Safety discovered two structures that had loose guy wires. Energy Safety considers loose guy wires as a condition that increases an electrical corporation's ignition risk because the primary purpose of a guy wire is to provide stability to a structure (e.g. a pole) where imbalanced loads are present. If a guy wire is loose and not maintained taut, it cannot serve its intended purpose of balancing load and adding stability, thus increasing the risk of structure failure and potential ignition under adverse weather conditions. Structures where loose guy wires were observed are identified in Table 3.

Item6GW1Img1: Overall view of loose guy wire

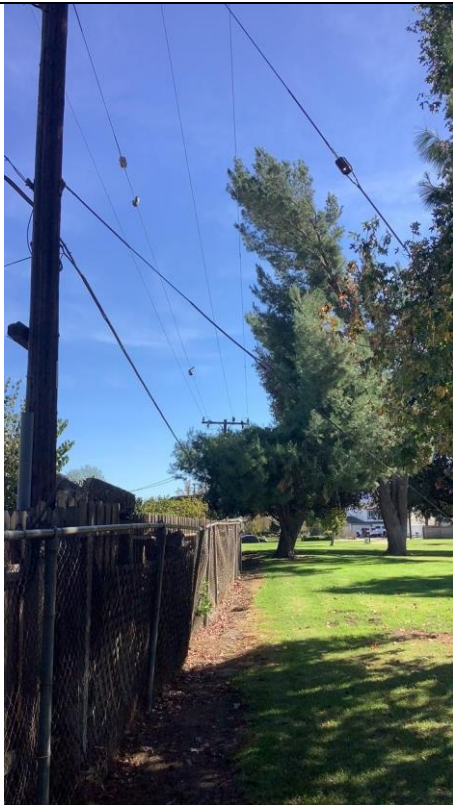
3. Defect 3: Pole numbered 1473789E had three or more splices in a single-phase conductor. Energy Safety considers the presence of three or more splices along a single phase of conductor to be excessive and require assessment for potential corrective action. Splices are used to connect two strands of conductor. Excessive splicing is indicative of potential issues with electrical loading, physical weakening of the line, or a pattern of repeated failures. Therefore, a span with an excessive number of splices is an indicator of increased the risk of conductor failure and potential ignition. Energy Safety considers this defect to be in the Minor risk category.

Energy Safety discovered a conductor that had an excessive number of splices along a single phase of overhead conductor. Energy Safety considers the presence of three or more splices along a single phase of conductor to be excessive. This excessive splicing is indicative of potential issues with electrical loading, physical weakening of the line, or a pattern of repeated failures. The weakening of conductors can result in increased risk of conductor failure or arcing that could result in an ignition. Repeated failures and splicing of a particular phase conductor highlights that the span in question is subject to risk drivers that cause line failures and increase the risk of causing a potential wildfire ignition. The structure where excessive splicing was observed is identified in Table 3.

Item7CD4Img1: Overall view of pole looking East containing three splices

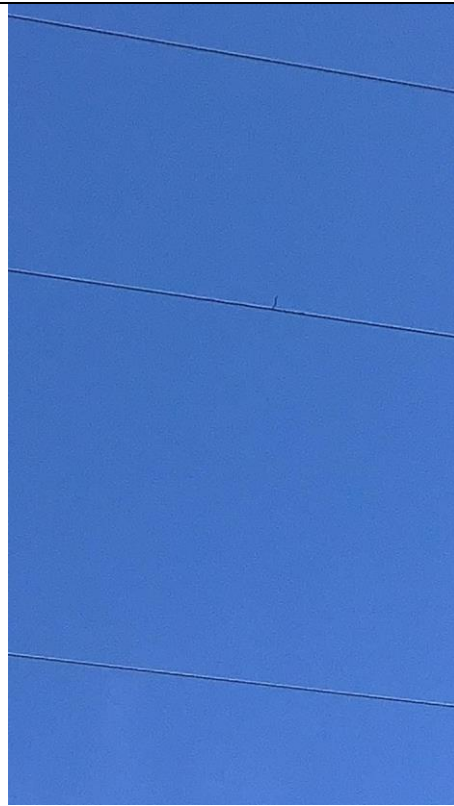
2. Defect 2: Pole numbered 1473789E had a frayed conductor strand. Broken strands weaken the tensile strength of a conductor. Therefore, a conductor with frayed strands can increase the risk of conductor failure and ignition. Energy Safety considers this defect to be in the Minor risk category.

Energy Safety also discovered a conductor that had a broken strand. Energy Safety considers the presence of broken or frayed conductor strands a condition that increases the electrical corporation's ignition risk because the broken strands can weaken the conductor. The weakening of conductors can result in increased risk of conductor failure or arcing that could result in an ignition. The structure where the broken conductor strand was observed is identified in Table 3.

Item7CD4Img2: Close up of frayed conductor

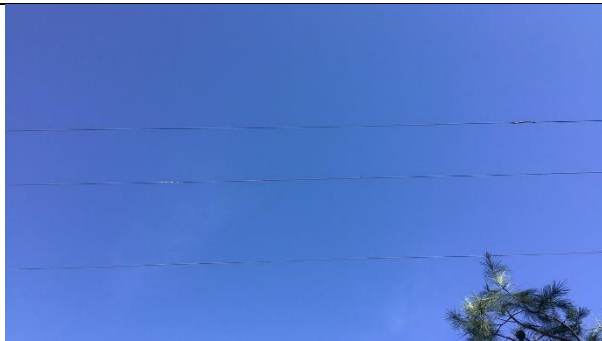
Item7CD4Img3: Two splices and frayed wire

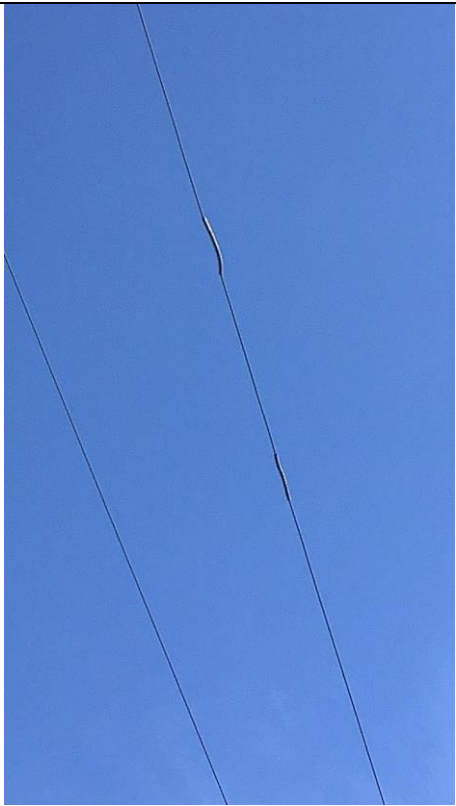
Item7CD9Img1: Two splices on one phase

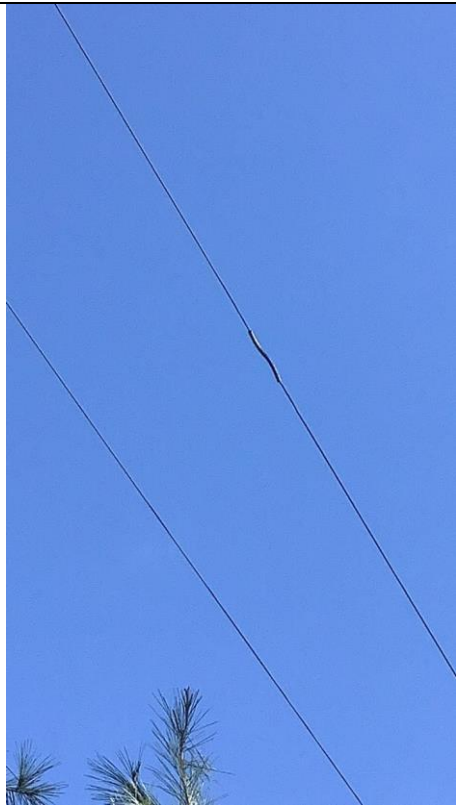
Item7CD9Img2: Third splice on same phase

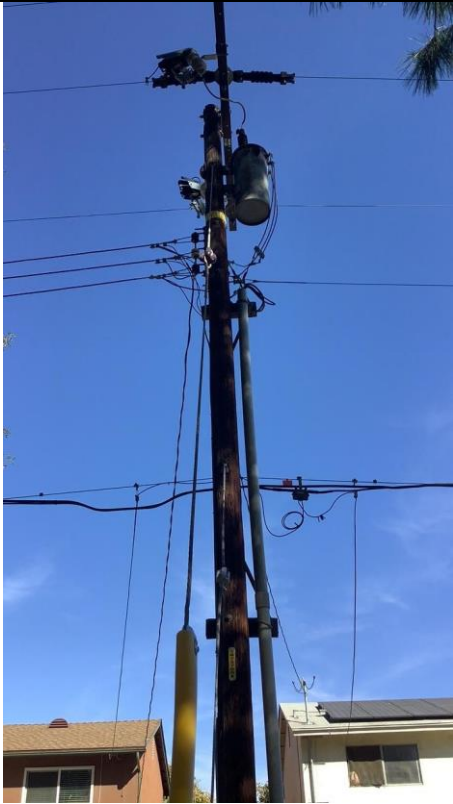
Item7GW1Img1: Loose guy wire

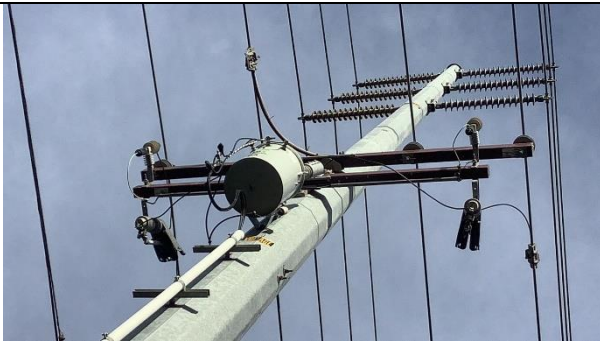
Item8IA1Img1: No vibration dampers installed

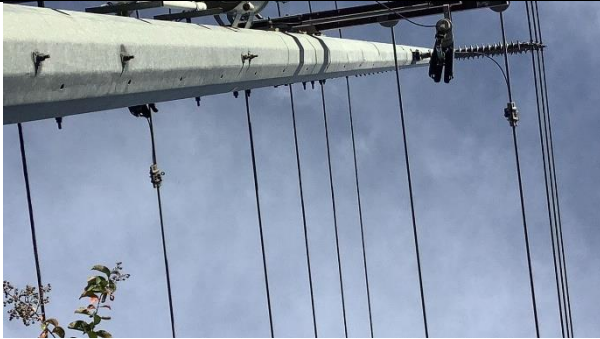
Item8IA1Img3: No vibration dampers installed

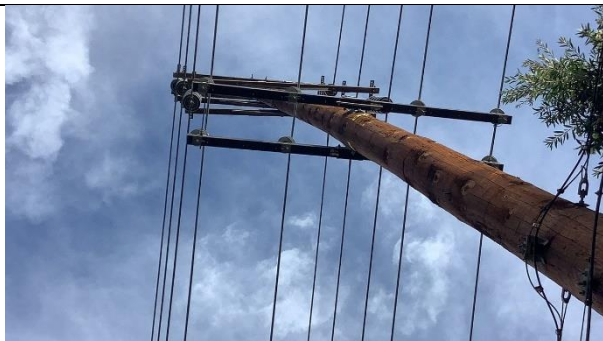
Item9IA1Img1: Vibration dampers not installed
