## **NOTICE OF VIOLATION**

# Energy Safety Inspection Report

Report Name: SCE\_ ATJ\_20211118-01  
Inspection Date(s): November 18, 2021  
Inspector: Anthony Trujillo  
Utility: Southern California Edison  
Attention: Erik Takayesu, Vice President Asset Strategy and Planning

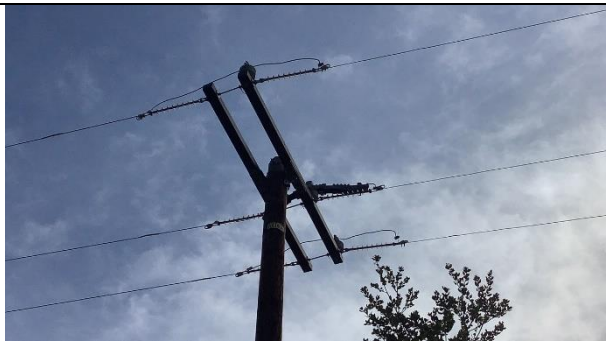
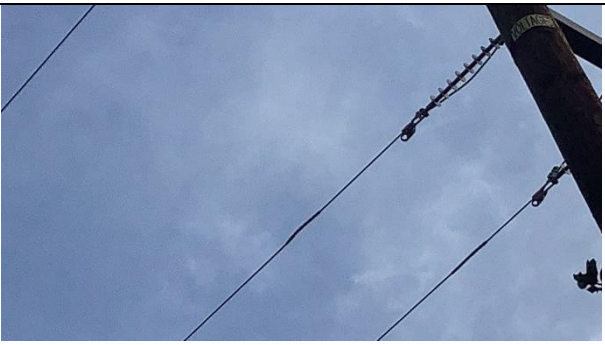
Structure ID: 4339409E

1. Violation 1: Per SCE’s 2021-Q1 quarterly data report (QDR), covered conductor was installed on poles numbered 4339409E, 4574184E, 4538061E, 4926384E, and 4263188E. All these structures reported a covered conductor initiative (2021 WMP initiative number 7.3.3.3.1) with a status of “Complete.” However, upon inspection, SCE has not even begun covered conductor installation at any of these locations. Energy Safety considers this data accuracy violation to be in the Moderate risk category.

2. Violation 2: Per SCE’s 2021-Q1 QDR, covered conductor was installed on poles numbered 4339409E, 4574184E, 4538061E, 4926384E, and 4263188E. Upon inspection, Energy Safety staff found no covered conductor installed at the above-mentioned structures. Given SCE’s focus on covered conductor as one of its flagship wildfire mitigation programs and the scope of this mitigation program, Energy Safety is greatly concerned about how

<p><b>Item1IA1Img1:</b> No covered conductor</p>	<p><b>Item1IA1Img2:</b> Close up of bare wire</p>

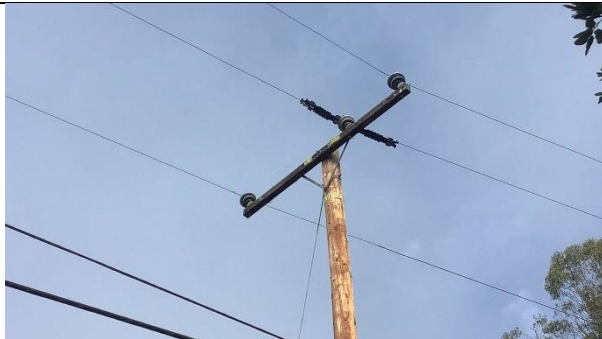
Item2IA1Img1: Bare wire

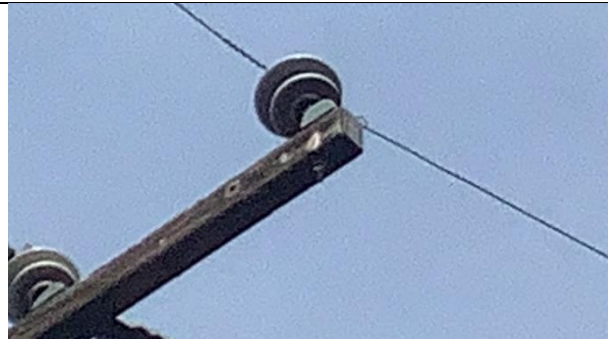
Item2IA1Img2: Bare wire closeup

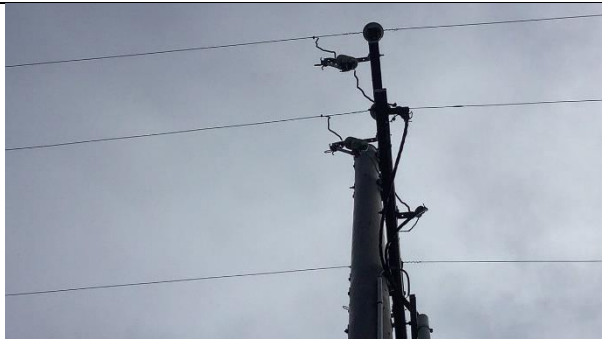
Item3IA1Img1: Bare wire

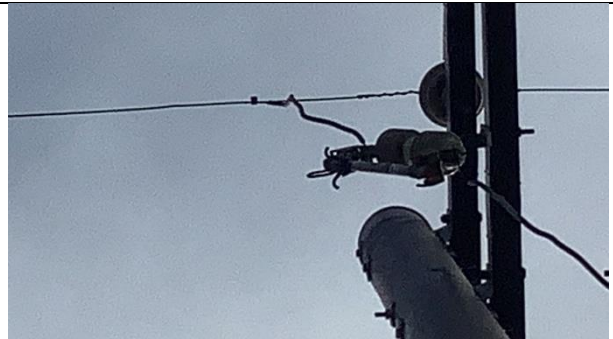
Item3IA1Img2: Close up of bare wire

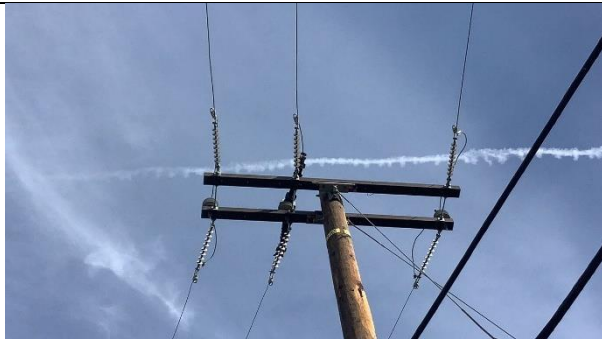
Item4IA1Img1: Bare wire

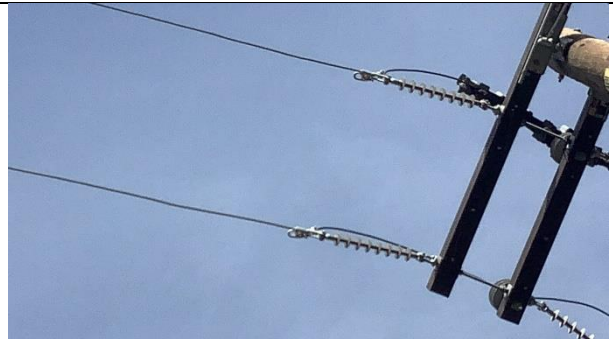
Item4IA1Img2: Close up of bare wire

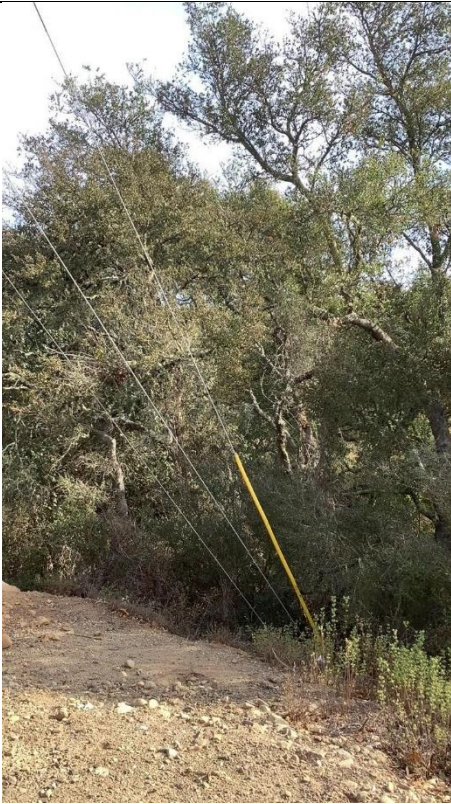
In addition to the violations discovered during WMP inspections of SCE's covered conductor installations, Energy Safety discovered two structures that had loose guy wires. Energy Safety considers loose guy wires as a condition that increases an electrical corporation's ignition risk because the primary purpose of a guy wire is to provide stability to a structure (e.g. a pole) where imbalanced loads are present. If a guy wire is loose and not maintained taut, it cannot serve its intended purpose of balancing load and adding stability, thus increasing the risk of structure failure and potential ignition under adverse weather conditions. Structures where loose guy wires were observed are identified in Table 3.

**Item4GW1Img1:** Loose guy wire

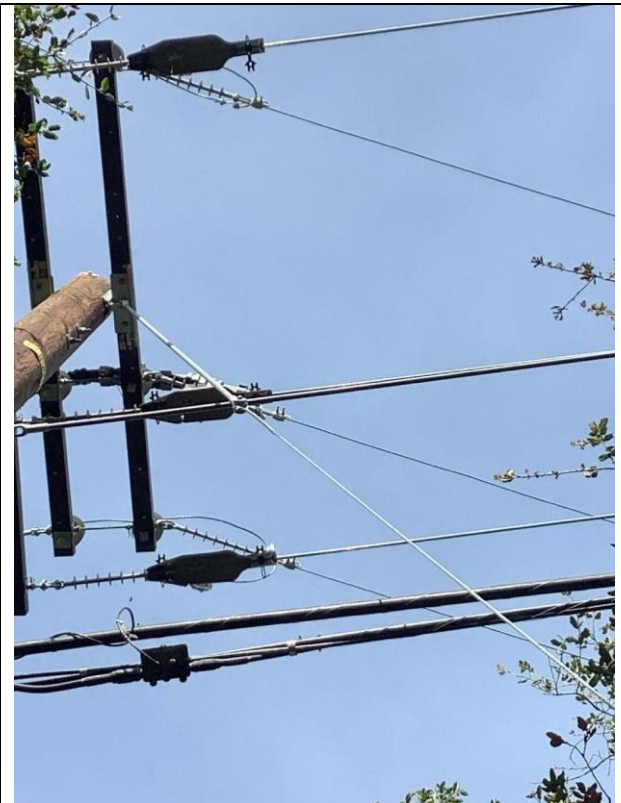
**Item5IA1mg1:** Bare wire

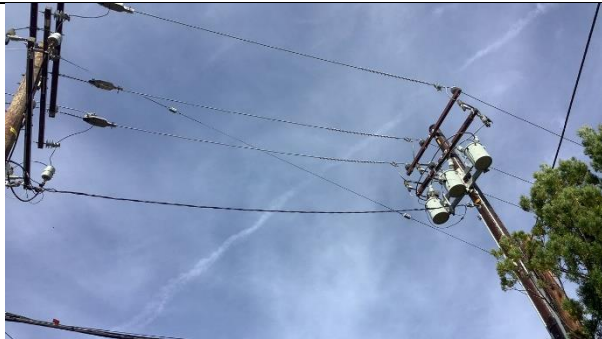
3. Violation 3: Per SCE’s Distribution Overhead Construction Standards (DOH), section PO 300, page 3 of 9, and Distribution Design Standards (DDS), section DDS-10, page 10-26, installation of a fiberglass guy strain insulator is required for distribution guying applications and repairs in high fire risk areas (HFRAs) and shall be installed in conjunction with covered conductor installation<sup>1</sup>. Poles numbered 1257280E, 4554703E, 4554704E, and 2144970E had covered conductor installed but failed to install fiberglass guy strain insulator, in accordance with SCE protocol. Energy Safety considers this violation for failure of adhering to protocol to be in the Minor risk category.

Item7IA1mg1: Porcelain guy insulator

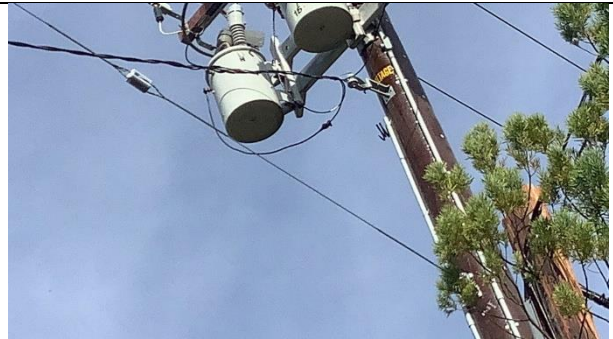
Item7IA1mg2: Porcelain insulator close up

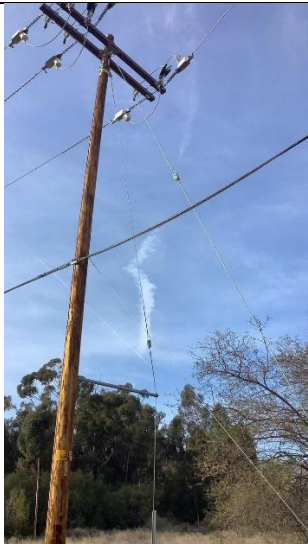
Item8IA1Img1: Porcelain guy insulator

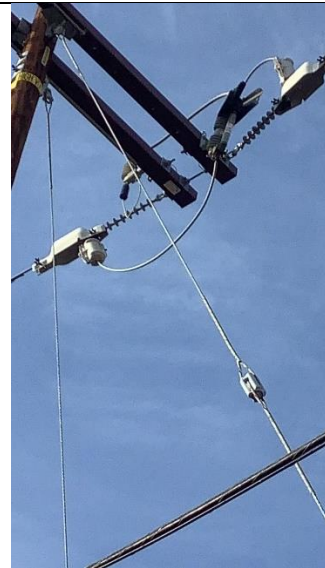
Item8IA1Img2: Porcelain guy close up

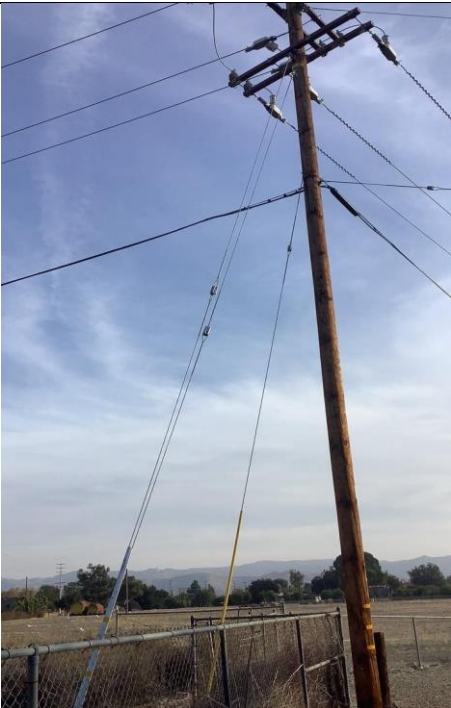
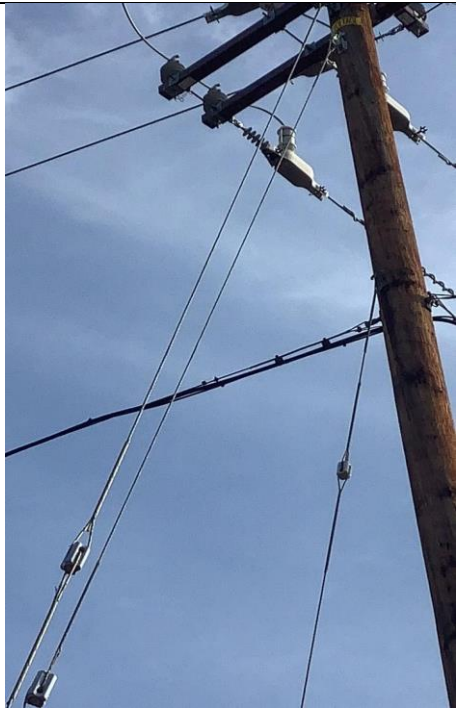
<b>Item9IA1Img1:</b> Overall guy wire	<b>Item9IA1Img2:</b> Close up porcelain insulator

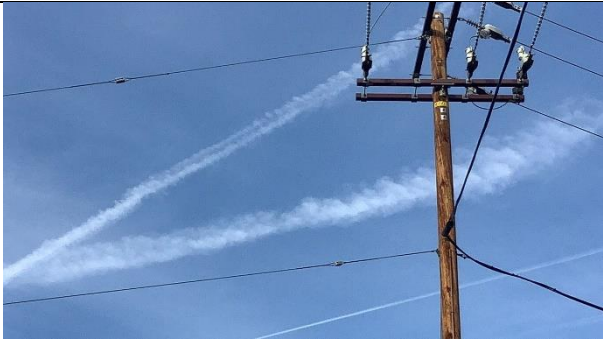
<b>Item9IA1Img3:</b> Porcelain insulator on span guy

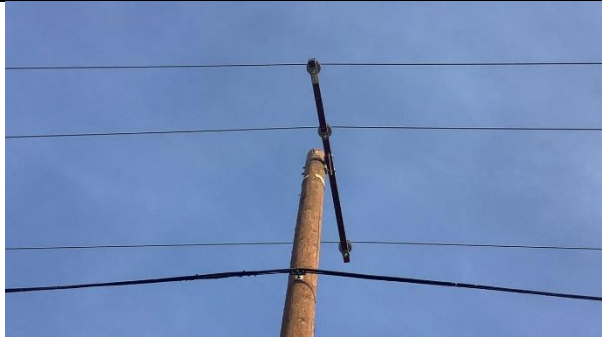
4. Violation 4: Per SCE’s Distribution Design Standards (DDS), section DDS-10, page 10-82, “for the 336 (30/7) ACSR covered conductor, vibration dampers shall be installed on every span in both light loading and heavy loading areas.” Also, SCE’s Distribution Overhead Construction Standards (DOH), section CC 190, page 1 of 11, states that vibration dampers are required when installing covered conductor. Pole number 2144971E had covered conductor installed but failed to install vibration dampers. Energy Safety considers this violation for failure of adhering to protocol to be in the Minor risk category.

Per SCE's DDS and DOH, when installing covered conductor, vibration dampers must also be installed.<sup>4</sup> Energy Safety staff found that no vibration dampers were installed at multiple structures where covered conductor was installed. The structures missing vibration dampers where covered conductor was installed are identified in Table 2 above. On November 19, 2021, SCE submitted a memo to Energy Safety titled, "Interim Deviation from Standards on Vibration Damper for Covered Conductor"<sup>5</sup> (hereafter, "Memo"). This Memo was dated August 18, 2021, and indicates that due to supply chain issues, SCE will suspend the installation of vibration dampers until December 31, 2021. In accordance with SCE's Q2 QDR submission, the covered conductor installations inspected by Energy Safety were completed prior to the issuance of the Memo. Also, SCE informed Energy Safety of this supply chain issue only after inspections commenced. Consequently, Energy Safety finds that

Item10IA1Img1: No vibration dampers installed

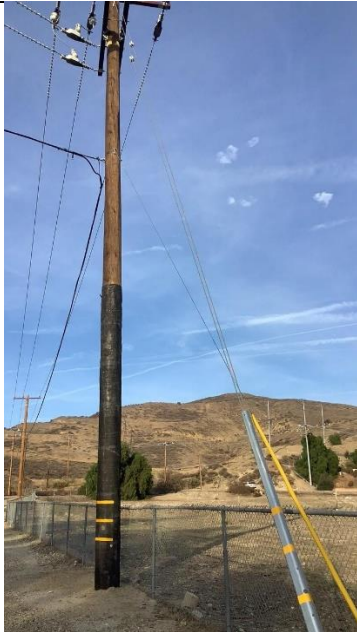
Item11IA1Img1: Overall view of down guy

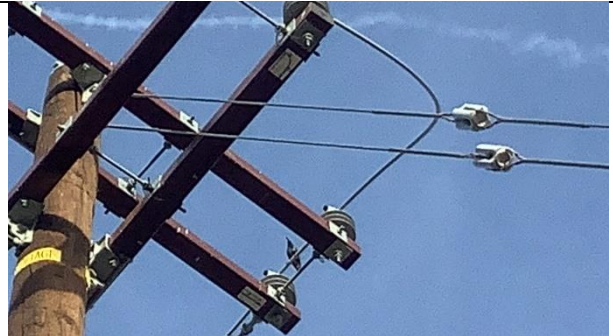
Item11IA1Img2: Close up of porcelain insulator
