NOD_SCE_ATJ_20211118-01

NOTICE OF DEFECT

Energy Safety Inspection Report

Report Name: SCE_ ATJ_20211118-01
Inspection Date(s): November 18, 2021
Inspector: Anthony Trujillo
Utility: Southern California Edison
Attention: Erik Takayesu, Vice President Asset Strategy and Planning

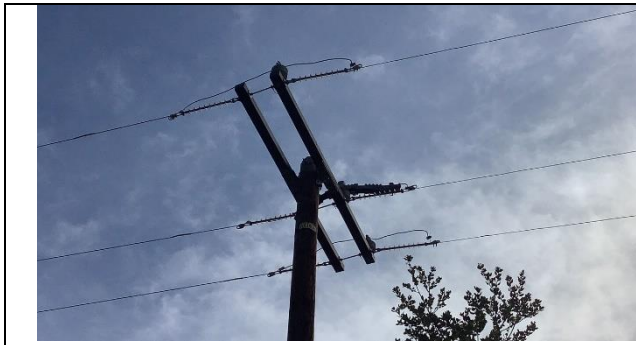
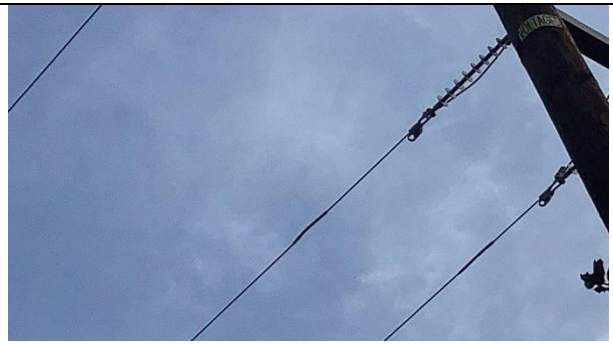
Item	Structure ID	HFTD	Initiative Number	Violation Type	Risk Category	Violation Description
1	4339409E	Tier 3	7.3.3.3.1	Data Accuracy	Moderate	Covered Conductor reported as completed, and has not started
2	4339409E	Tier 3	7.3.3.3.1	Completeness	Moderate	No covered conductor installed
3	4574184E	Tier 3	7.3.3.3.1	Data Accuracy	Moderate	Covered conductor reported as completed, and has not started
4	4574184E	Tier 3	7.3.3.3.1	Completeness	Moderate	No covered conductor installed
5	4538061E	Tier 3	7.3.3.3.1	Data Accuracy	Moderate	Covered Conductor reported as completed, and has not started
6	4538061E	Tier 3	7.3.3.3.1	Completeness	Moderate	No covered conductor installed
7	4926384E	Tier 3	7.3.3.3.1	Data Accuracy	Moderate	Covered Conductor reported as completed, and has not started
8	4926384E	Tier 3	7.3.3.3.1	Completeness	Moderate	No covered conductor installed
9	4263188E	Tier 3	7.3.3.3.1	Data Accuracy	Moderate	Covered Conductor reported as completed, and has not started

Item1IA1Img1: No covered conductor

Item1IA1Img2: Close up of bare wire

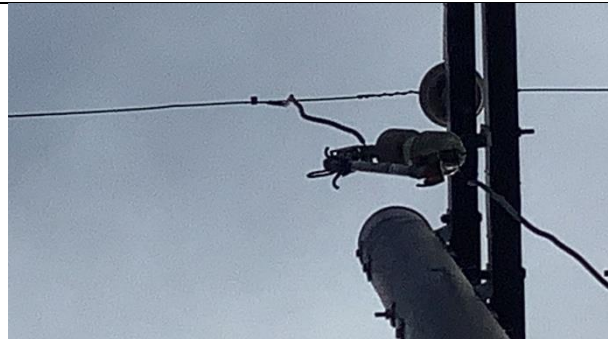
Item3IA1Img1: Bare wire

Item3IA1Img2: Close up of bare wire

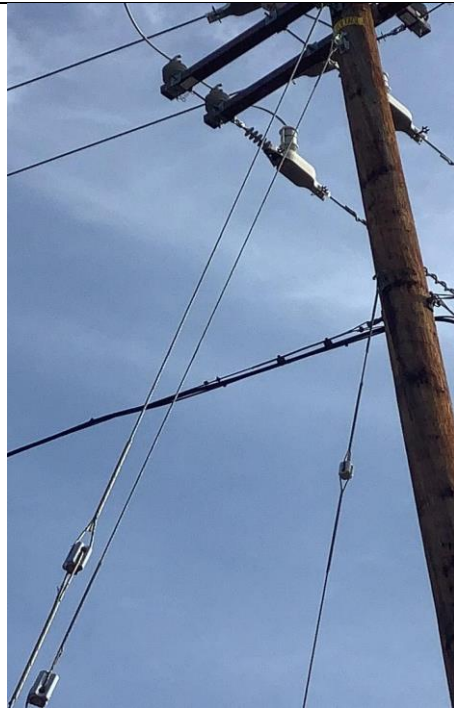
In accordance with SCE's protocols for covered conductor installation, Distribution Overhead Construction Standards (DOH) PO section 300, SCE states, "In HFRA installations of covered conductor it is required to upgrade down guy/span guy insulation to include Fiberglass Guy Strain Insulators."¹ In addition, SCE's Distribution Design Standards (DDS), section DDS-10 indicate that, "Beginning July 2020, SCE has transitioned to a standard requirement in guying to utilize the fiberglass guy strain insulators where traditional porcelain guy strain insulators have been applied."² Further, in response to Energy Safety Data Request (DR-030), SCE stated "In HFRA installations of covered conductor it is required to... upgrade down guy/span guy installation to include Fiberglass Guy Strain Insulators."³ During the inspection, Energy Safety found several instances where fiberglass guy wire strain insulators were not installed where covered conductor work was completed, per SCE's protocols. Structures where this protocol was not followed are noted in Table 2 above.

Item9IA1Img1: Overall guy wire	Item9IA1Img2: Close up porcelain insulator

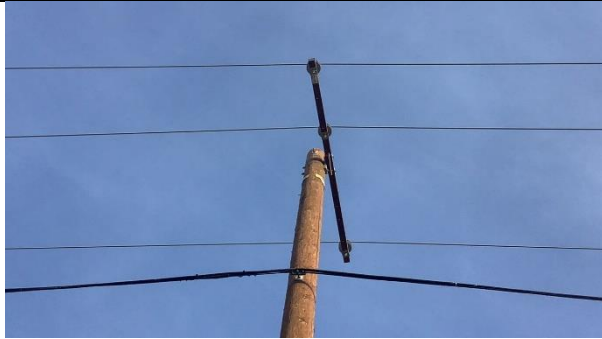
Per SCE's DDS and DOH, when installing covered conductor, vibration dampers must also be installed.⁴ Energy Safety staff found that no vibration dampers were installed at multiple structures where covered conductor was installed. The structures missing vibration dampers where covered conductor was installed are identified in Table 2 above. On November 19, 2021, SCE submitted a memo to Energy Safety titled, "Interim Deviation from Standards on Vibration Damper for Covered Conductor"⁵ (hereafter, "Memo"). This Memo was dated August 18, 2021, and indicates that due to supply chain issues, SCE will suspend the installation of vibration dampers until December 31, 2021. In accordance with SCE's Q2 QDR submission, the covered conductor installations inspected by Energy Safety were completed prior to the issuance of the Memo. Also, SCE informed Energy Safety of this supply chain issue only after inspections commenced. Consequently, Energy Safety finds that

SCE is still in violation of its protocols requiring the installation of vibration dampers as part of covered conductor installations.

Item10IA1img1: No vibration dampers installed

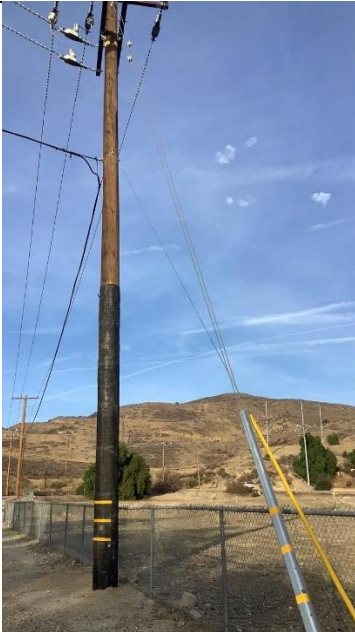
Item11IA1Img1: Overall view of down guy
