**CALIFORNIA UNDERGROUND FACILITIES SAFE EXCAVATION BOARD
INVESTIGATION DIVISION
INCIDENT INVESTIGATION REPORT COVER SHEET**

Case Number: 20SA1040	Report Date: 5/01/2020
Subject Name: PG&E	Notification Date: 4/6/2020

Location of the Incident: Agricultural field bordering 10 1/2 Ave and Nevada Ave, Northwest of Corcoran, CA

Facility Type Damaged: 5" gray PVC conduit with a 440v electrical line running inside

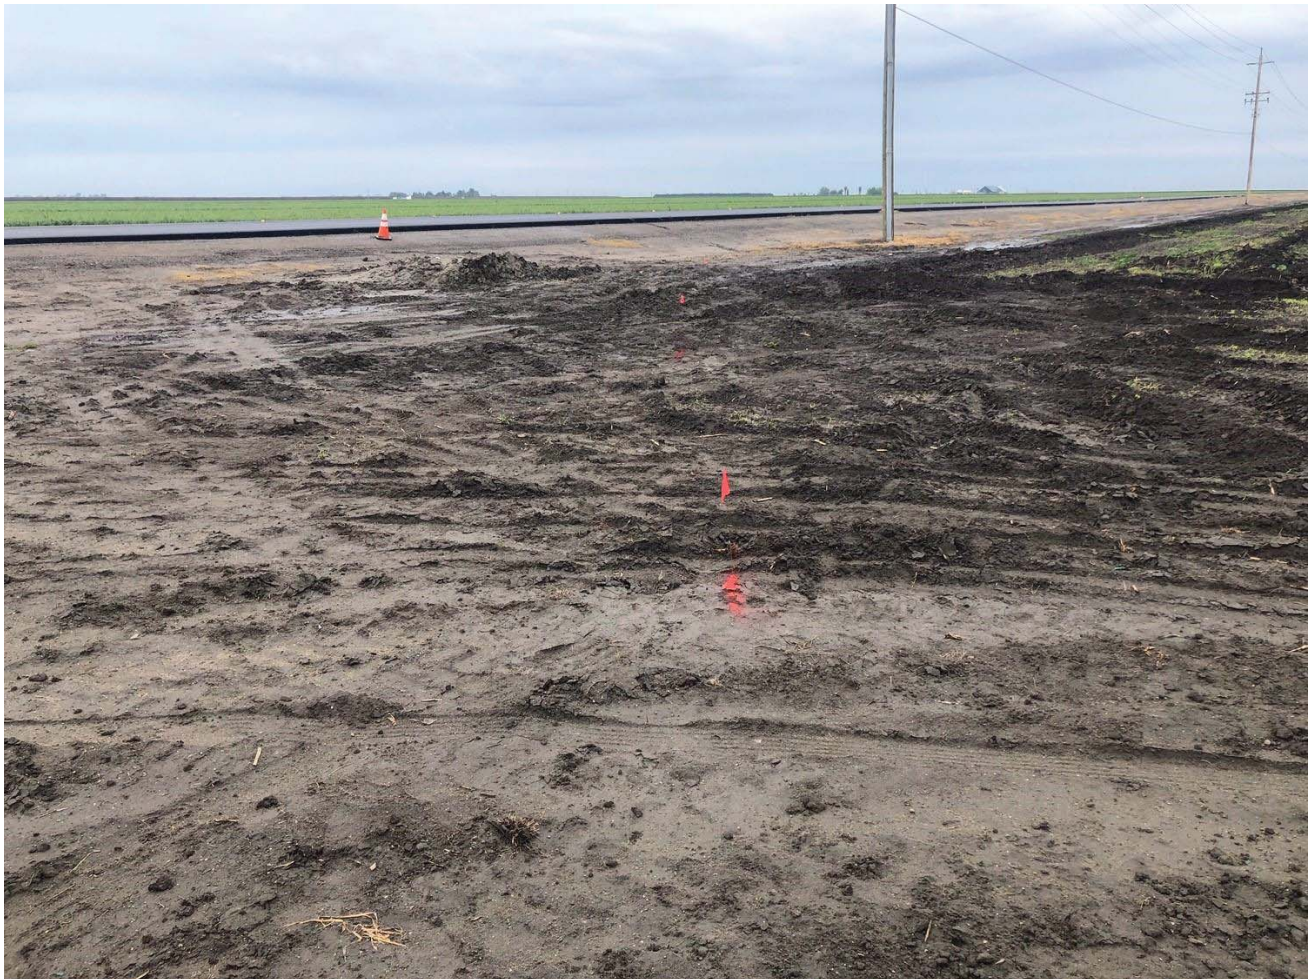
Photo: site of repaired line and new markings. Provided by Mr. Kincaid.

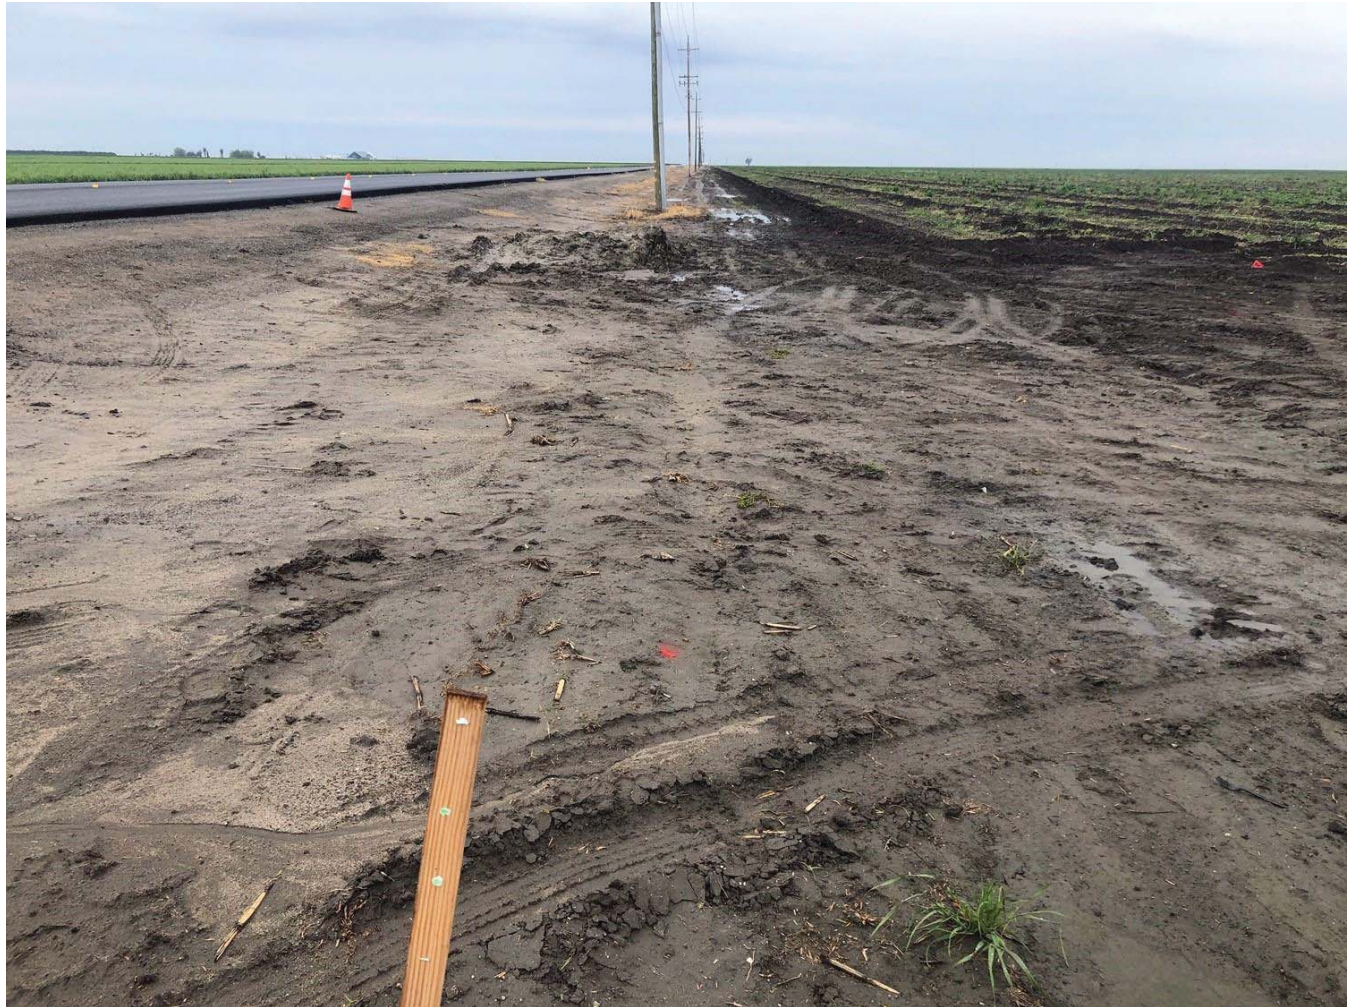
Photo: Potential old marking showing mismark. Provided by Mr. Kincaid.

The PG&E locator did not hook up the locate equipment to the meter directly. When the locator was unable to open the metal meter box, he hooked up to the box directly and received a false positive signal leading to the inaccurate marks, off by approximately 20 feet per the excavator and confirmed by the utility operator. The locator failed to communicate with the excavator that he was unable to hook up to the facility directly. Following the investigation, I concluded that PG&E violated GC 4216.3 (a)(1)(A)(ii) by not providing information of a buried facility’s location to the extent and accuracy that was available and violated GC 4216.4(d) by not communicating with the excavator on the inability to access the facility directly when said communication could have mitigated the locator’s lack of access to the facility, resulted in accurate markings, and potentially avoided the incident.
