NOD\_LU\_QAP\_20211207-01

## **NOTICE OF DEFECT**

# Energy Safety Inspection Report

Report Name: QAP\_LU\_20211207-01

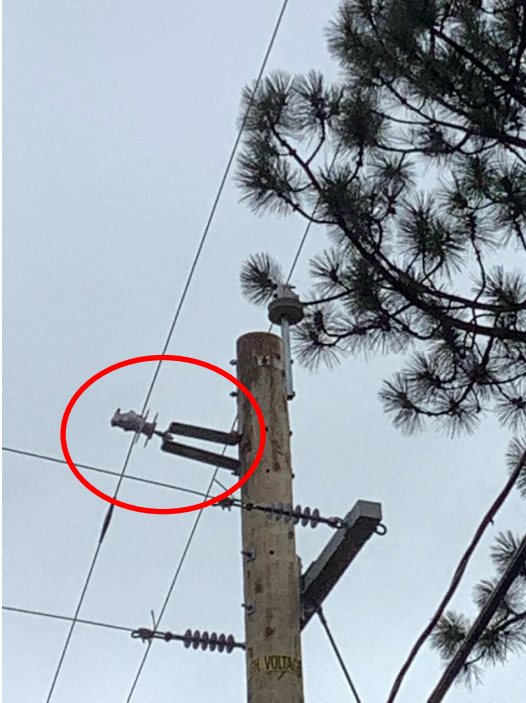
1. Defect 1: Energy Safety notes the conductor at Structure ID 294704 is not mechanically secured to the insulator. The conductor is resting on the insulator but should be secured within the vise of the vise top insulator. An unsecured conductor can fall off or pull out of the insulator or support structure, increasing the risk of a wire down event or potential ignition. Energy Safety considers this defect to be in the Moderate risk category.

During the inspection, Energy Safety discovered that the conductor at structure numbered 294704 was not mechanically secured to the insulator. The subject insulator is a vise top insulator type, which utilizes a clamp mechanism and bolts to secure the conductor to the insulator. Photos labeled Item5CD6Img1 and Item5CD6Img2 show the subject conductor resting on the side of the insulator and not within the vise. The conductor should be secured within the vise of the vise top insulator and bolts tightened to ensure the conductor is mechanically secured to the insulator. An unsecured conductor can fall off or pull out of the insulator or support structure, increasing the risk of a wire down event or potential ignition.

Item5CD6Img1: Conductor not secured

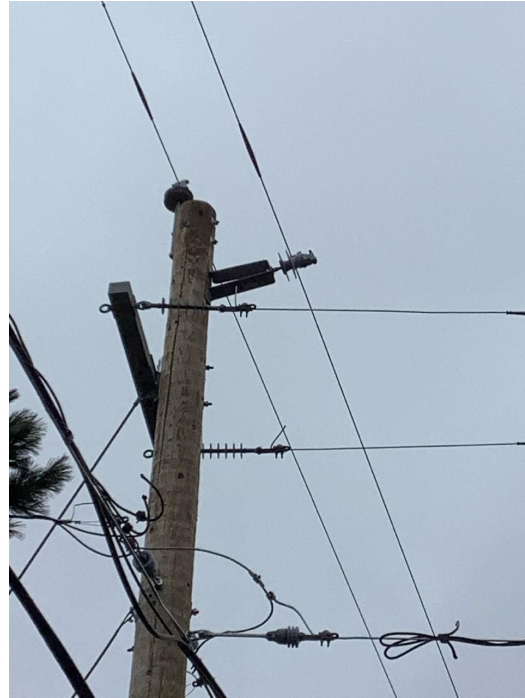
Item5CD6Img2: Conductor not secured
