OFFICE OF ENERGY INFRASTRUCTURE SAFETY

NOD_ MJ4_PGE_20211207_01

NOTICE OF DEFECT

Report Name: MJ4_PGE_20211207_01

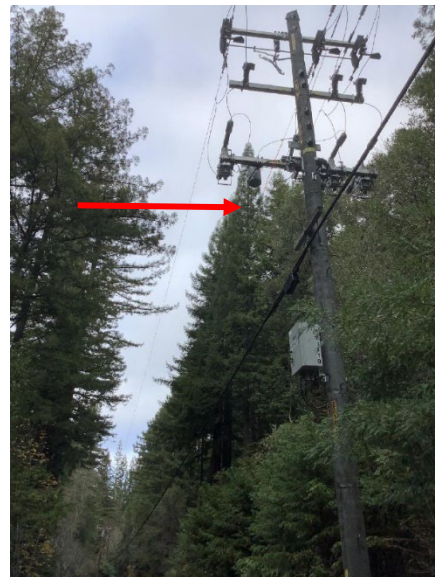
Structure ID: 121024191

Energy Safety also discovered one instance of a conductor that had an excessive number of splices along a single phase of overhead conductor. Energy Safety considers the presence of three or more splices along a single phase of conductor to be excessive. This excessive splicing is indicative of potential issues with electrical loading, physical weakening of the line, or a pattern of repeated failures. The weakening of conductors can result in increased risk of conductor failure or arcing that could result in an ignition. Repeated failures and splicing of a particular phase conductor highlight that the span in question is subject to risk drivers that cause line failures and increase the risk of causing a potential wildfire ignition. The structure where three or more splices were observed is identified in Table 2.

Photo 4: Picture of the primary conductors showing the middle phase conductor with four splices.

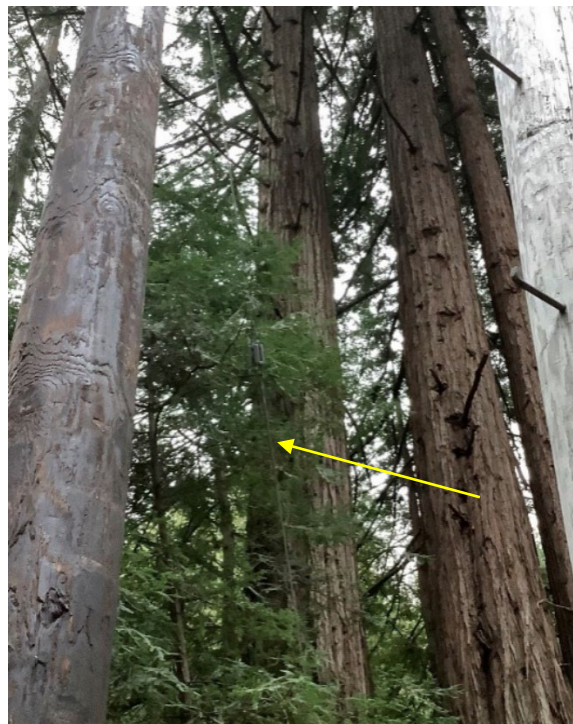
Structure ID: 120784771

During the inspection, Energy Safety discovered several instances where vegetation was in contact with a guy wire above the insulator. Guy wires are metallic and can become energized in some circumstances. Insulators break the current path and prevent electricity from reaching the ground where a down guy wire is anchored. However, the portion above the insulator may remain energized until the circuit is deenergized and may cause an ignition if in contact with vegetation while energized. Accordingly, Energy Safety considers vegetation in contact with down guy wires above the insulator a condition that increases an electrical corporation's ignition risk. Structures where vegetation was in contact with the guy wire above the insulator are noted in Table 2.

Photo 3: Picture of vegetation contacting the guy wire

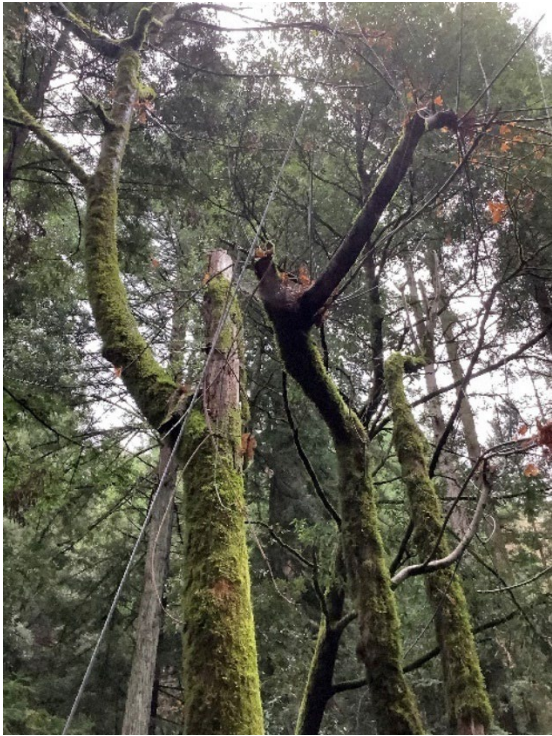
Structure ID: 120795203

Photo 3: Picture of vegetation contacting the guy wire

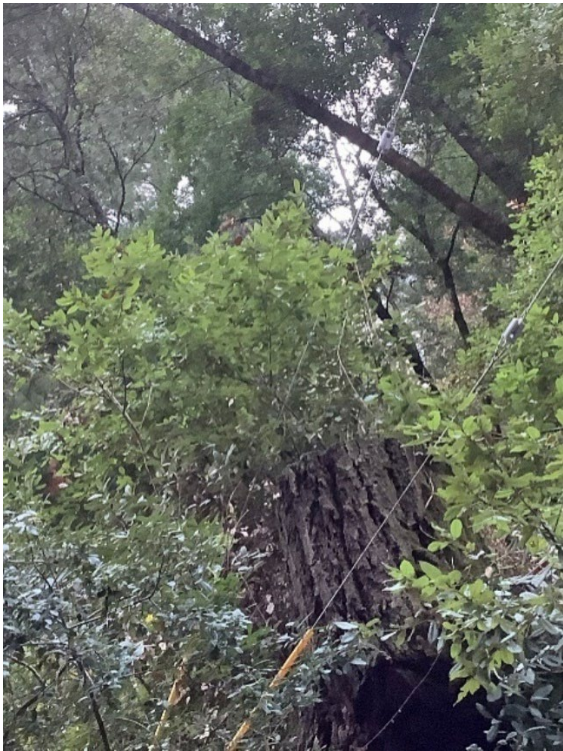
Structure ID: 120786270

Photo 3: Picture of vegetation contacting the guy wire

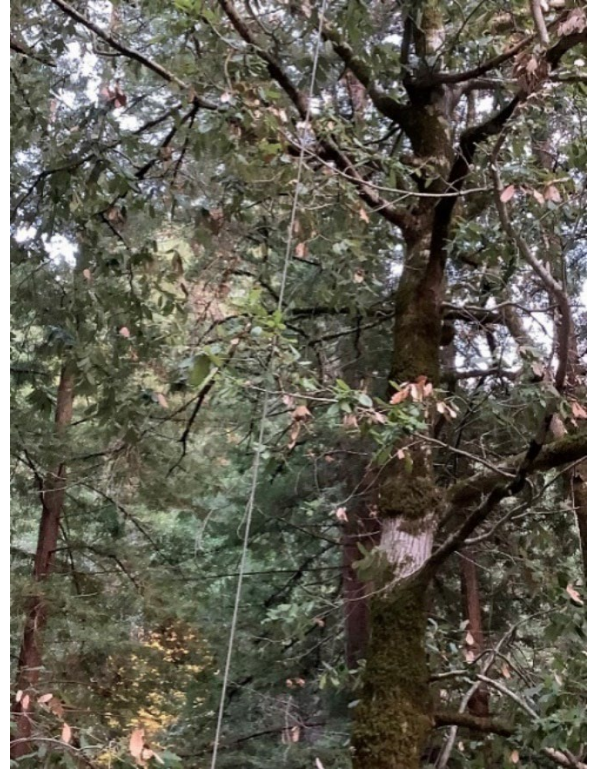
Structure ID: 120786268

Photo 3: Picture of vegetation contacting the guy wire

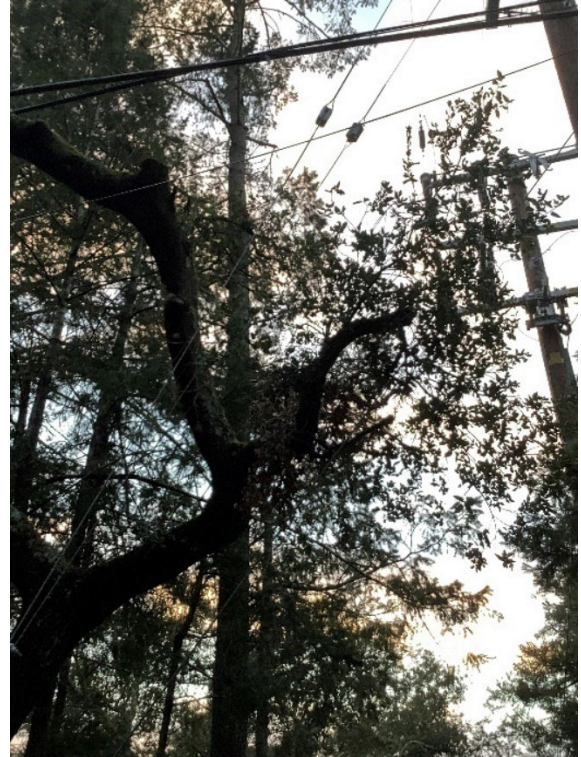
Structure ID: 120832674

Photo 3: Picture of vegetation contacting the guy wire
